CK-2263

STAVE 10.3km

2019 Inspection

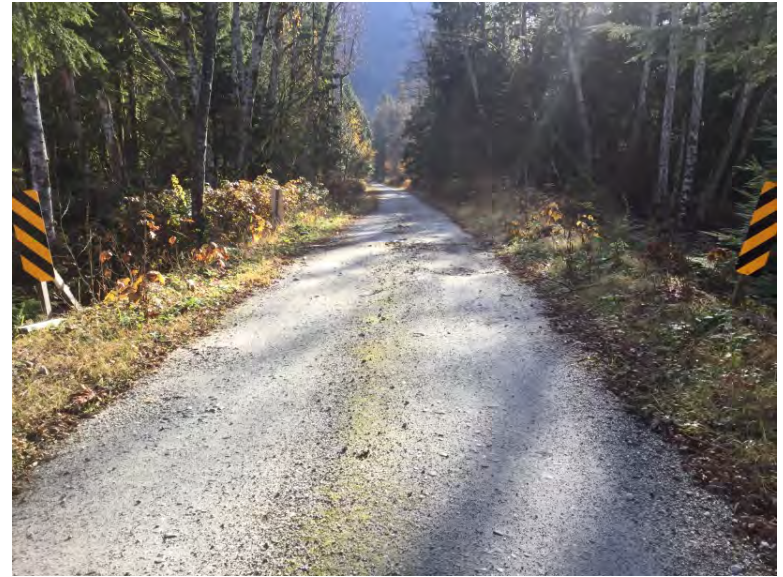
Overall Deck Condition Poor No guardrail

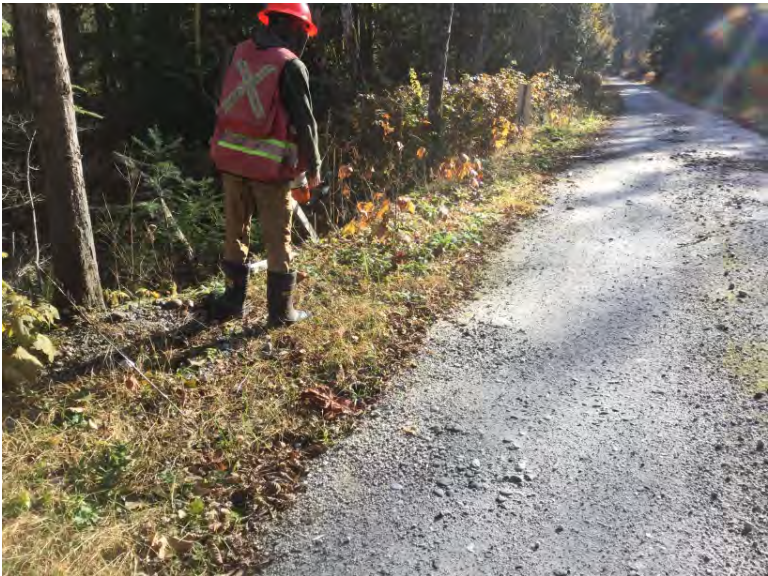
Curb Rail/Blocks/Posts Poor None

No guardrail

| Repair Item | Priority | Repair Description |
|---|---|---|
| 1 | High | Install curb logs or remove and replace bridge |

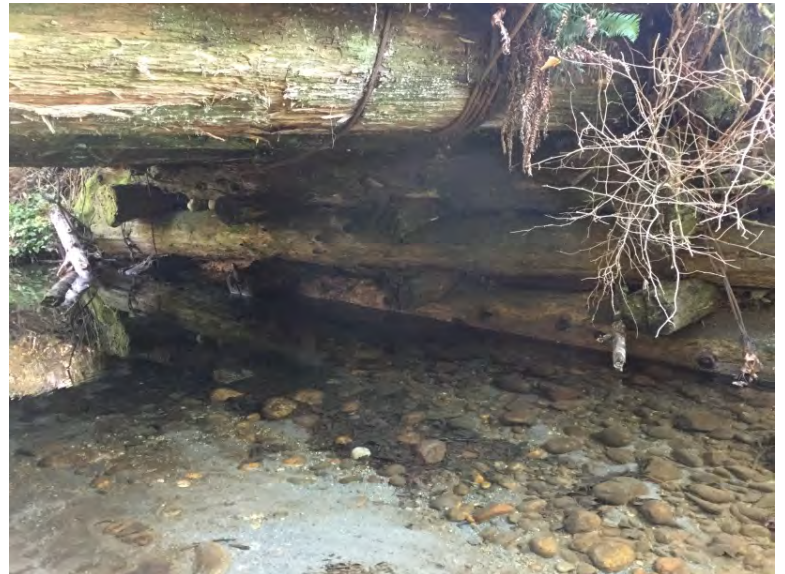
Left Bank Abutment when facing downstream

3x left bank with horizontal cracking on top log, 1x right bank

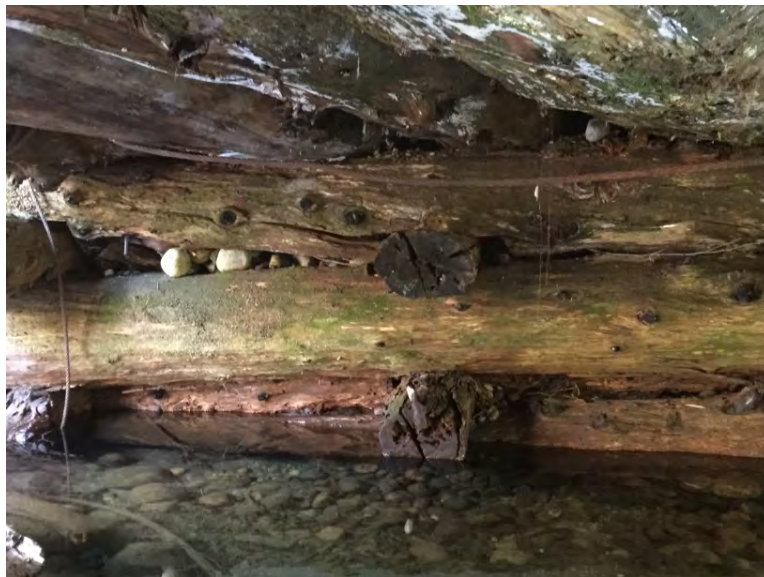
Uneven bearing as top log cracked and settling

Top face log horizontally cracked

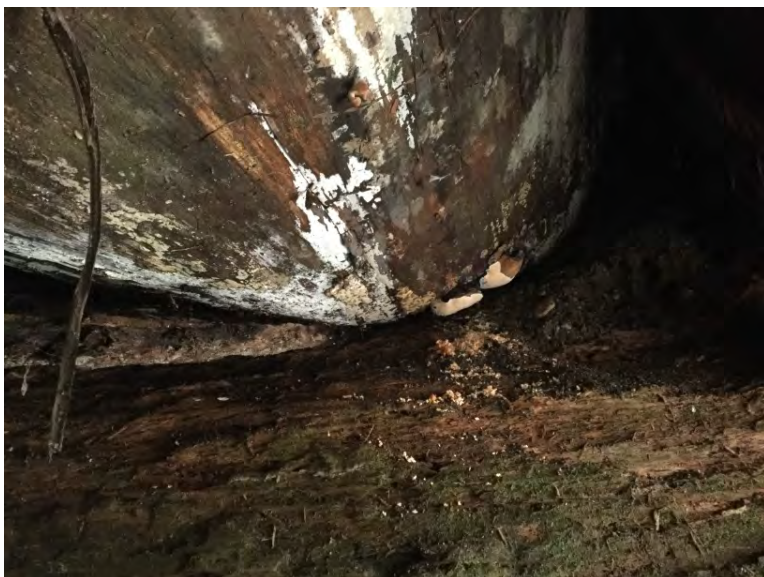
Stringer 2 condition

| 2 | Cw | Y | 900 | 30 | | Fruiting bodies present |
