CK-2264

STAVE 11.9km

2019 Inspection

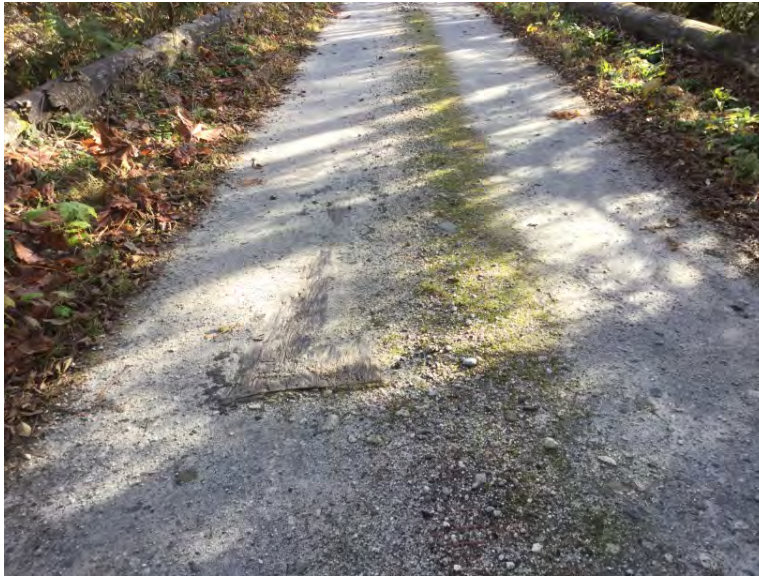
Too shallow

Running directly on stringer

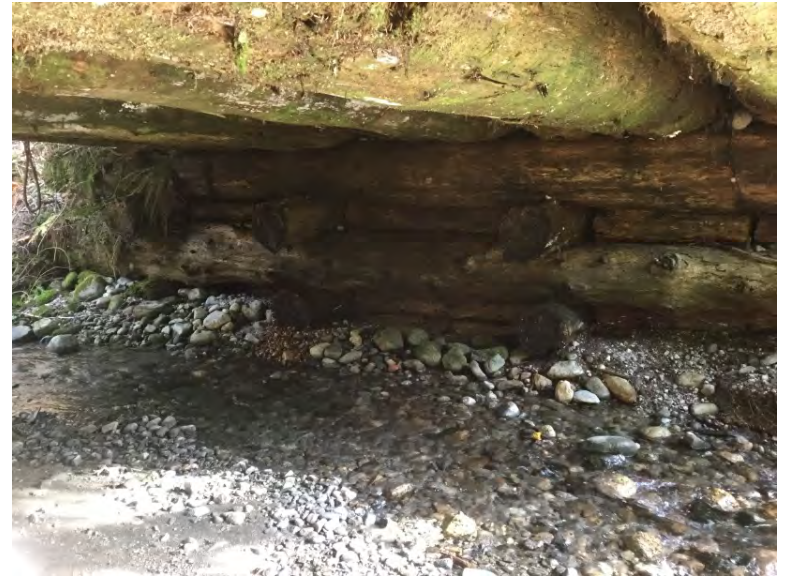
Left Bank Abutment when facing downstream

Log/Timber Cribbs Fair 3x face logs

Tie Backs Poor 4x with end splits and rot

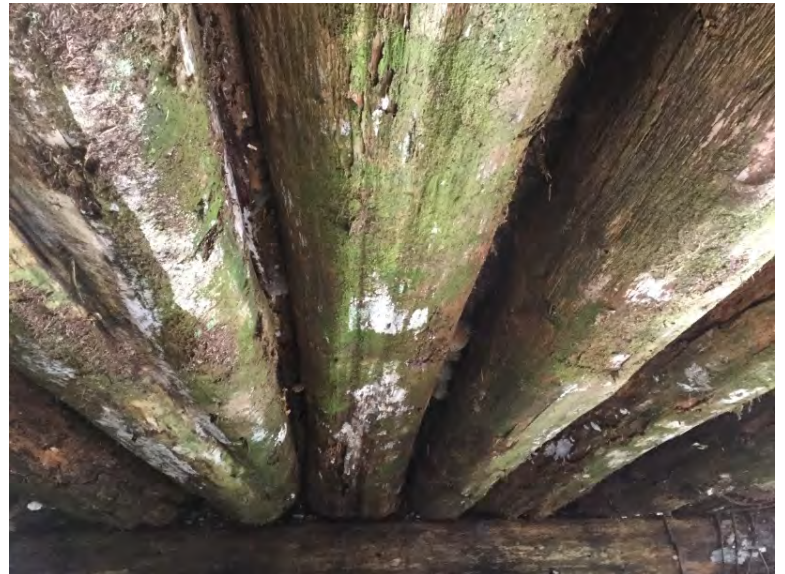
Stringers

The structure continues to degrade. Fruiting bodies or conk are visible on the outside top layer of stringers (visible on downstream end). Without the top layer of stringers being visible for a more thorough inspection all stringers are assumed to be degrading similar to that of the outside ones. Limit loading to 20 tonnes and plan to replace the structure soon. Post load rating signs.

| Repair Item | Priority | Repair Description |
|---|---|---|
| 1 | High | Post load rating sign |

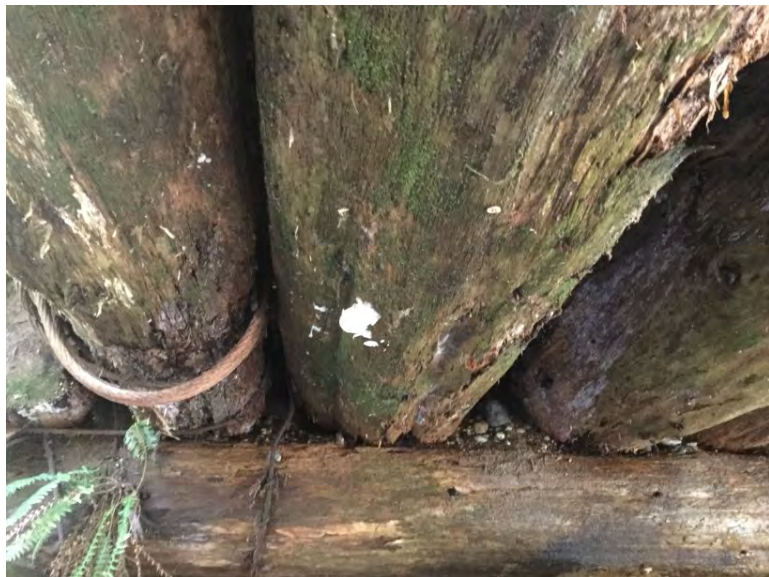
Stringer 2

| Stringer<br>Number | Species | Peeled | Diameter<br>(mm) | Rot Depth<br>(mm) | Condition | Comment |
|---|---|---|---|---|---|---|
| 2 | Cw | Y | 620 | 60 | Fair | 20mm sap and 10mm heart |

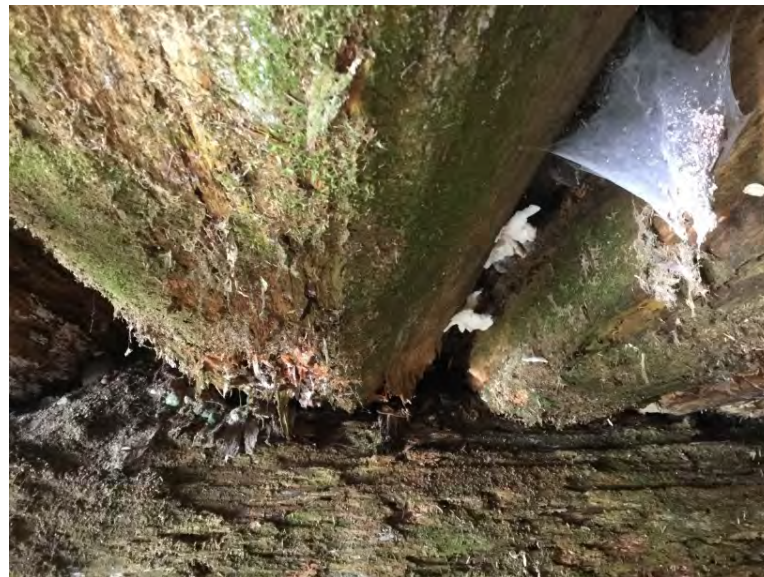
Stringer 4

| Stringer<br>Number | Species | Peeled | Diameter<br>(mm) | Rot Depth<br>(mm) | Condition | Comment |
|---|---|---|---|---|---|---|
| 4 | Cw | Y | 580 | 50 | Fair | 25mm sap |

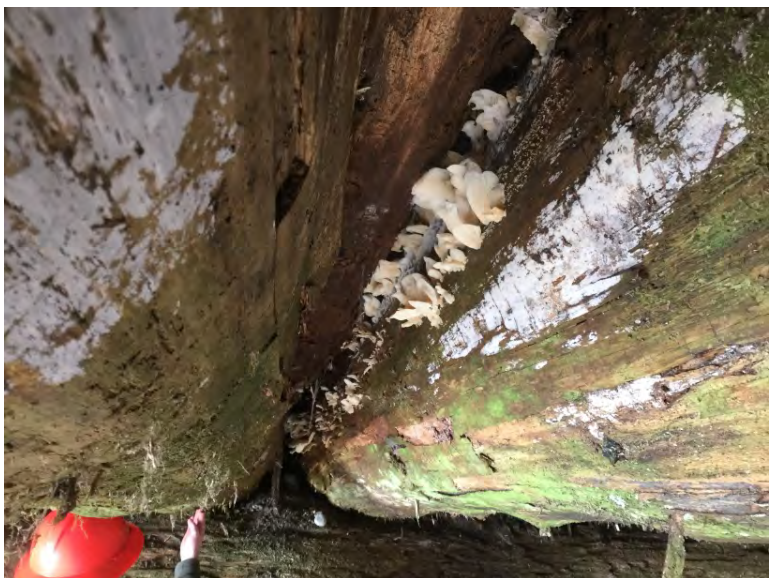
Stringer 5

| Stringer<br>Number | Species | Peeled | Diameter<br>(mm) | Rot Depth<br>(mm) | Condition | Comment |
|---|---|---|---|---|---|---|
| 5 | Cw | Y | 565 | 50 | Fair | 25mm sap rot |

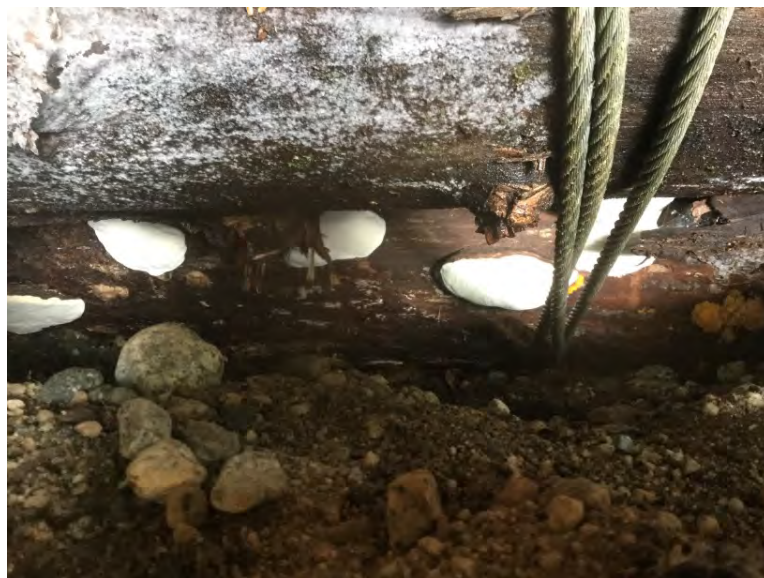
Top layer of stringers condition
