CK-2265

STAVE 12km

2019 Inspection

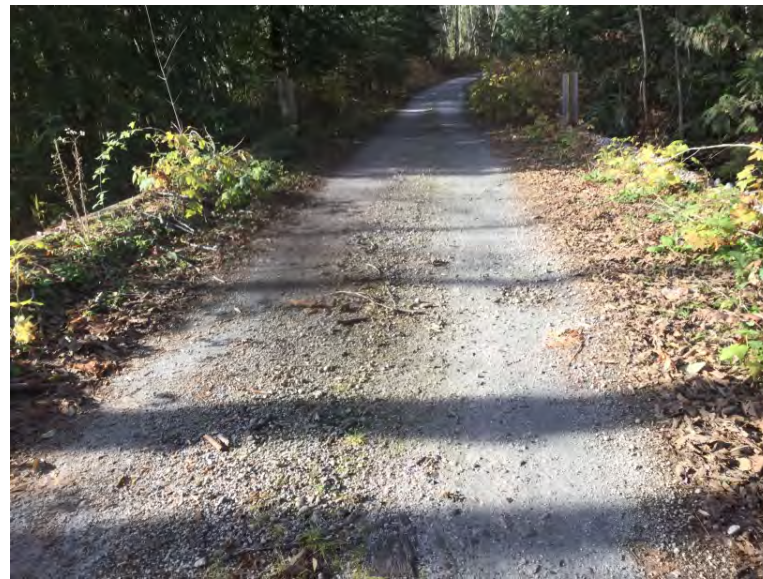
| Overall Deck Condition | Poor | Due to rail and gravel deck thickness |

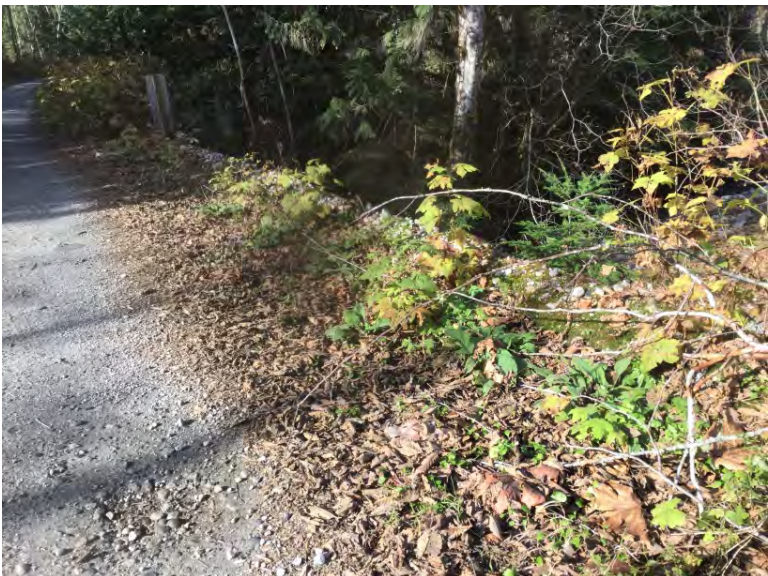
| Curb Rail/Blocks/Posts | Poor | Too small |

| Hardware | Poor | No rail hardware |

No guardrail

| 2 | High | Place properly sized curb logs |

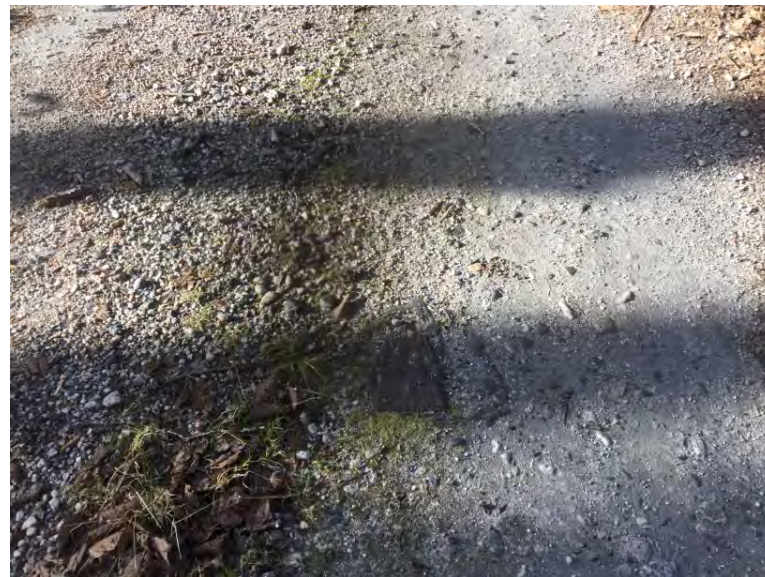
Running directly on stringer

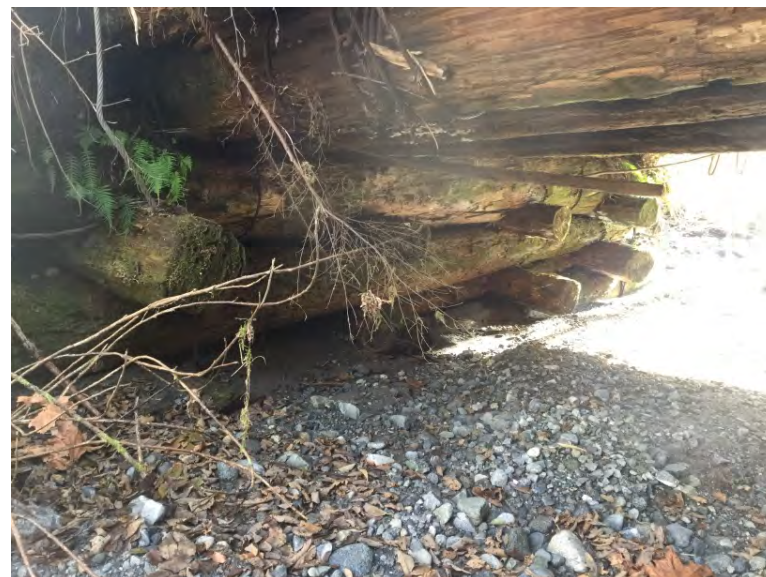
Left Bank Abutment when facing downstream

Log/Timber Cribs Poor Old and rotting, left bank splitting top face log

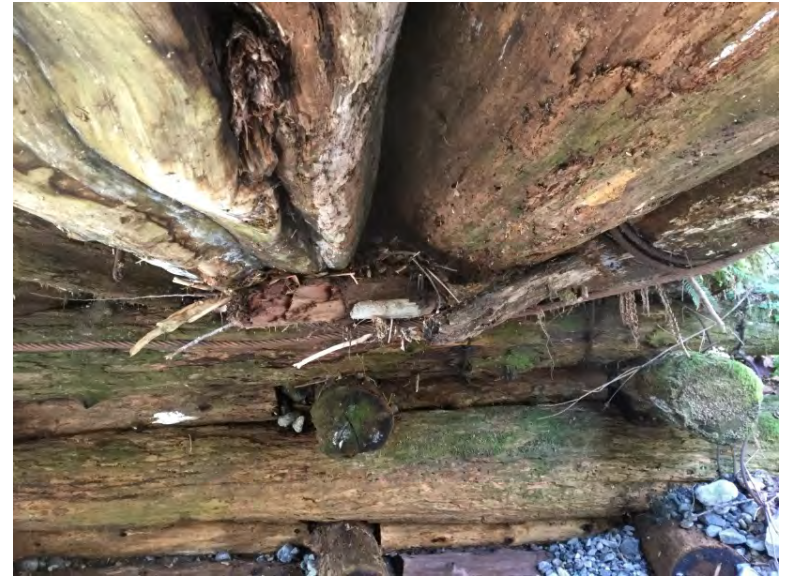
Evidence of stream flow at stringers

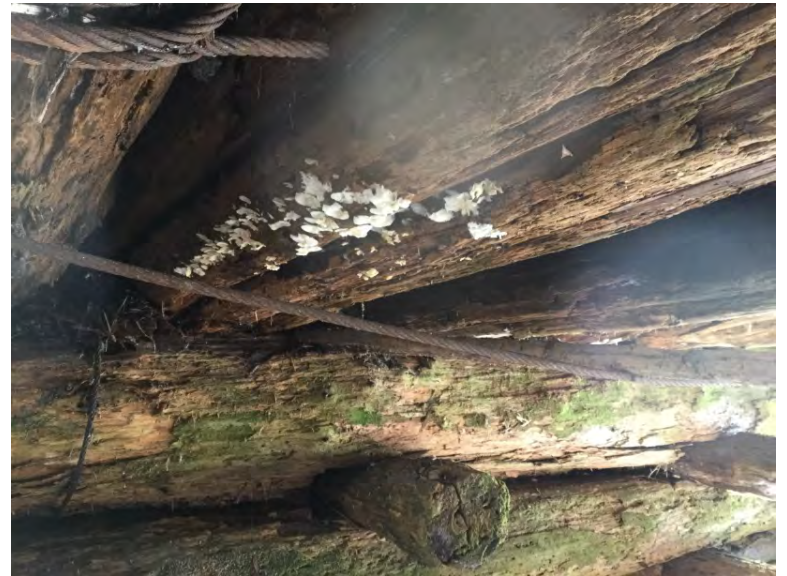
Stringer 2

| Stringer<br>Number | Species | Peeled | Diameter<br>(mm) | Rot Depth<br>(mm) | Condition | Comment |
|---|---|---|---|---|---|---|
| 2 | Cw | Y | 790 | 40 | Fair | 20mm sap rot |

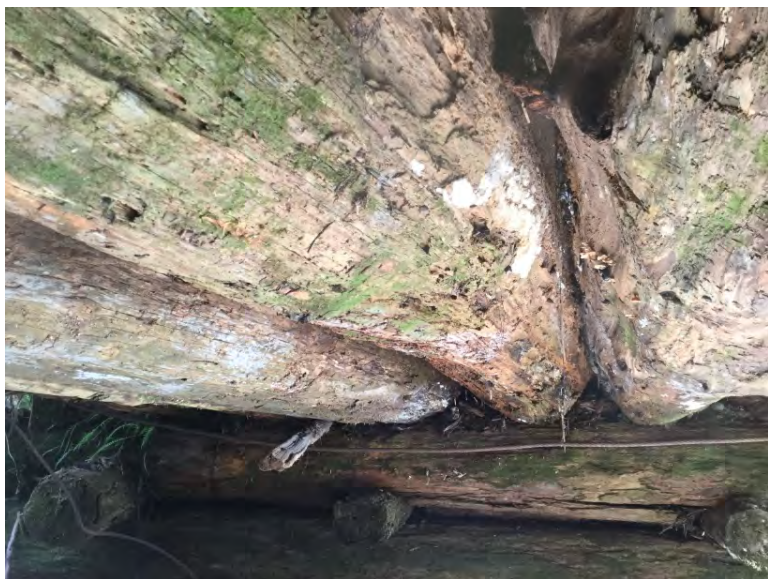
Stringer 4

| Stringer<br>Number | Species | Peeled | Diameter<br>(mm) | Rot Depth<br>(mm) | Condition | Comment |
|---|---|---|---|---|---|---|
| 4 | Cw | Y | 720 | 120 | Poor | 20mm sap and 40mm pocket |

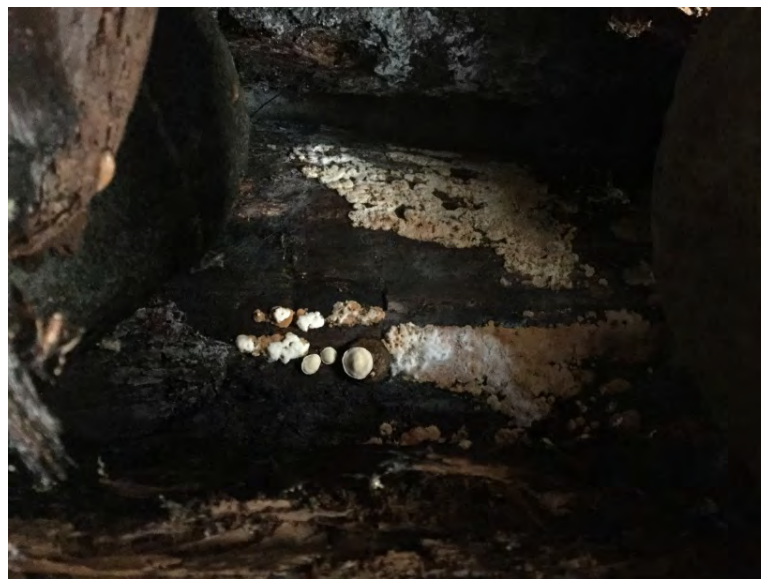
Top layer of stringers

The structure continues to degrade. Fruiting bodies or conk are visible on the outside top layer of stringers (visible on downstream end). For the top layer of stringers, all of them are assumed to be degrading similar to that of the outside ones. Current load rating of 10 tonnes to continue and plan to replace the structure soon. Post load rating signs and place properly sized curb logs.

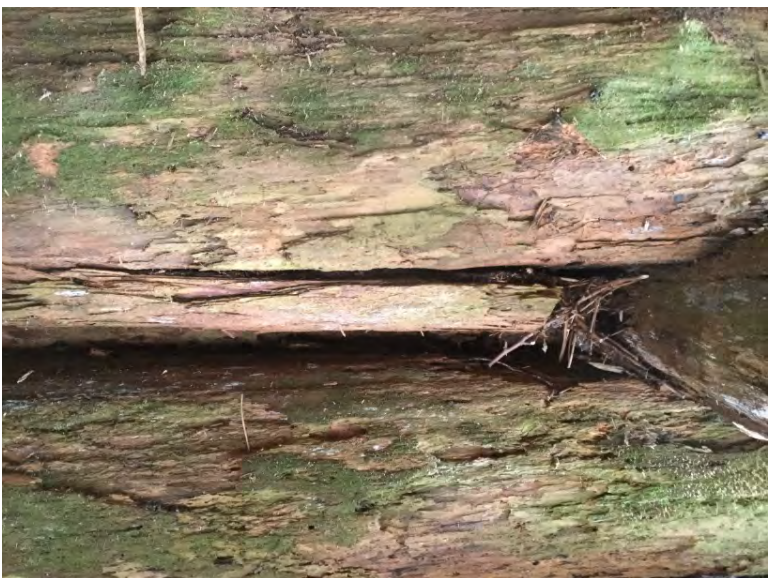
Top face log at left bank horizontal crack

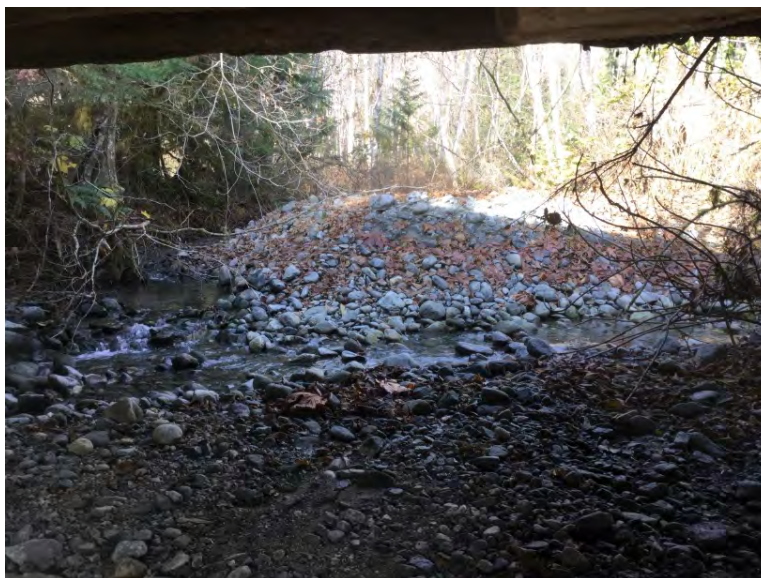
| Estimated Present Water Level Width (m) | 2.0 | Aggradation | <input checked="" type="checkbox"/> | Scour | <input type="checkbox"/> |

Inlet aggradation
