CK-2266

STAVE 15.8km

2019 Inspection

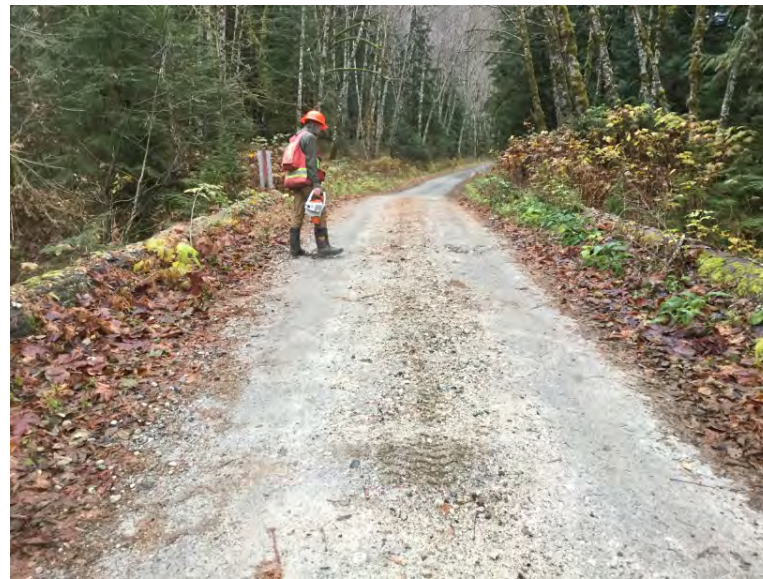
Hardware Poor No connection visible

Overall Deck Condition Fair

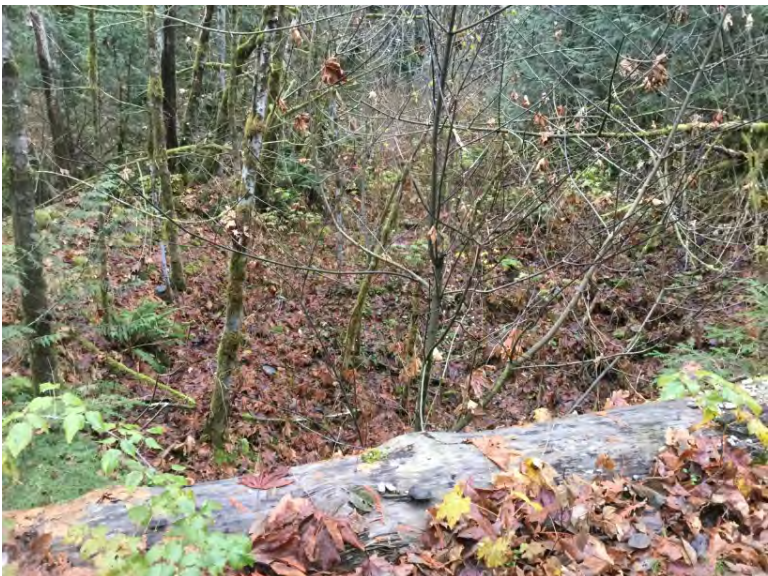
Upstream from Crossing

Comments No stream flow through crossing for years now

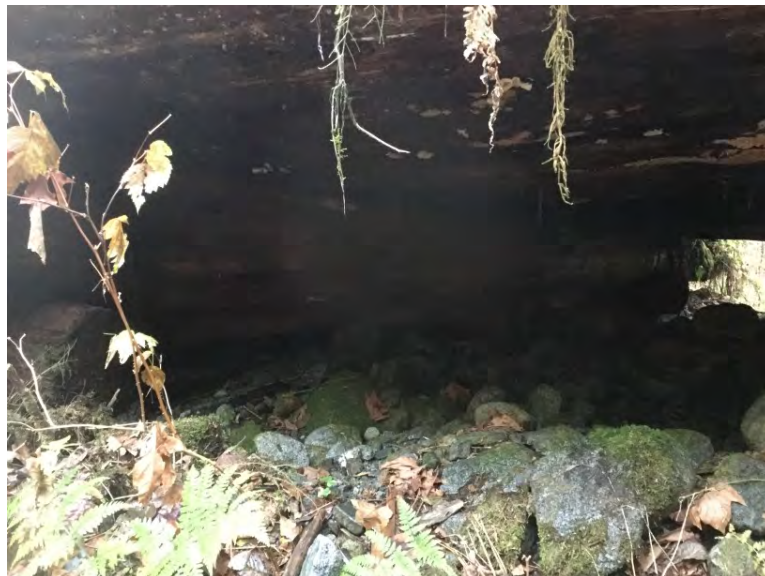
Left Bank Abutment when facing downstream

2x face logs with 100mm sap rot

End splitting and rotten

Loose lashing

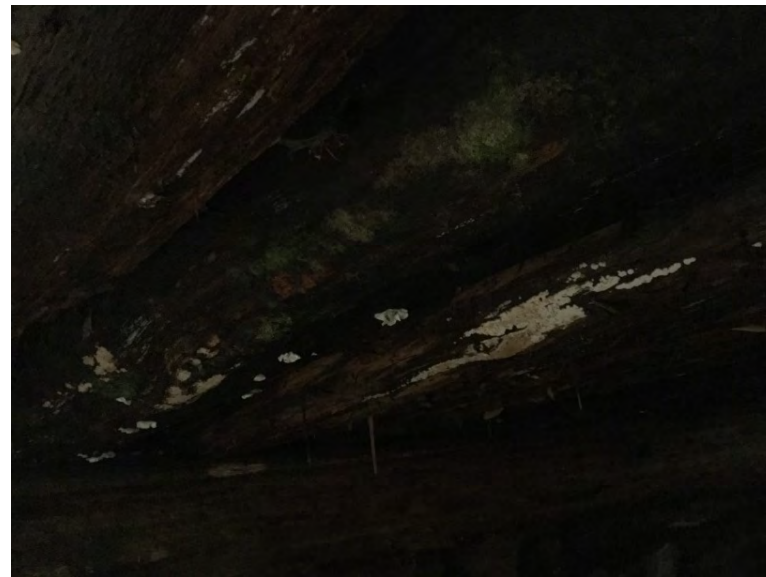
Stringers

Use stringer diameters and rot from last year for bottom stringers  
Use asbuilt information for top stringers  
No change in condition  
Replace bridge soon

The current load rating of 30 tonnes can continue. Post load rating signs and plan for a complete replacement soon.

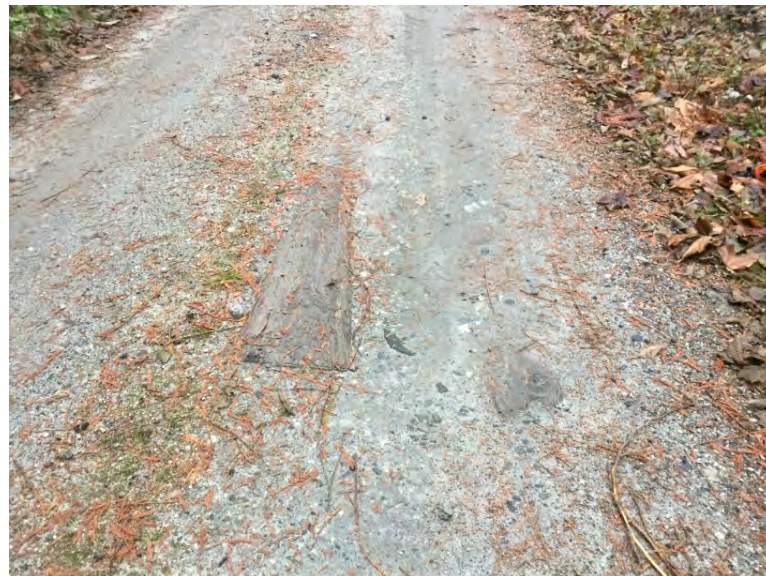
Top layer of stringers right at running surface
