CK-2267

STAVE 17.8km

2019 Inspection

| Crossing Name | Ole Creek | | |

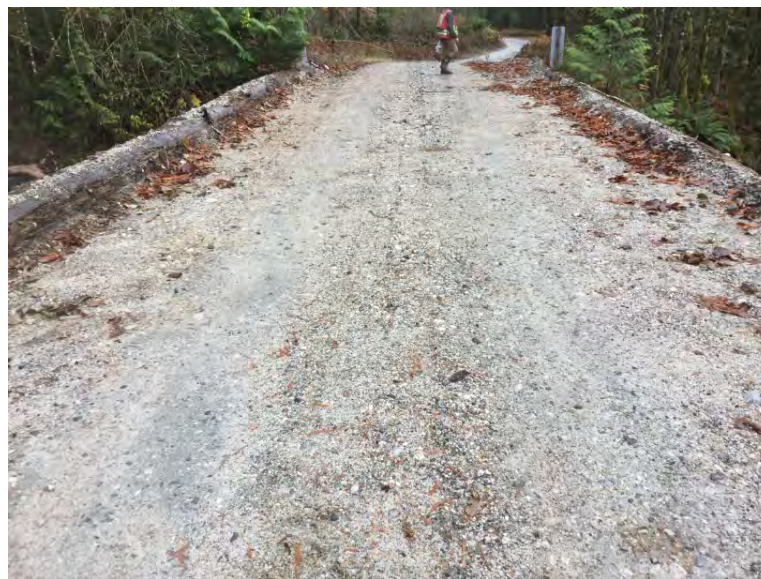
Deck

Gravel Surface **Fair**

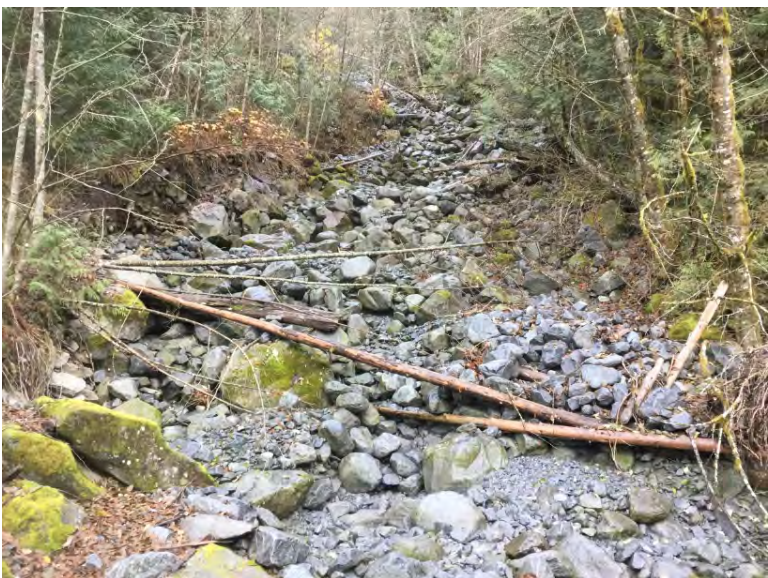
Upstream from Crossing

Comments    Inlet 50% plugged

Current load rating of 10 tonnes to continue. Due to the poor condition of the entire structure continue to monitor it while in use, and inspect after heavy precipitation events. Consider cleaning the inlet to increase hydraulic capacity. Post load rating signs. Plan to replace the structure soon.

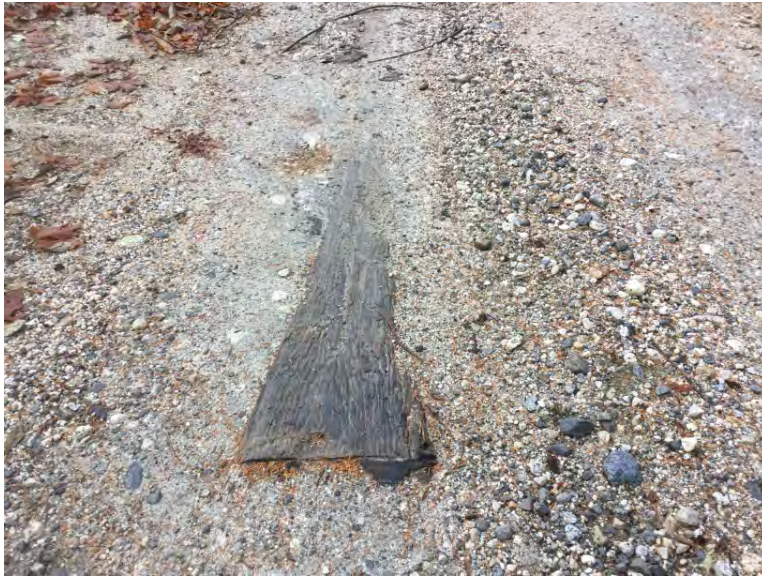
Stringers at surface

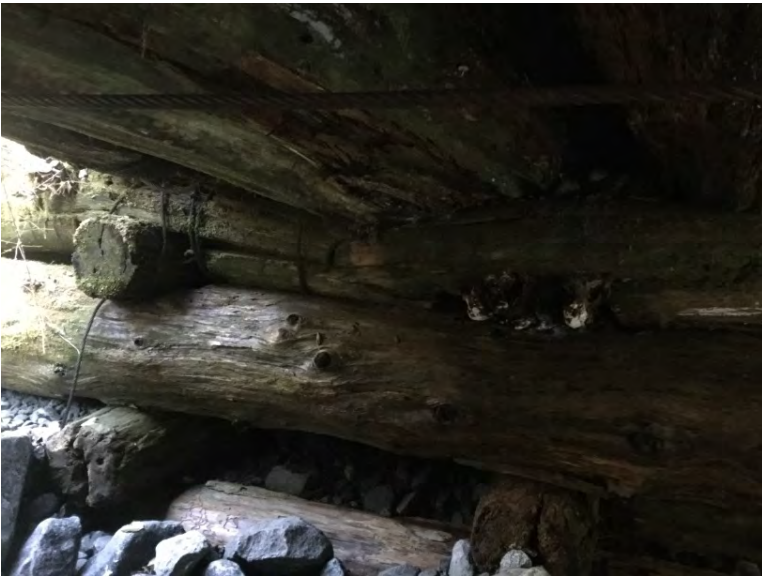
Top face log on left bank cracked horizontally and vertically

Left bank top face log cracked resulting in inconsistent bearing

Top crib log at left bank cracked horizontally and vertically

2    High    Replace

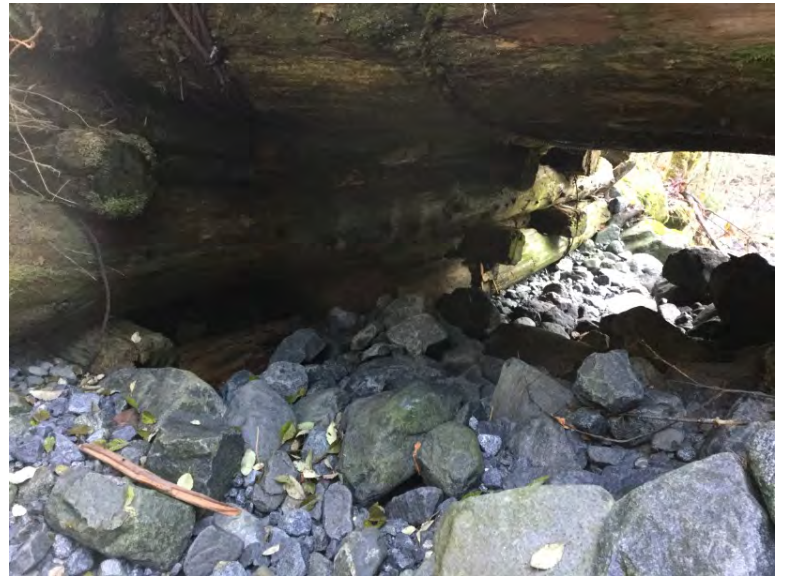
Left Bank Abutment when facing downstream

Log/Timber Cribs Poor

End splitting and rotten

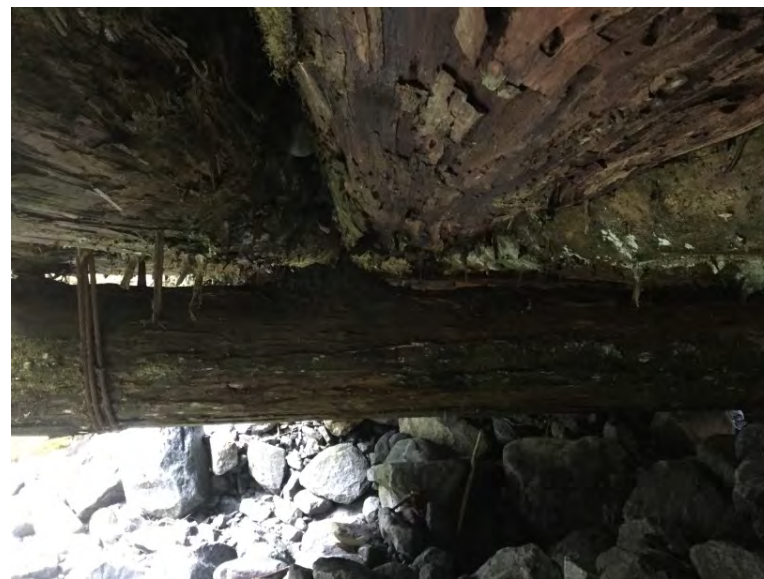
Needle Beam Poor Loose and ineffective

Needle Lashing/  
Shimming Poor Loose and ineffective

Needle beam not functional
