CK-2270

STAVE 22.2km

2019 Inspection

| Crossing Name | Side Creek | | |

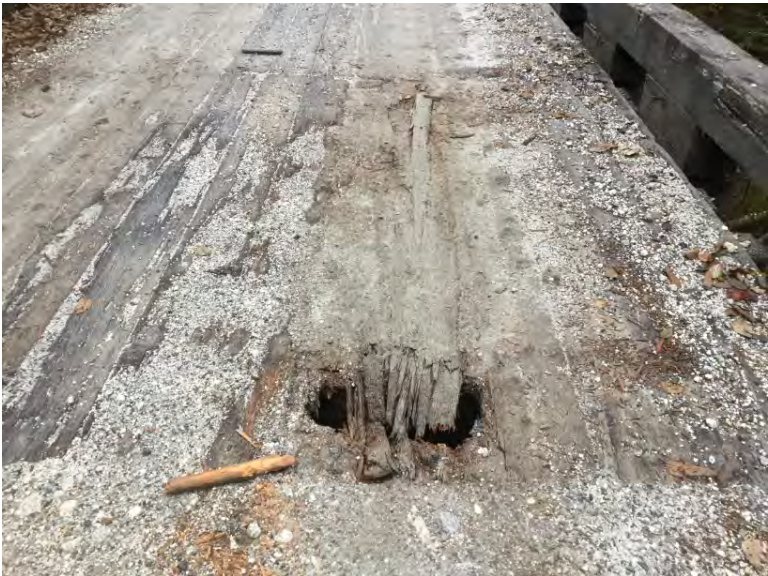
| Running Planks | Poor | Wheel path planks rotten |

Timber deck condition

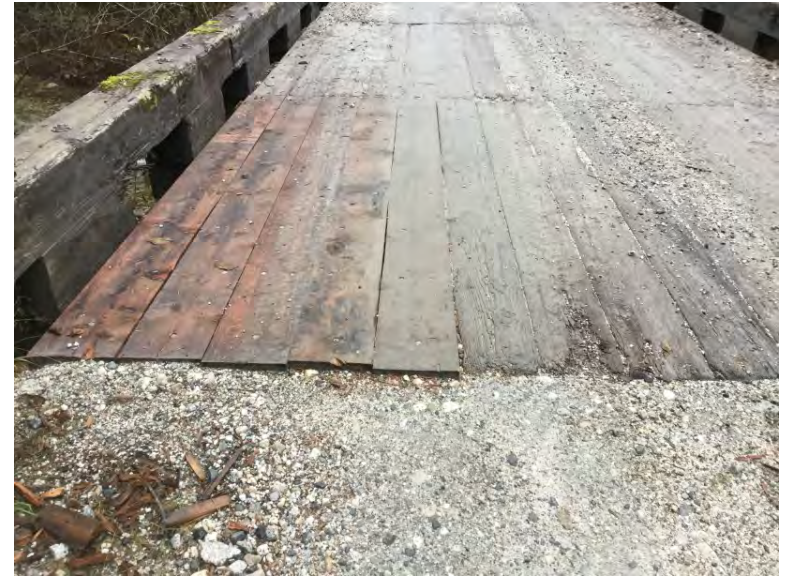
Some planks recently replaced at right approach

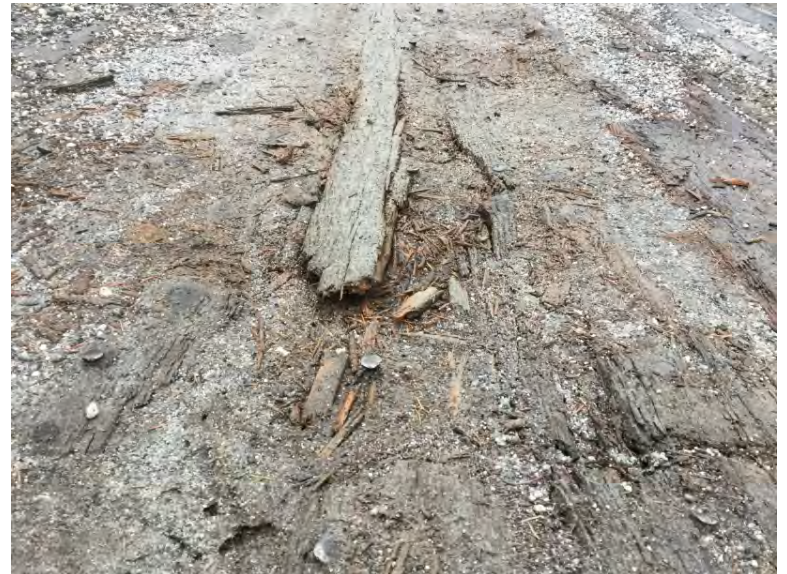
| Nails | Poor | On rotten planks nails protruding |

Nails protruding through planks

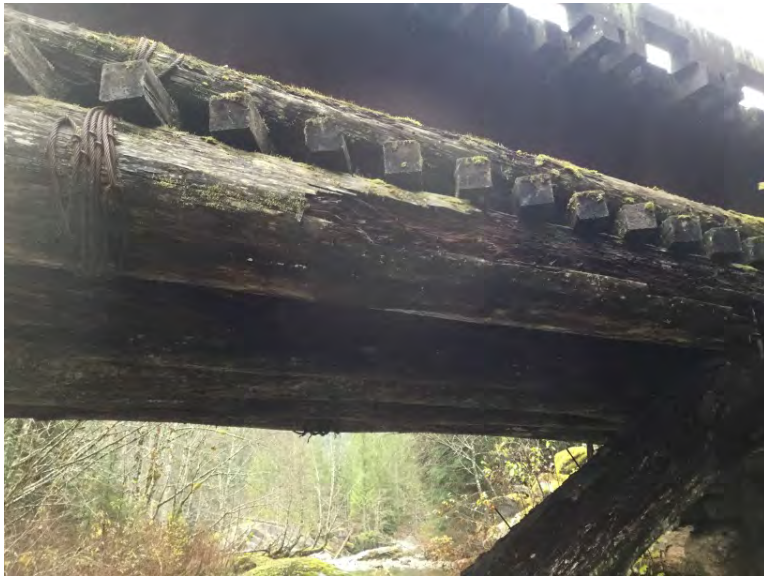
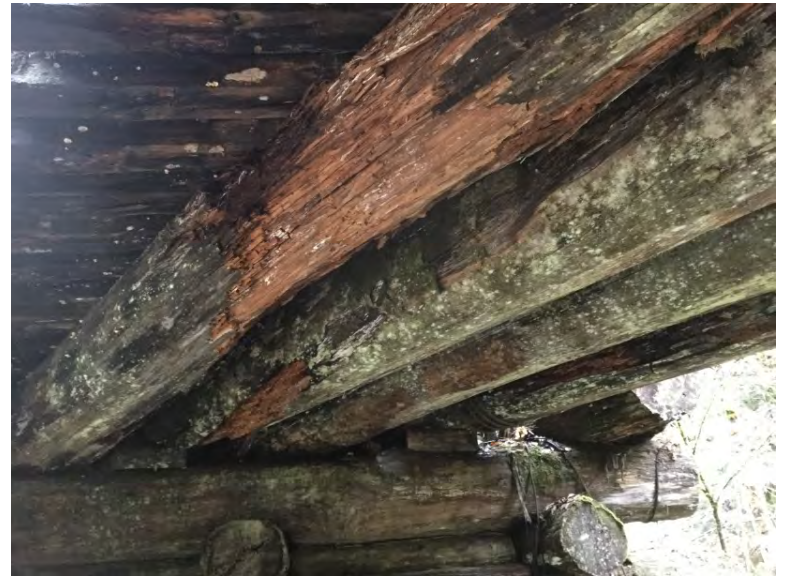
Stringers

The upstream left bank bearing of the steel girder has now been compromised due to a failed log stringer. The remaining log stringers are in extremely poor condition and the structure is at risk to failure. Bridge condemned (0 tonnes load rating). In the interim, if daily use of the structure is required the RUP holder must submit a plan in order to monitor its current condition and the required load rating until the structure is replaced. This plan must be submitted to the district and approved prior to implementation.

Comments Rotten stringers under steel girder put entire structure at risk

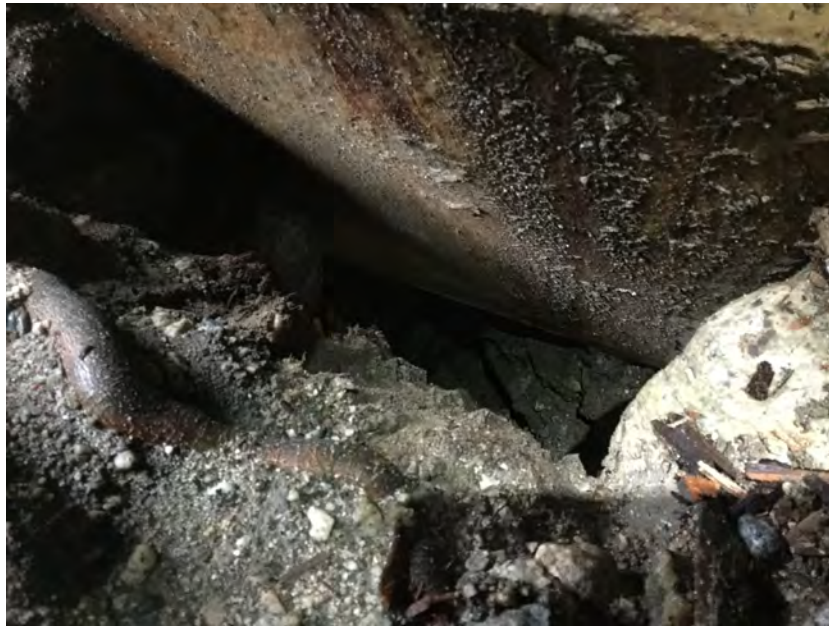
Upstream left bank lock block has been undermined

Failed under upstream left bank lockblock

Upstream left bank has inconsistent bearing capacity due to failed stringer and undermined

Scour under upstream left abutment lock block
