CK-2271

STAVE 24.6km

2019 Inspection

| Crossing Name | Stave River |

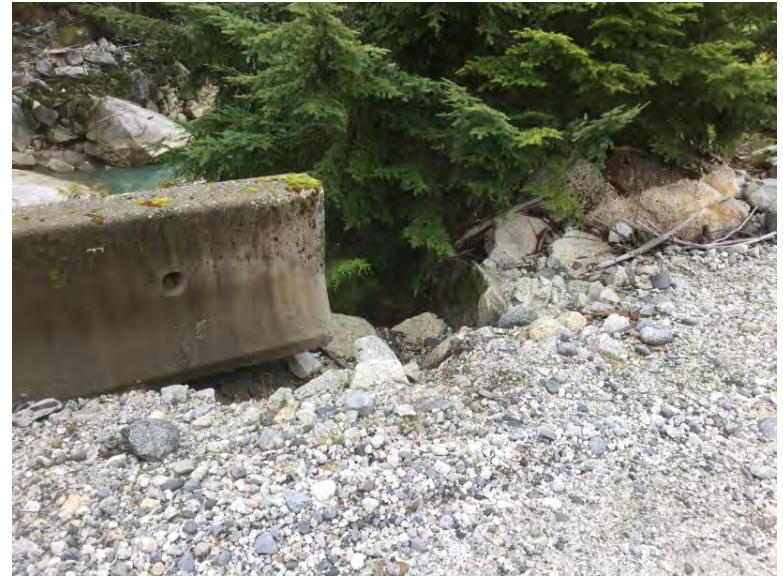
Eroding downstream right bank

Eroding fill on downstream right approach

| Item | Priority | Repair Description |
|---|---|---|
| 4 | Medium | Repair the failing fill at downstream right bank approach and add transition and bullnose to CRB |

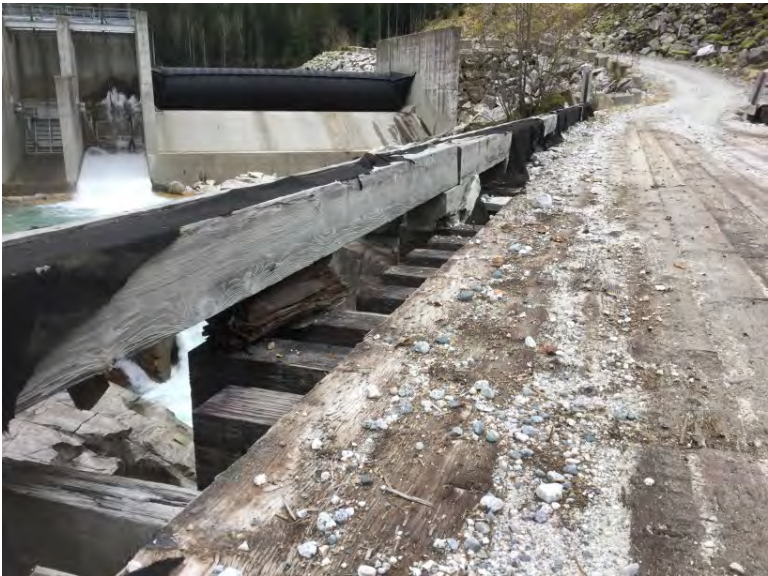
| Curb Rail/Blocks/Posts | Poor | Rotten risers |

Rotten risers

| Item | Priority | Repair Description |
|---|---|---|
| 3 | Medium | Replace guardrail and risers |

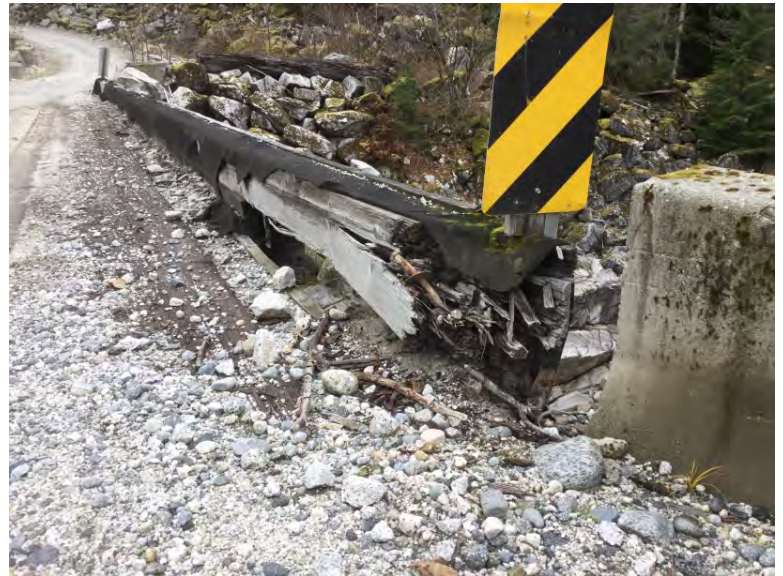
| Hardware | Poor | Loose rail bolts |

Guardrail damage

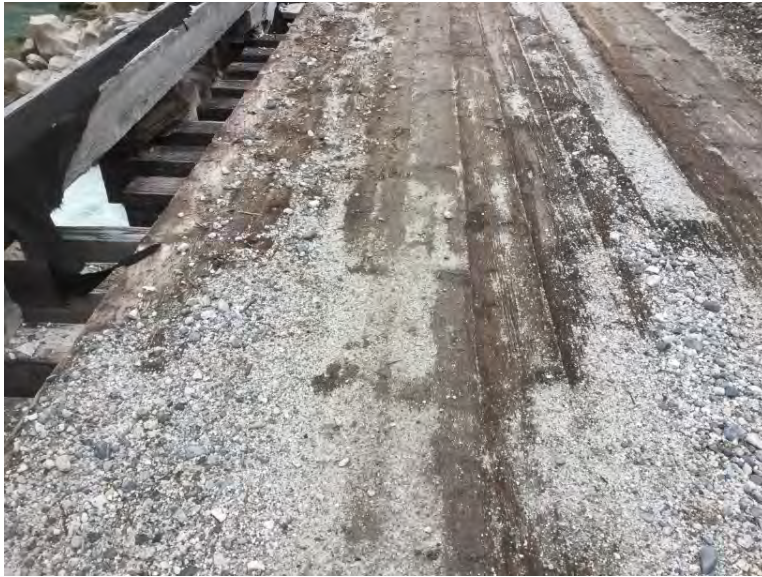
| Running Planks | Poor | Creosote planks wearing on wheel path |

Rotting deck planks

| Item | Priority | Repair Description |
|---|---|---|
| 2 | High | Replace worn/rotten planks and place wear planks on top for added protection |

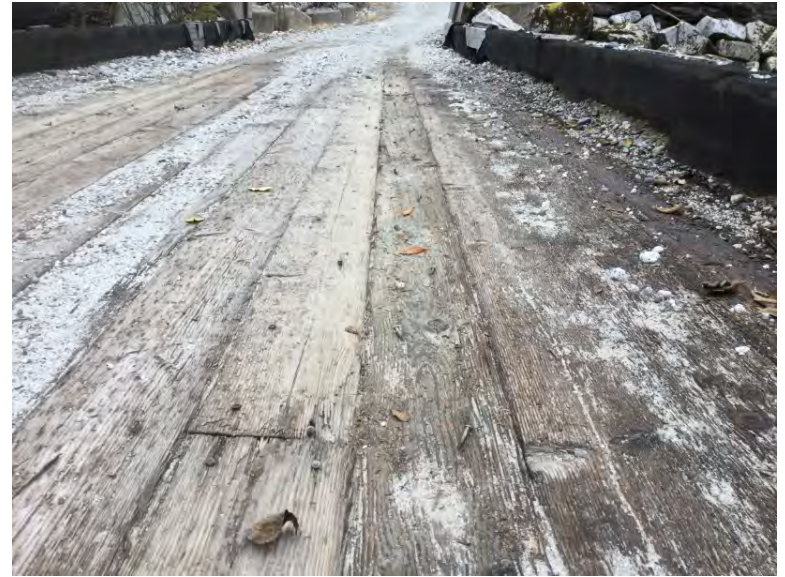
Rotting deck planks

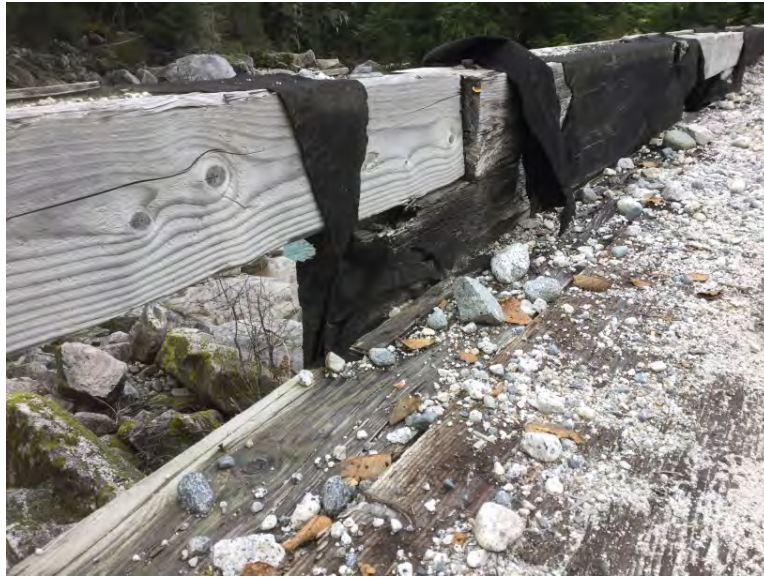
Guardrail condition

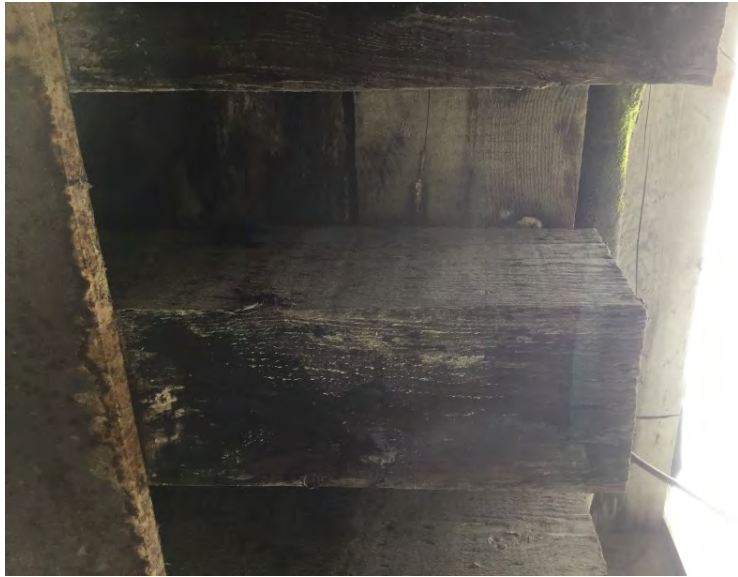
Upstream planks are untreated

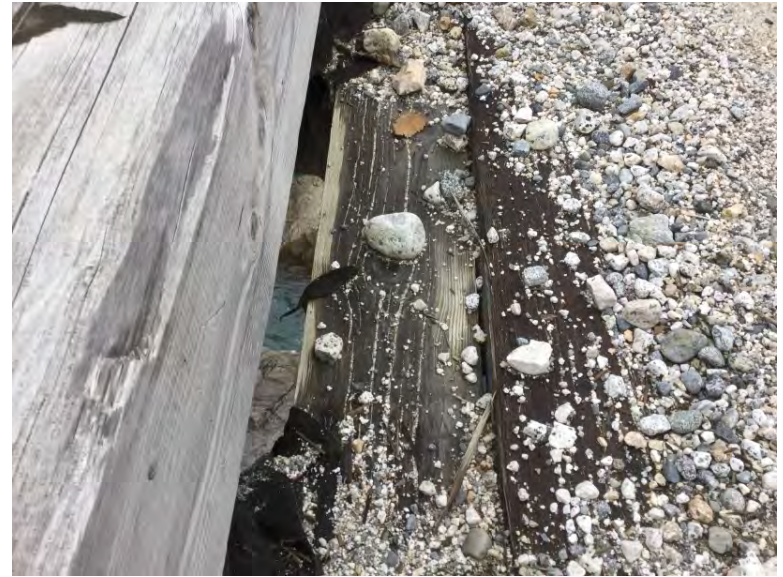
Downstream planks are untreated

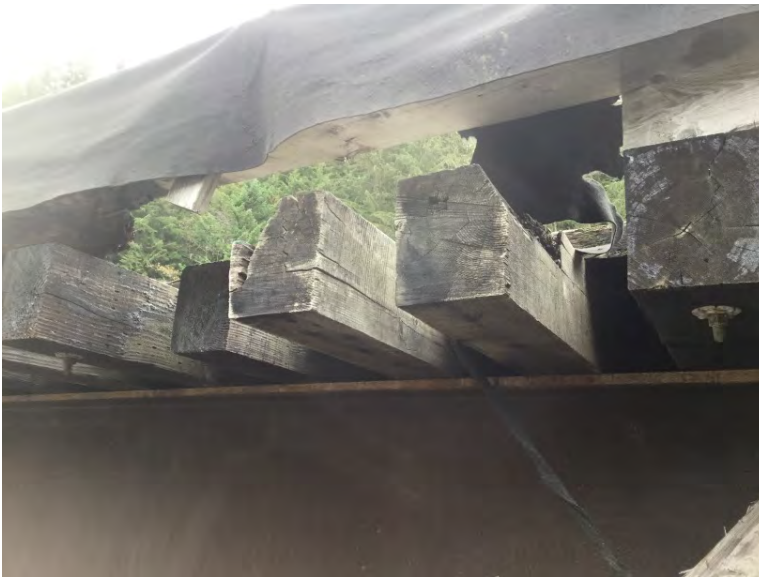
| Ties | Good | 2 untreated ties at right bank to be replaced |

2 untreated ties at right bank untreated and in poor condition

Replace the running planks and add wear planks on top of those to help protect the creosoted ties. Replace the 2 untreated ties at the right bank at the same time. Replace the guardrail and risers. Repair the failing fill located at the downstream right bank approach and add a concrete transition and bull nose. The current load rating of L45 or 41 tonnes to continue. Post load rating signs.
