CK-2273

STAVE 29km

2019 Inspection

| Structure Class | Major Culvert | | |

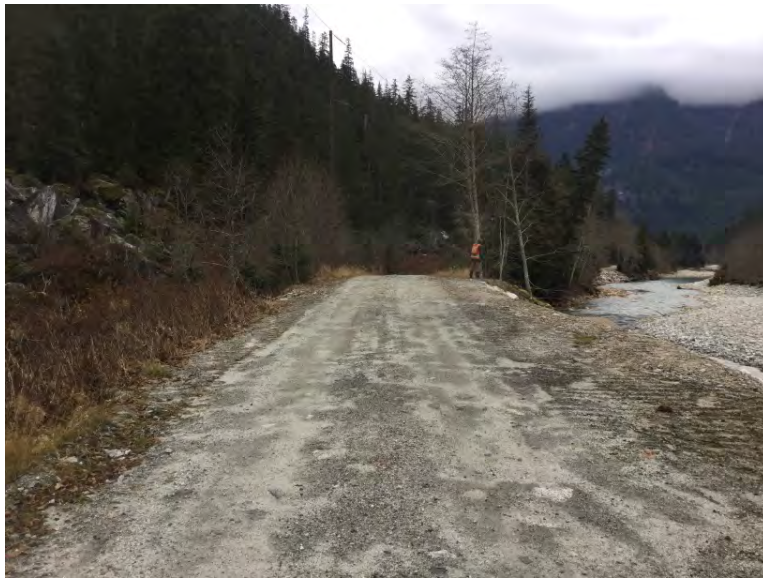
Approach from Right Bank when facing downstream

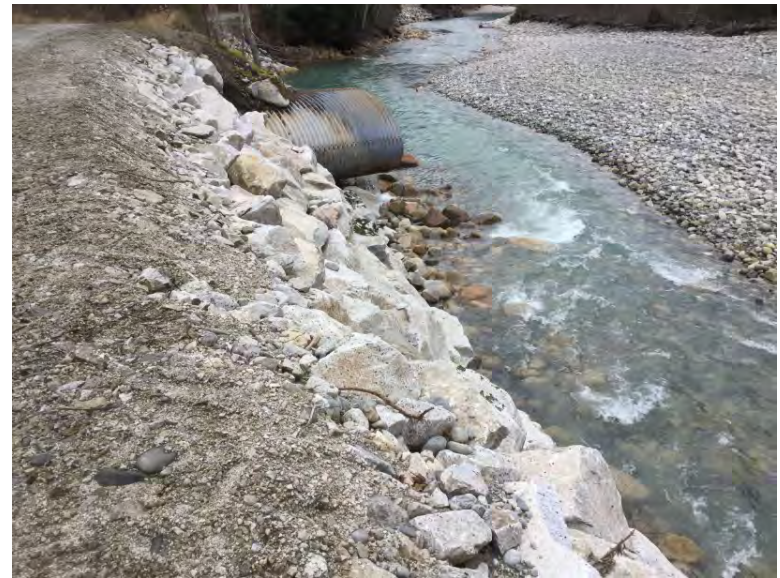
Downstream right approach fillslope

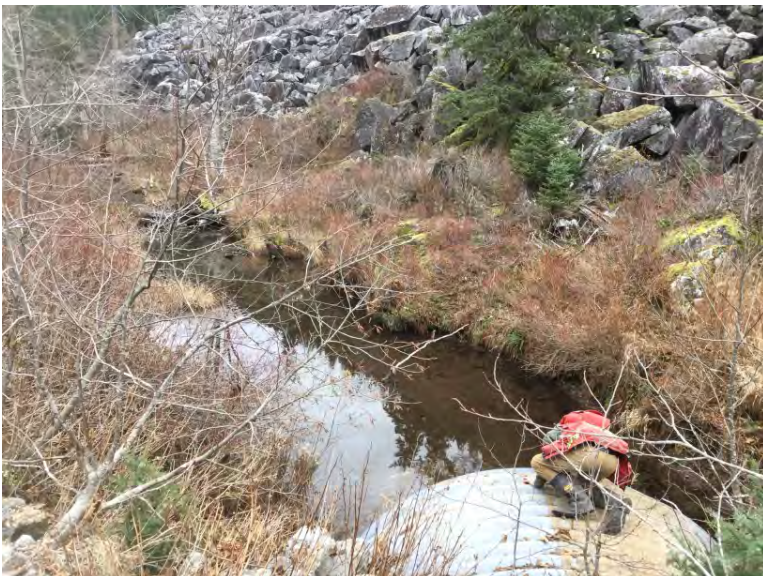
Upstream from Crossing

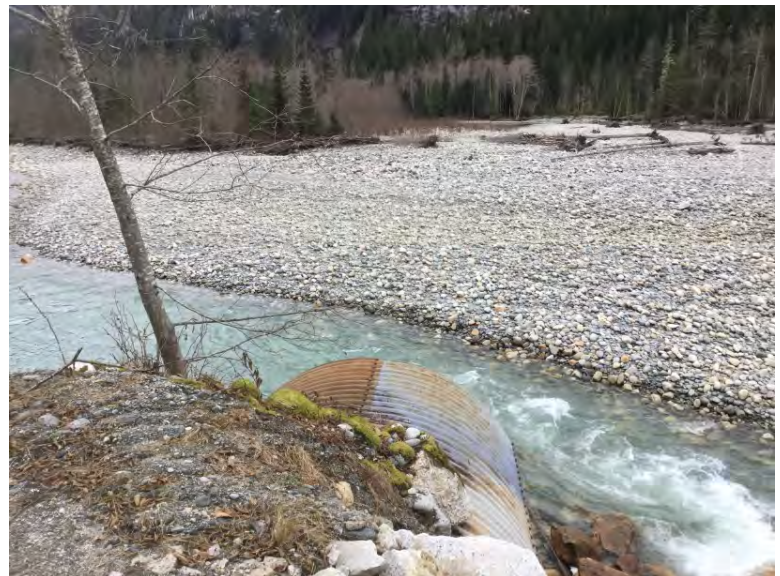
Downstream from Crossing

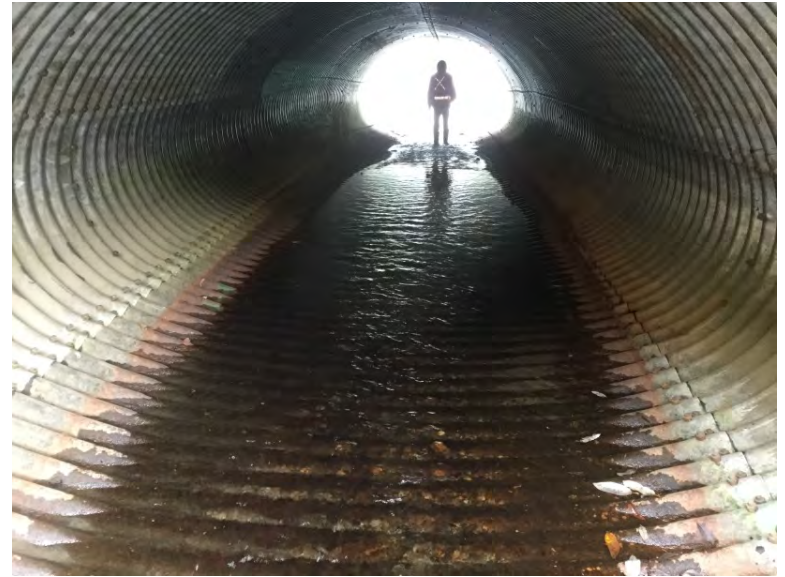
Looking through culvert from inlet

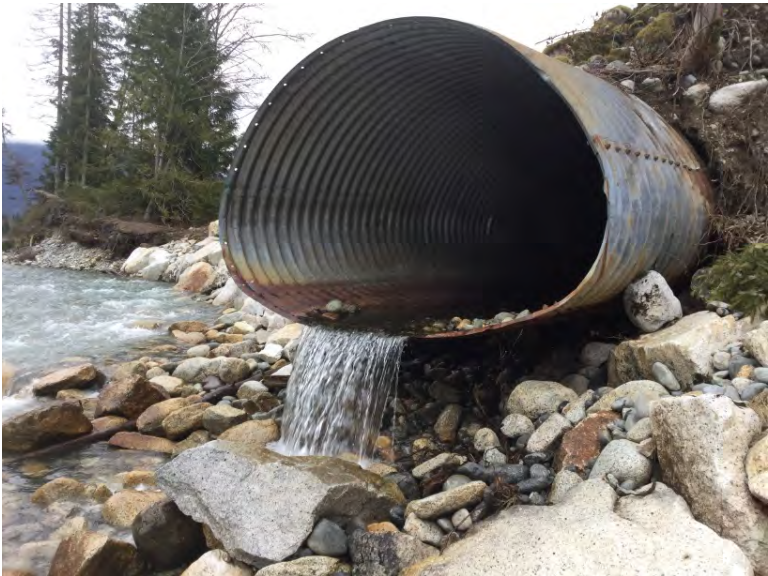
Outlet

The Stave River has recently damaged sections of the FSR in this general location. The outlet of the culvert is not completely supported and needs to be monitored

1.0 drop and last 6m of culvert unsupported

The culvert has sustained damage by recent high flows from the Stave River. Ensure the base of the culvert is properly supported and add riprap to the downstream left bank to prevent further scour. Monitor these items until they are repaired. The current load rating of L75 or 68 tonnes to continue.

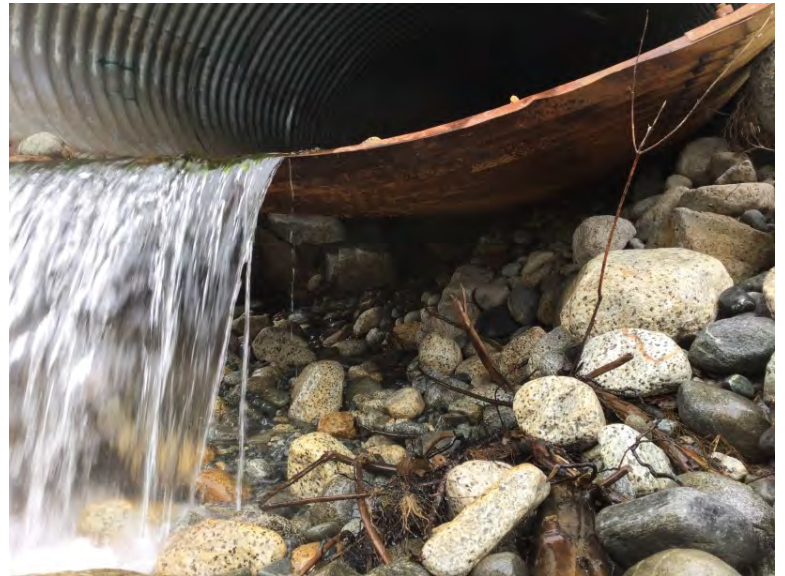
6m of outlet culvert unsupported

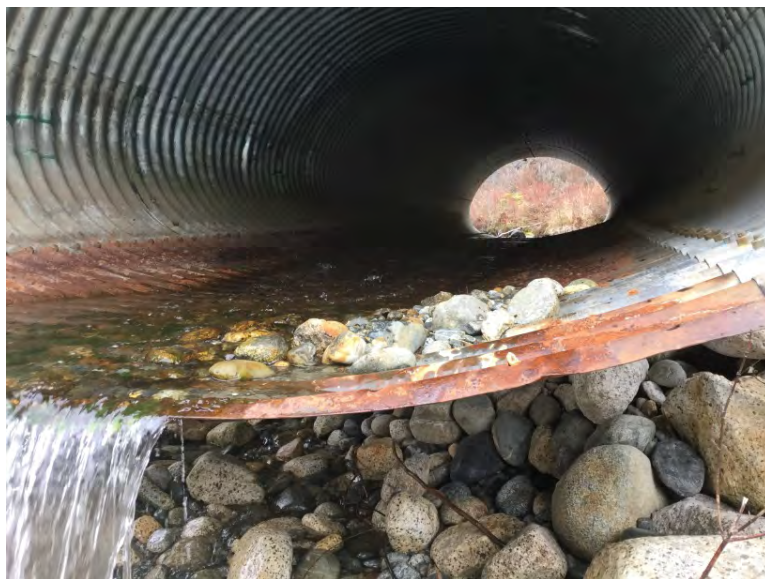
Starting to sag where unsupported

Culvert is sagging where unsupported at outlet

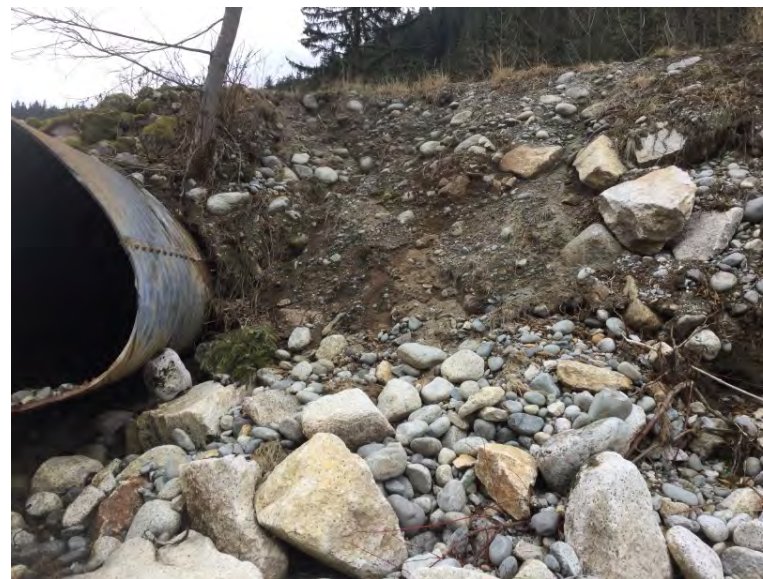
Poor at downstream left bank

Downstream left fillslope eroding

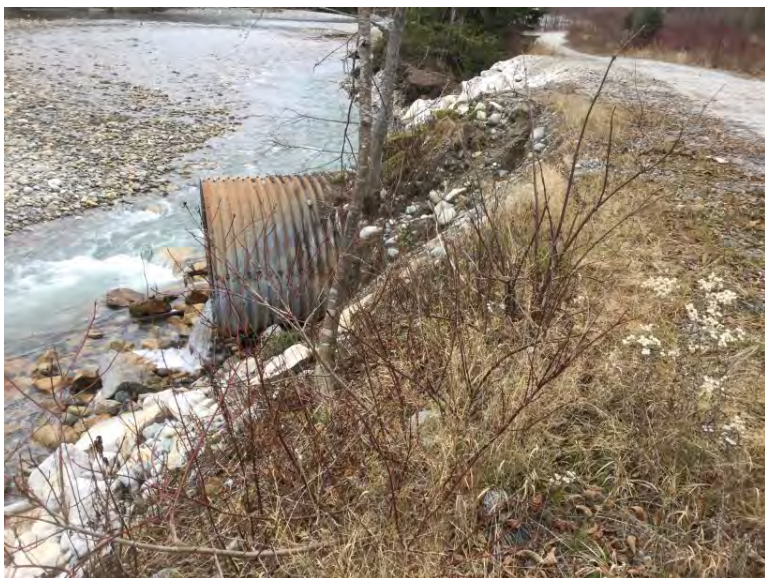
Downstream left fillslope eroding and over steepened at 1.25:1

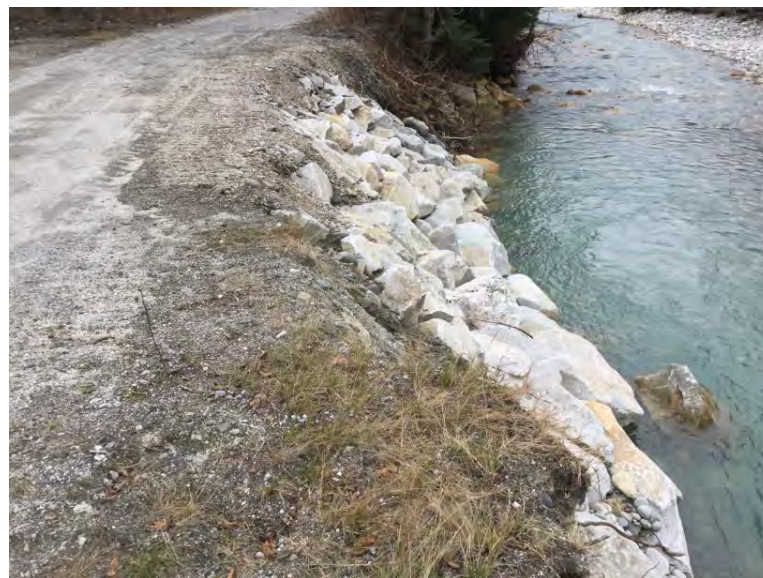
Fillslope repair 30m from culvert
