CK-2275

STAVE 30.9km

2019 Inspection

| Structure Class | Major Culvert | | |

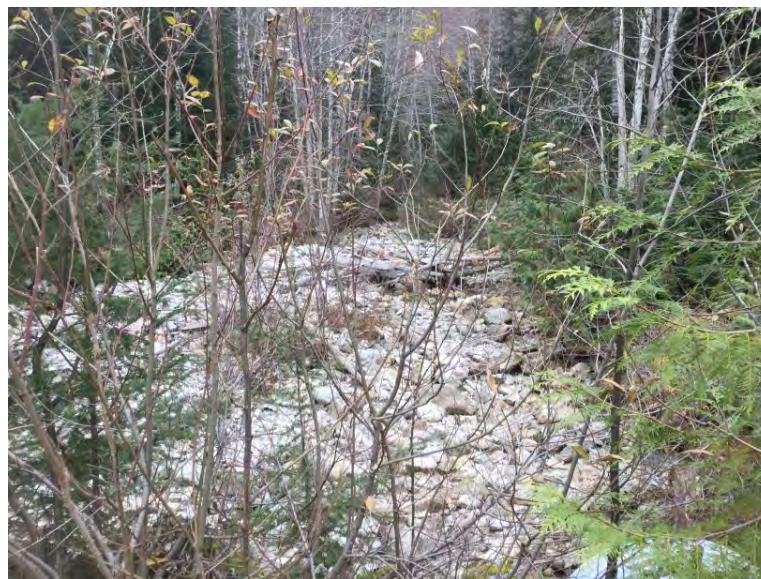
Upstream from Crossing

Comments    Site is aggrading at inlet  
                  Inlet has evidence of debris accumulations

Monitor debris upstream from the culvert inlets. Consider installing a large sump at the inlet. The current load rating of L75 or 68 tonnes to continue.

| Repair Item | Priority | Repair Description |
|---|---|---|
| 1 | Low | Excavate sump at inlet |

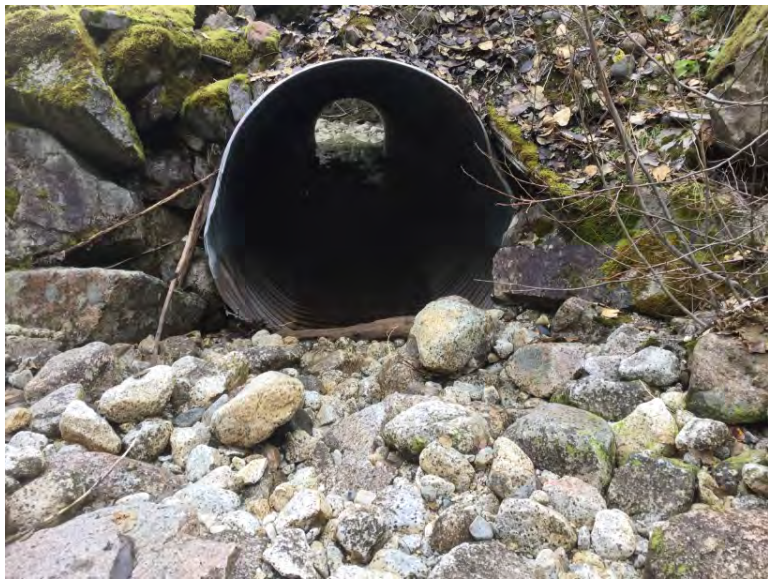
Inlet of high chain culvert

Inlet cover on high chain culvert = 600mm  
 Inlet cover on middle culvert = 600mm  
 Inlet cover on low chain culvert = 400mm  
 Outlet cover on low chain = 800mm  
 Outlet cover on middle = 1000mm  
 Outlet cover on high chain culvert = 1200mm

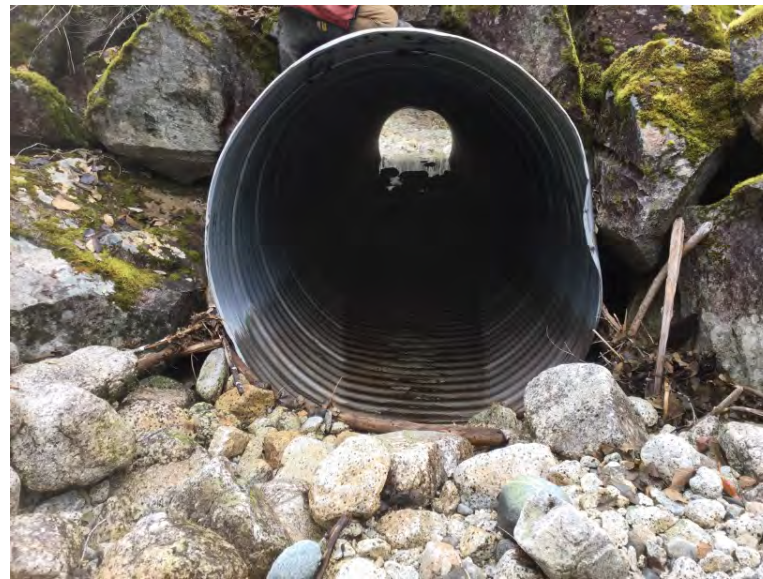
Inlet of middle culvert

Minor damage to inlet of culvert 2 &amp; 3

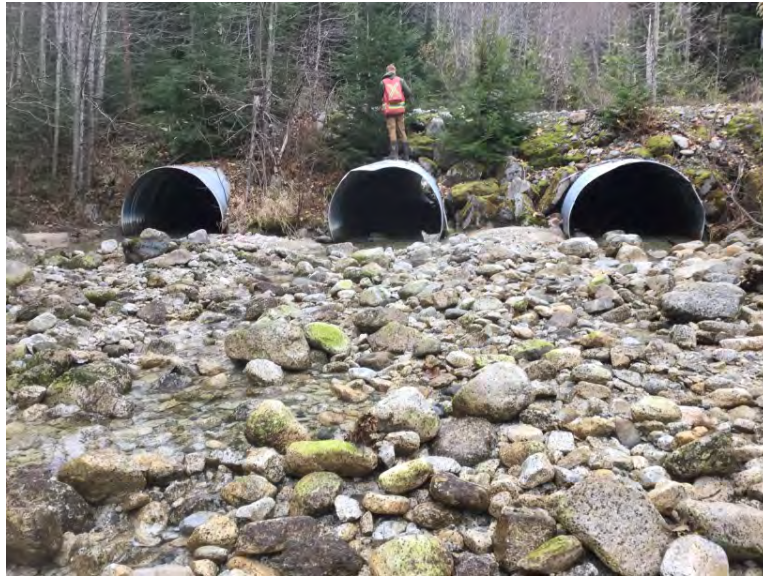
Outlet

Minor damage to outlet of culverts 2. River deposits have reduced Culvert 3 outlet to 1.3 m.
