CK-2279

SUMALLO 4.7km

2019 Inspection

| Crossing Name | Tearse Creek (structure #11) |

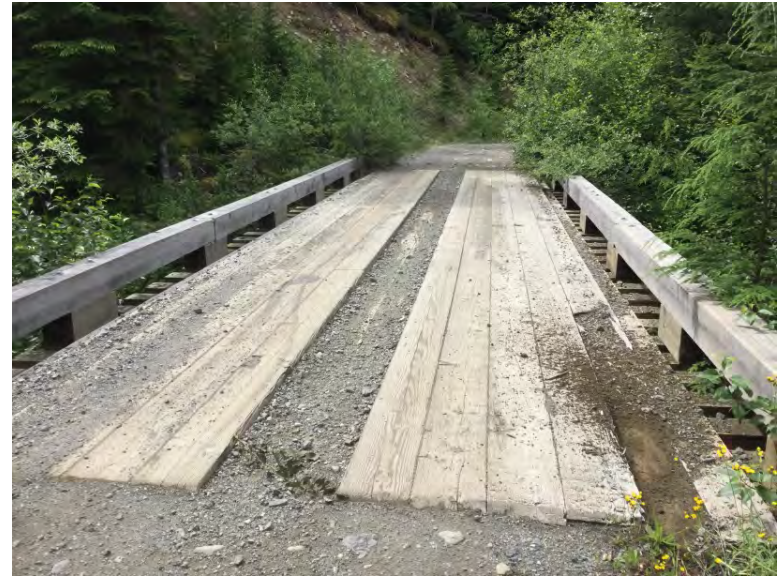
Deck

Fair

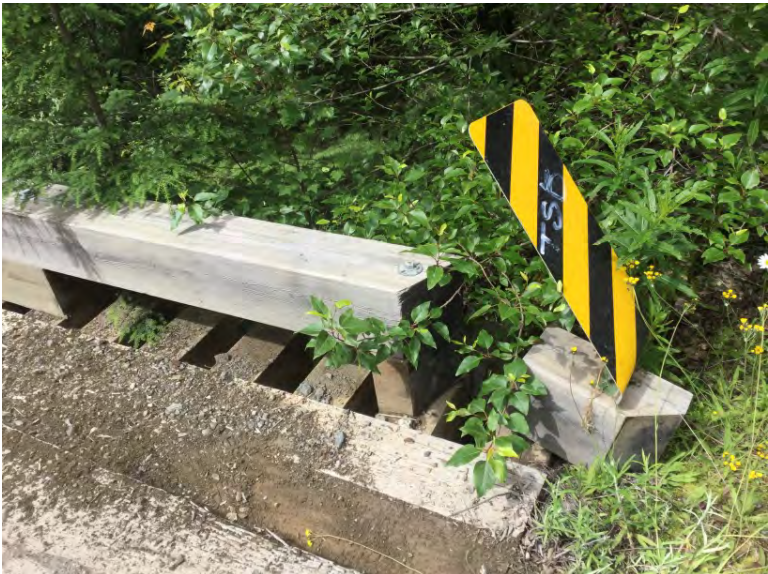
Down stream right bank rail and riser

Fair

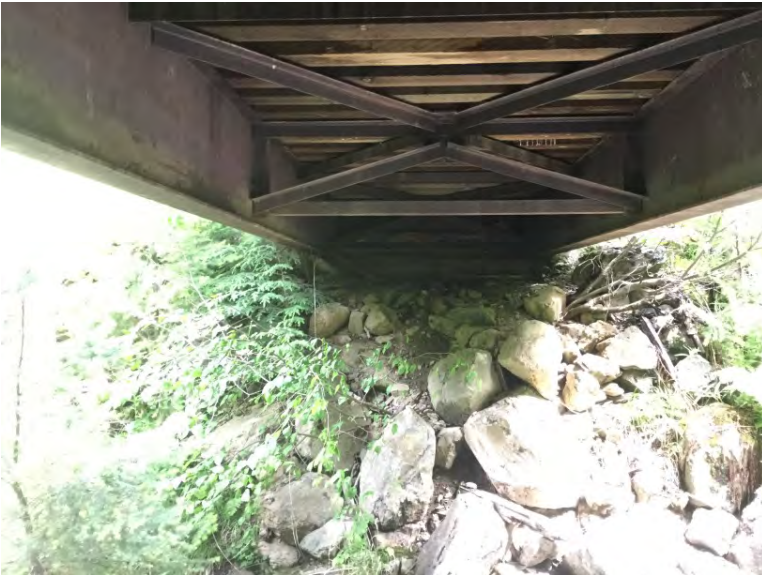
Right Bank Abutment when facing downstream

Single log sill with 30mm sap rot. No signs of crushing

Not well graded or keyed in

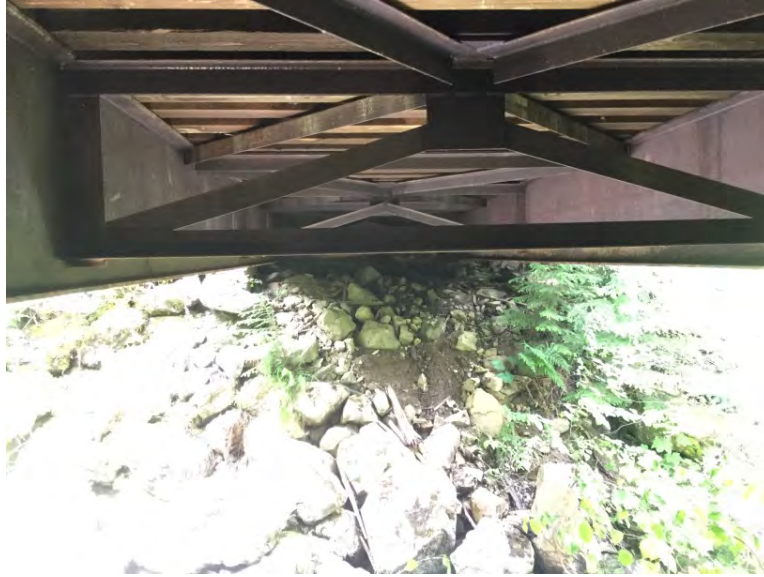
Superstructure

Girders Good Minor corrosion

Diaphragms Good 4 welded bays, minor corrosion

Bracing Good Minor corrosion

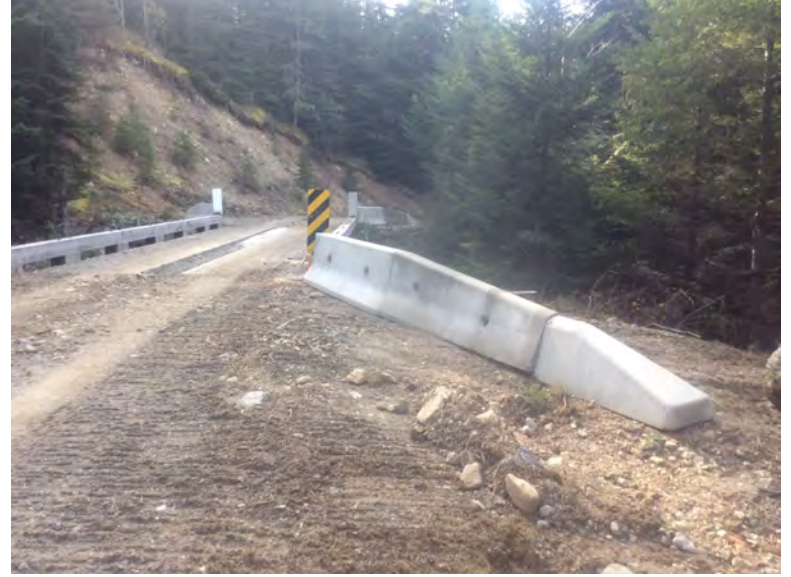
Concrete no post barriers added in October 2019

Work completed in October 2019

Maintenance work completed in October 2019

Post bridge ahead signs. There was a number of maintenance items completed between the time of inspection and the signing of this load rating, those being brushing, grading, and the placement of the concrete no post barriers - see photos. The current load rating of L60 or 54 tonnes to continue.
