CK-2289

UZTLIUS 8.7km

2019 Inspection

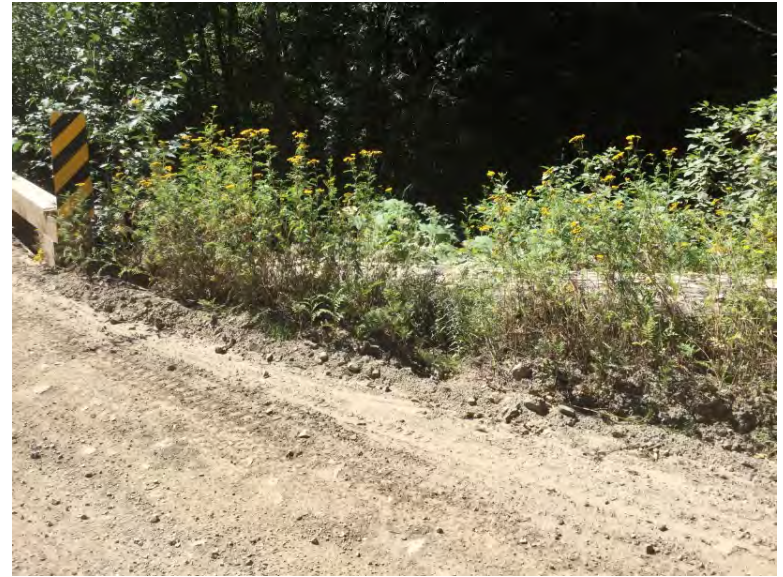
Fender off road downstream right bank

| Item | Priority | Repair Description |
|---|---|---|
| 2 | Medium | Brush approaches and realign downstream right bank log fender |

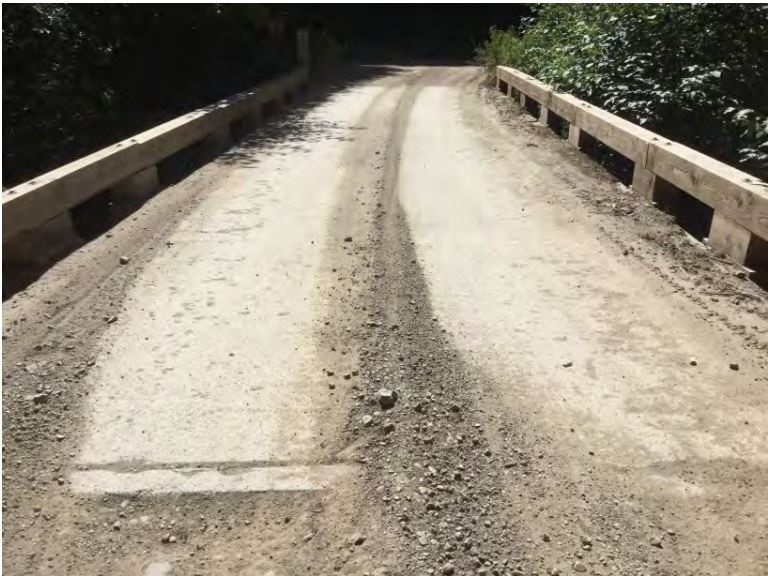
Concrete Deck      Fair      Minor damage at surface likely due to track equipment

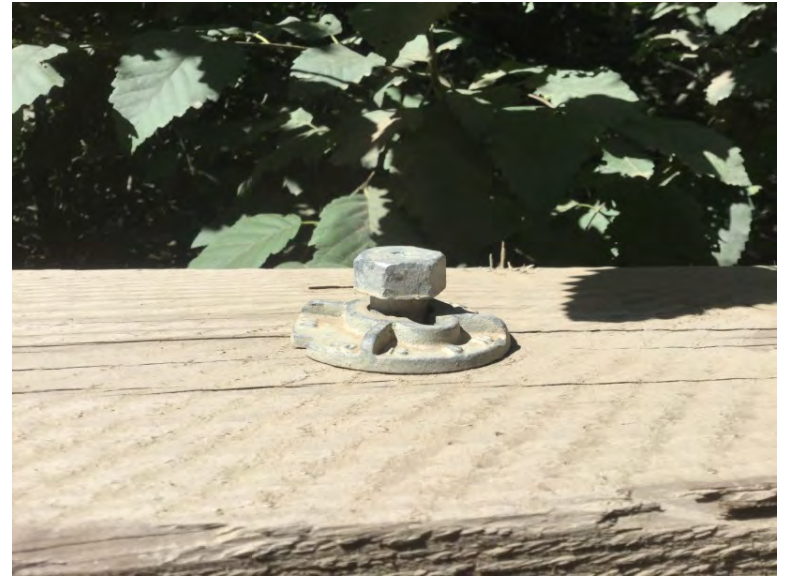
Hardware      Poor      All rail bolts loose

Loose rail bolts throughout

| Item | Priority | Repair Description |
|---|---|---|
| 1 | High | Repair right bank upstream rail and tighten ALL guardrail hardware |

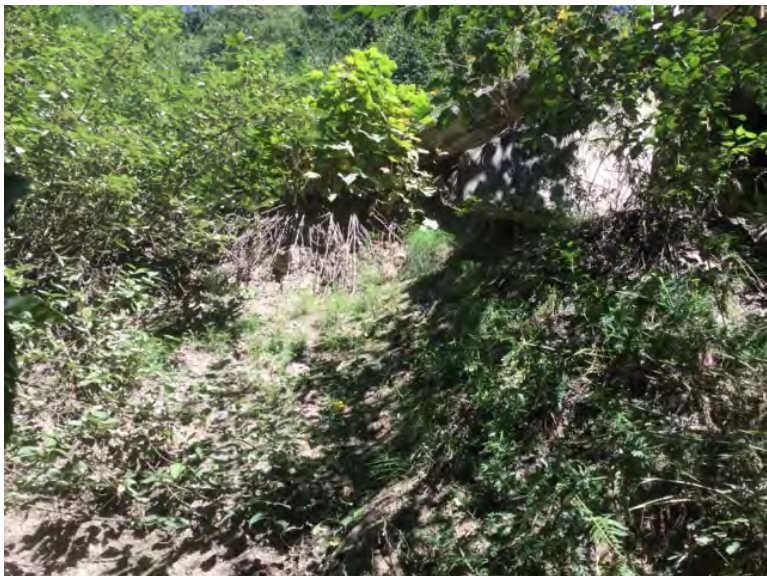
Fill Fair Poor at downstream right bank

Downstream right fill slope eroding

| Item | Priority | Repair Description |
|---|---|---|
| 3 | Medium | Repair failing fill slope at downstream right bank |

| Item | Monitor Description | Frequency |
|---|---|---|
| 1 | Downstream right bank fill slope | Routine Inspection |

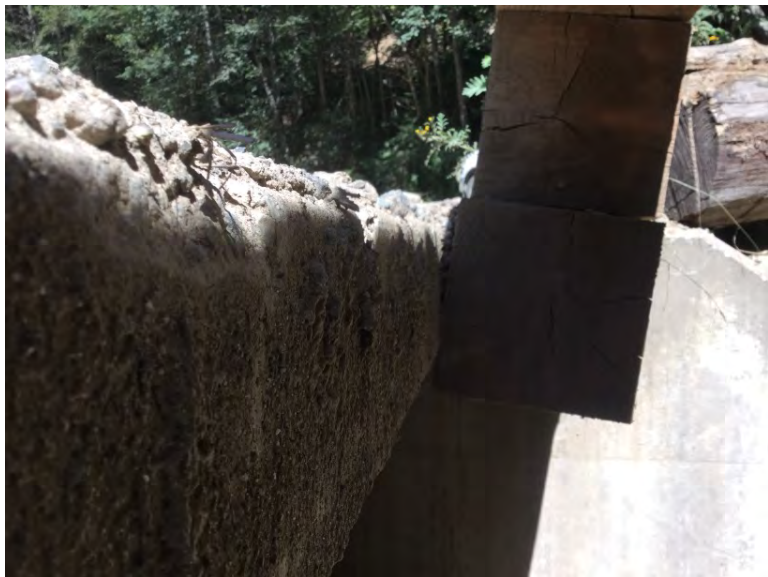
Upstream right bank blocks, risers and rail has been pushed out
