CK-2290

UZTLIUS 16.7km

2019 Inspection

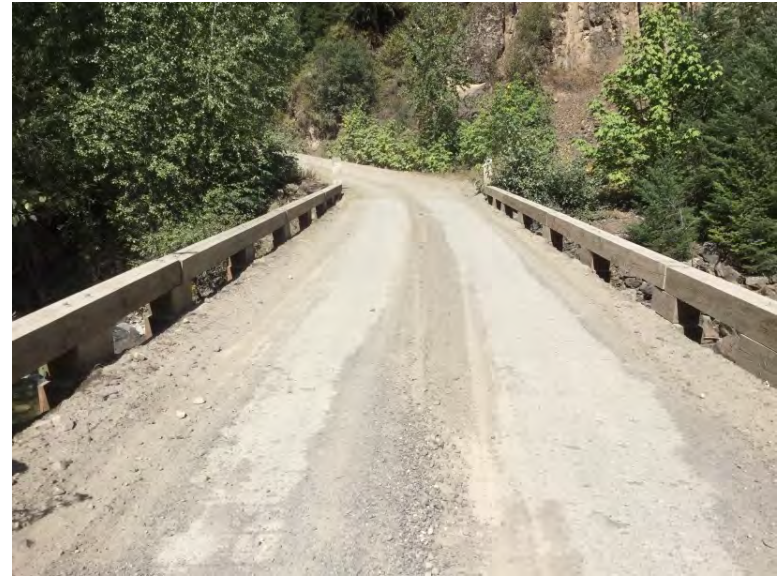
Concrete Deck Fair Minor damage noted at surface likely due to track equipment

Deck Joints Fair Hairline cracks noted

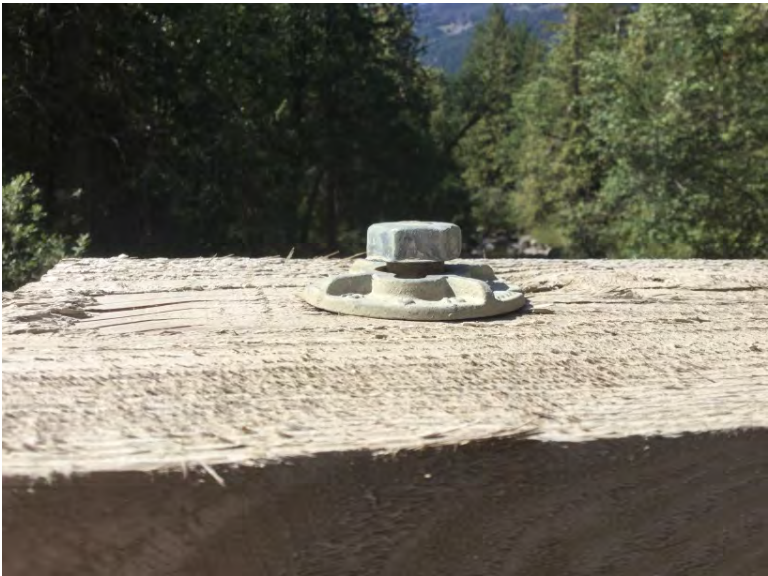
Hardware Poor All rail bolts are loose

Overall Deck Condition Poor Due to loose rail hardware

Loose hardware on rail, typical

All guardrail hardware needs to be tightened prior to any activity. The current load rating of L75 or 68 tonnes can continue subject to the tightening of all guardrail hardware.

| 1 | High | Tighten all guardrail hardware |
