CK-2292

UZTLIUS 18.5km

2019 Inspection

| Crossing Name | Uzlius Creek |

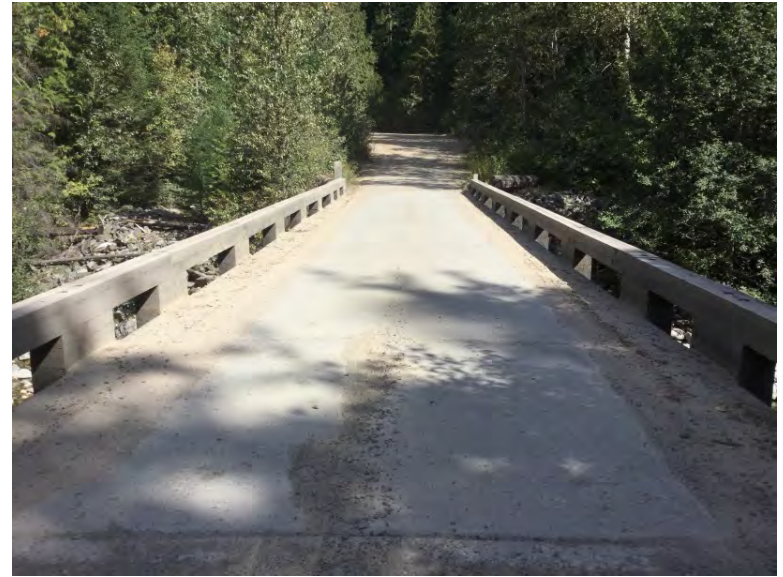
Concrete Deck Fair Minor damage noted at surface likely from track equipment

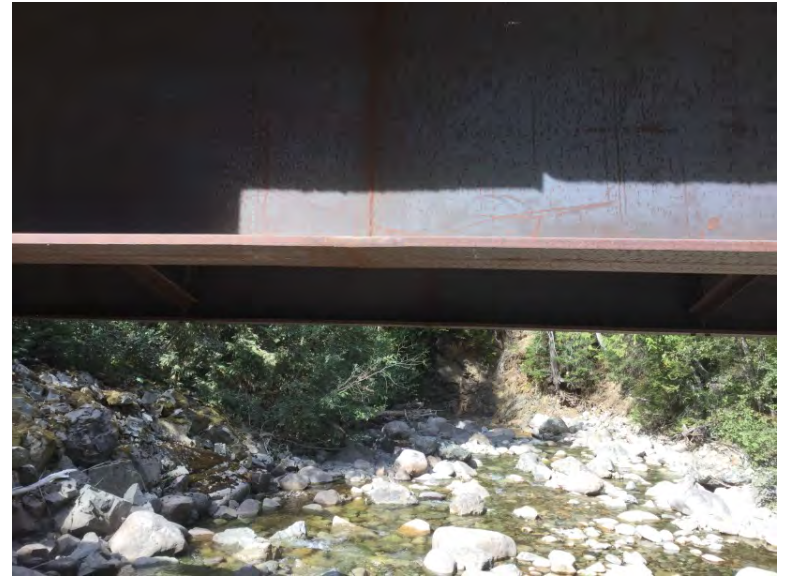
Slight deformation on bottom flange on both girders but suspect from welding

Slight deformation on bottom flange - at weld location

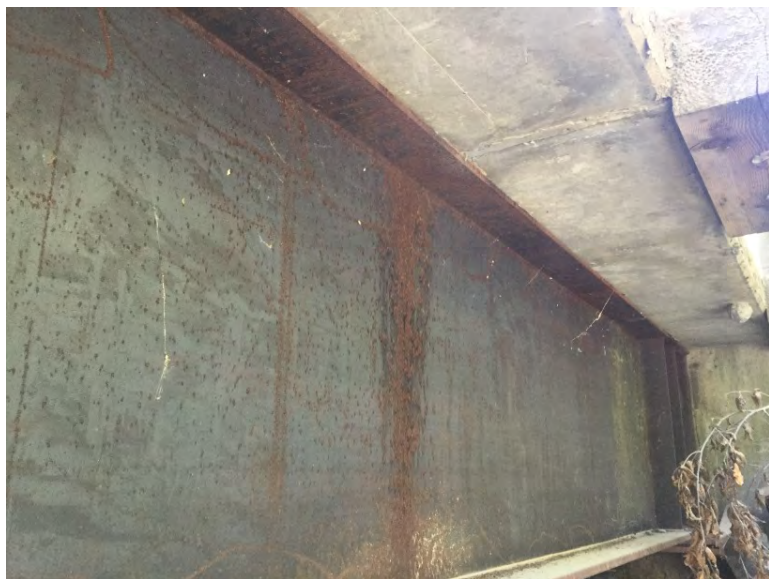
Deck Joints Fair Lower than deck surface causing water to sit

Evidence that water is getting through deck joint

| 1 | Deck joint condition | Routine Inspection |

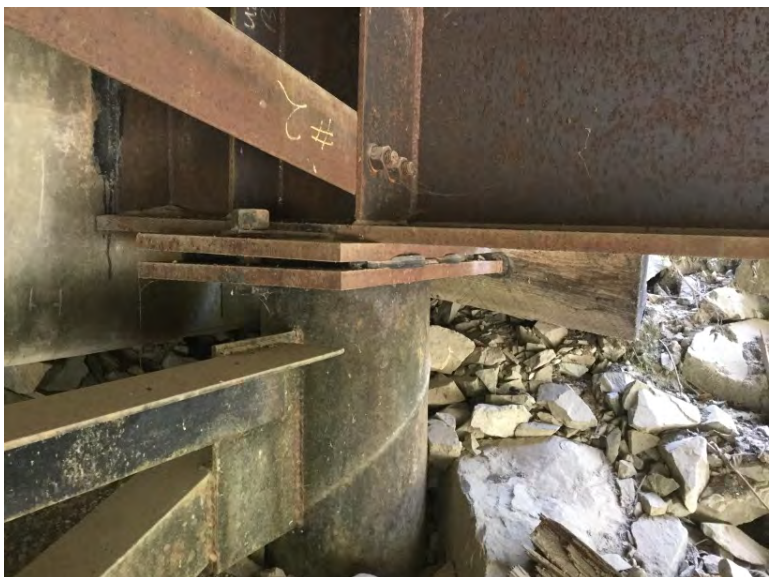
Bearings Fair Minor buldging of rubber pads

Slight bulging of bearing pads at left bank

| 2 | Bearings | Routine Inspection |
