CK-2293

UZTLIUS 19km

2019 Inspection

| Crossing Name | Uztlus Creek |

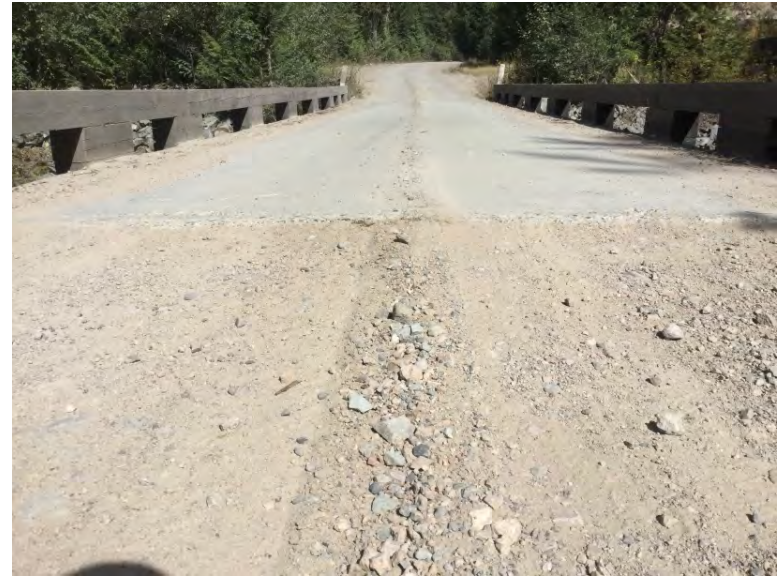
Road Surface Poor

lower than bridge deck elevation

Require material to be added to right approach

Replace all delineators and monitor the condition of the ballast wall and the first deck panel on the right bank. Add material to each approach and grade in. The current load rating of L75 or 68 tonnes to continue.

| Repair Item | Priority | Repair Description |
|---|---|---|
| 2 | Medium | Add gravel to both approaches and blend in |

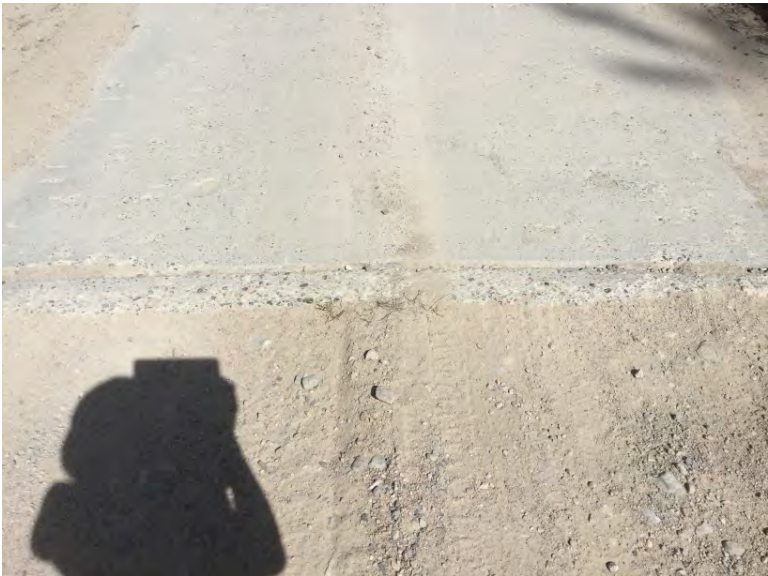
Ballast Wall Fair

Damage to top at right bank

Minor damage to top of ballast wall and panel 1 at right bank

| Item | Monitor Description | Frequency |
|---|---|---|
| 1 | Ballast wall and deck panel condition at right bank | Routine Inspection |

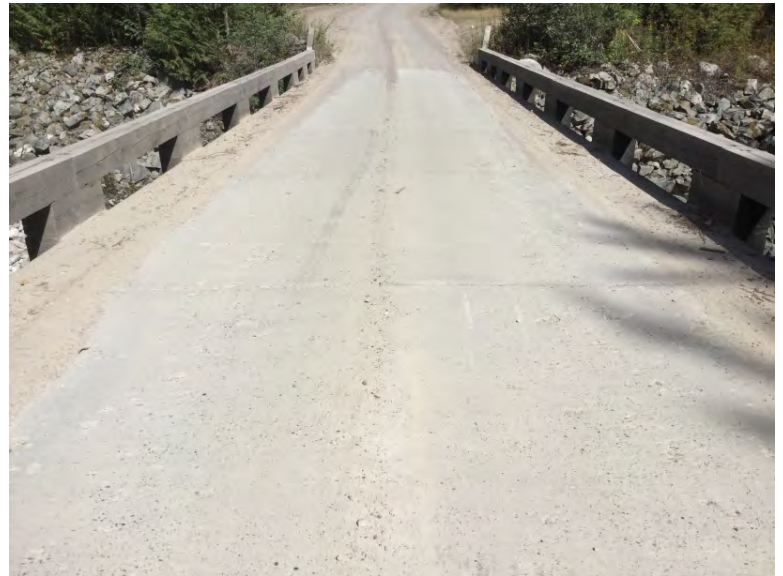
| Concrete Deck | Fair | Minor damage noted to surface from track equipment |

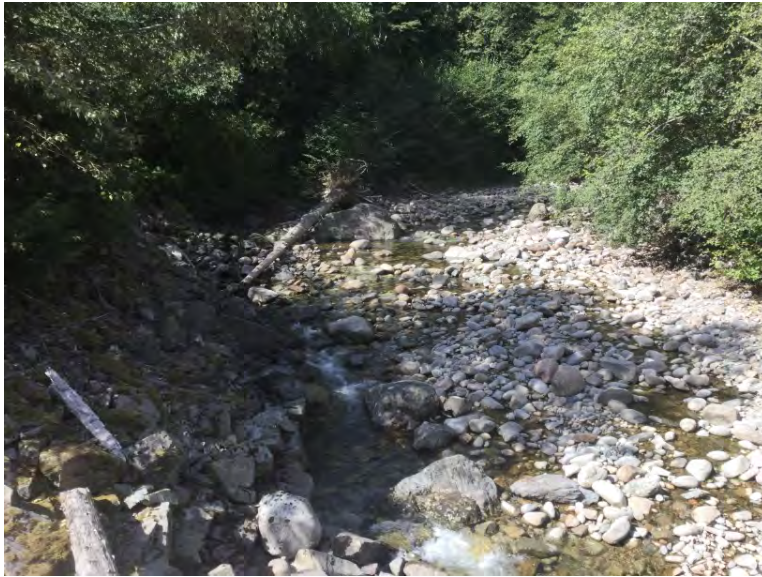
Upstream from Crossing

The log at the inlet that's visible in the photos was cut and no longer poses a threat to the girders

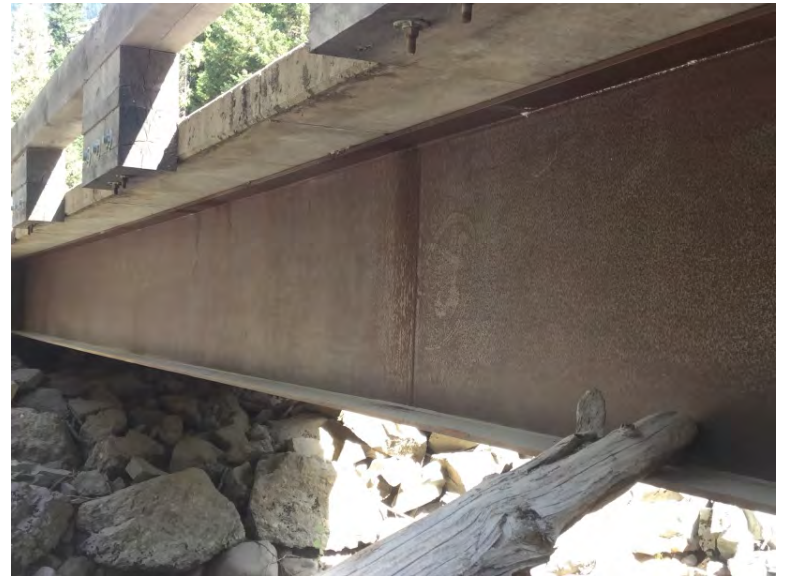
| Deck Joints | Fair | Lower than deck surface causing water to sit |

Evidence that water is getting through deck joint

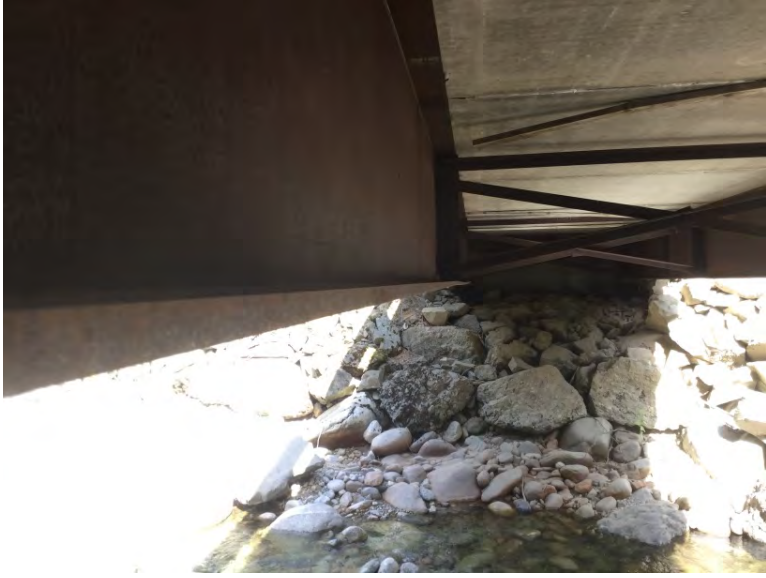
Both girders have slight deformation on bottom flange

Upstream girder has slight deformation on bottom flange
