CK-2294

UZTLIUS 20.5km

2019 Inspection

| Crossing Name | Uztlus Creek | | |

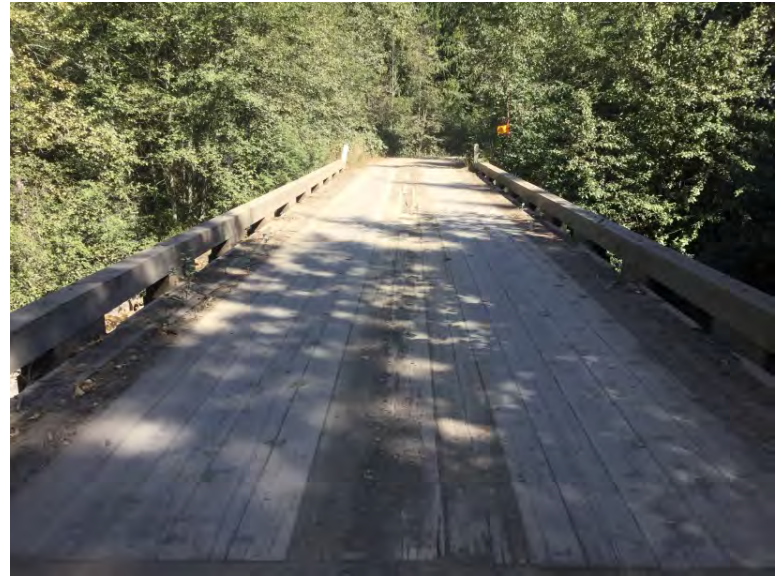
| Overall Deck Condition | Fair | |

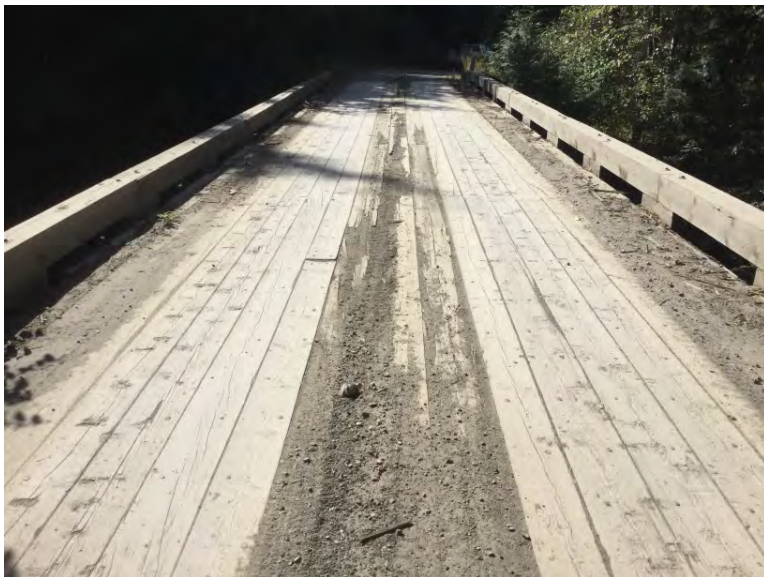
| Running Planks | Fair | Middle 3 and outside 2 rows were not replaced |

Middle 3 and outside 2 rows of planks were not replaced

Replace the 3 middle and 2 outside rows of planks. Place fender logs at all 4 corners with minimum 600mm diameter x 6 meter length or with concrete no post barriers. Tighten all guardrail bolts and replace all delineators. The current load rating of L75 or 68 tonnes to continue.

| Item | Priority | Repair Description |
|---|---|---|
| 1 | Low | Replace middle 3 and 1 outside (each side - 2 total ) rows of planks |
