CK-2295

UZTLIUS 21.9km

2019 Inspection

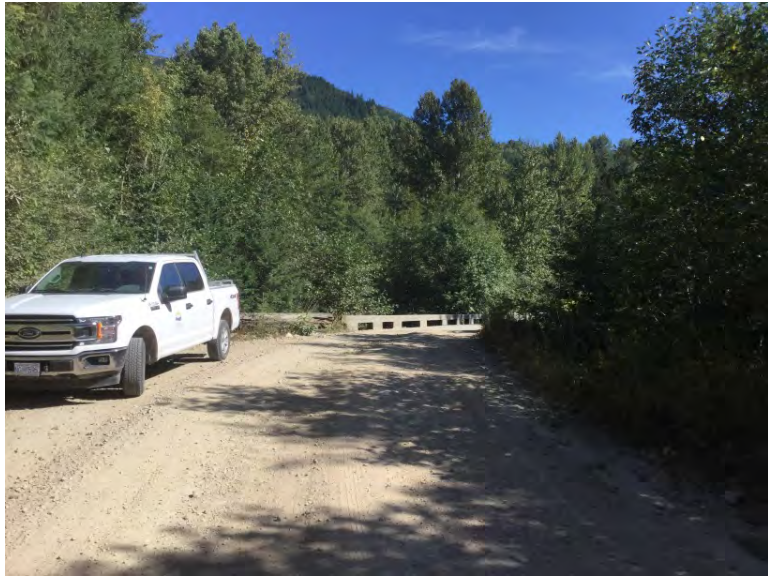
Requires material at right bank

Approach from Right Bank when facing downstream

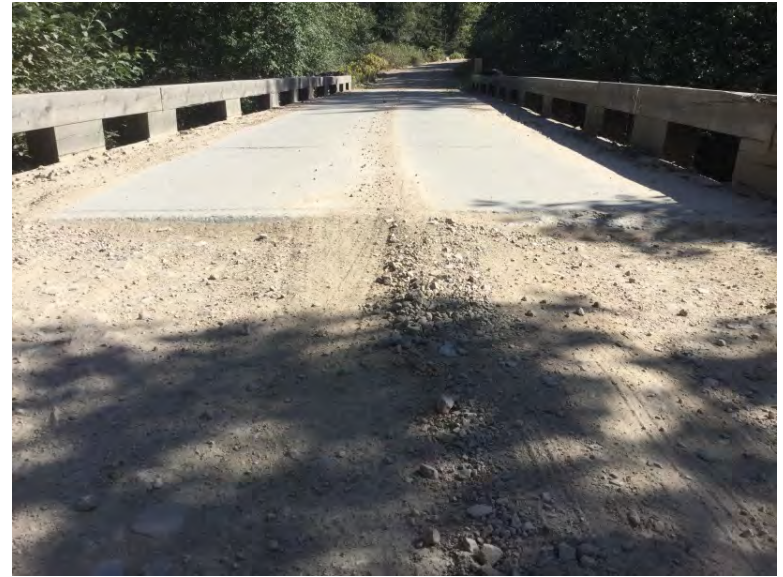
Bridge deck sits higher than road surface causing damage to ballast wall and deck panel at right bank

Repair to the damage to the top of the concrete ballast wall and underside of deck panel 1 at the right bank consistent with the Concrete Repair Guide for concrete bridge components (MoFLNRO, 2017). Add material to both approaches and grade in. Replace the upstream right bank delineator. The current load rating of L75 or 68 tonnes to continue.

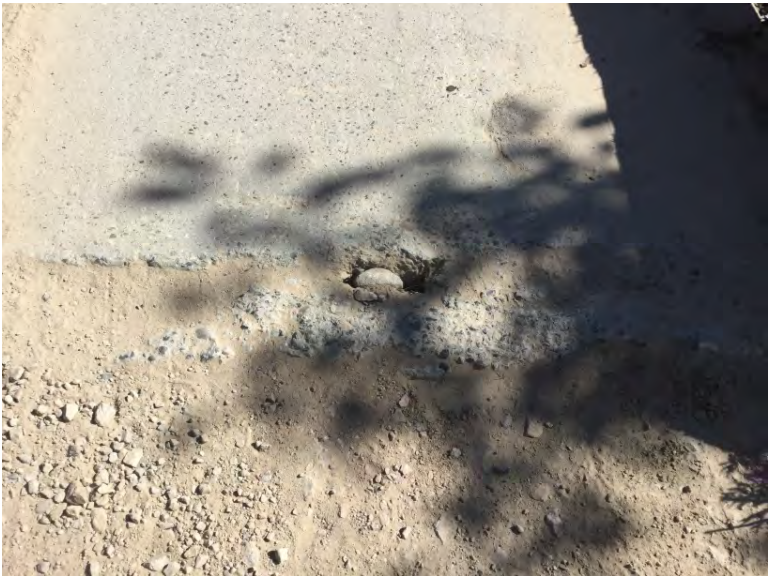
Damage noted to top at right bank

Damage to top of right bank ballast wall and deck panel 1

| Item | Priority | Repair Description |
|---|---|---|
| 1 | Medium | Repair damage to top of ballast wall and deck panel at right bank |

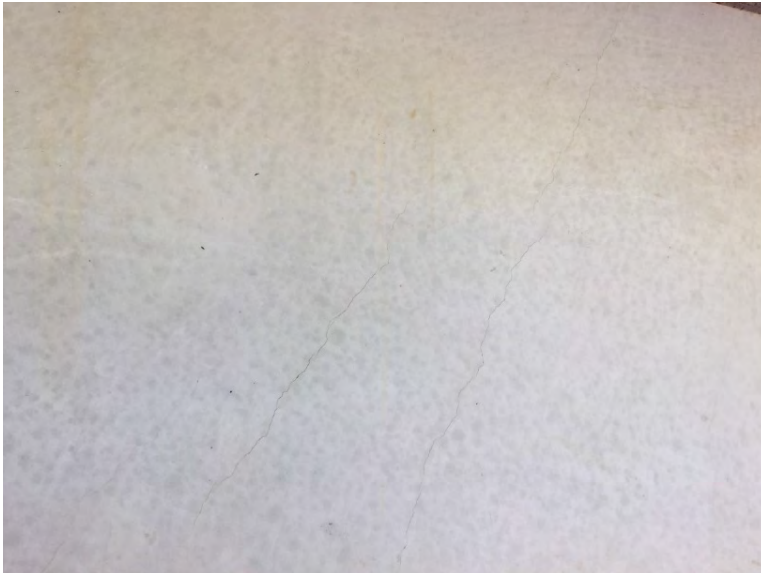
Composite girders with hairline cracks noted on outside of both

Hairline cracks noted on upstream girder

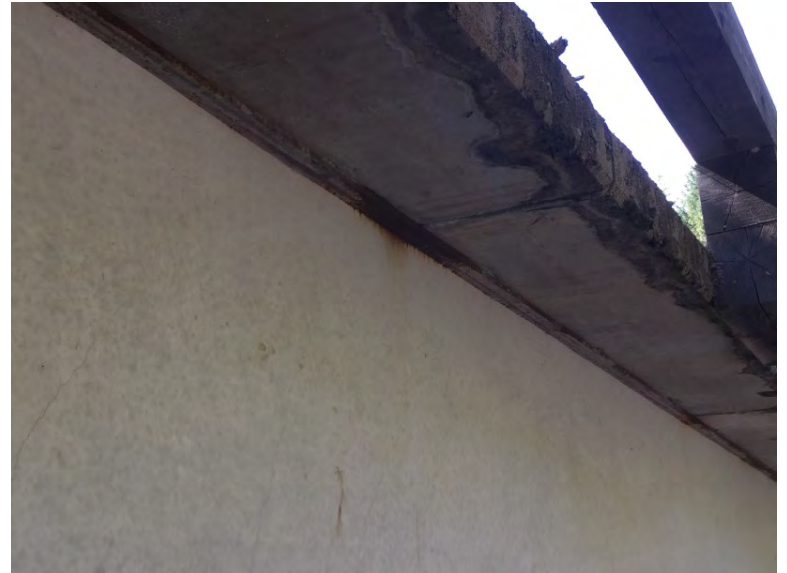
| Deck Joints | Fair | Not flush with deck panels causing water to sit |

Evidence that water has been getting through deck joints

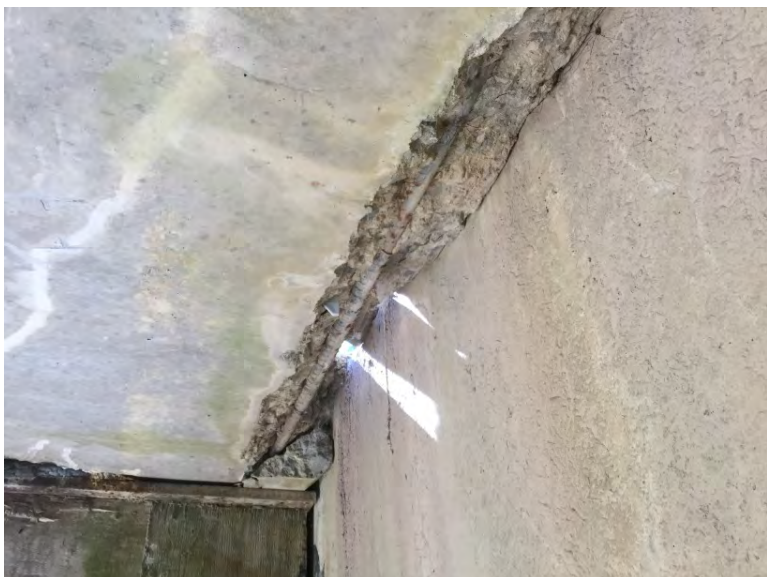
Damage to underside of deck panel 1 on right bank
