CK-2298

UZTLIUS 27.5km

2019 Inspection

| Crossing Name | Uztlus Creek | | |

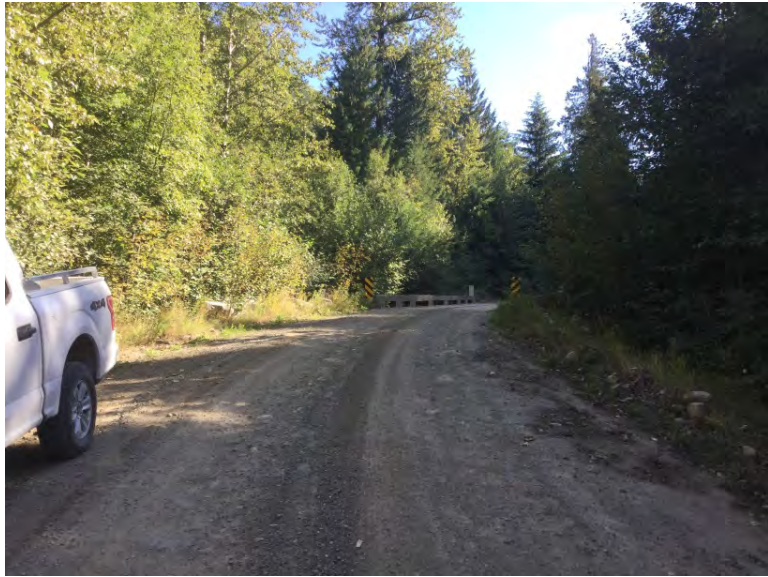
Approach from Right Bank when facing downstream

Fender Condition Poor

Small logs and rocks

Bridge deck higher then road approach

Grade approaches and place new fender logs at all 4 corners, minimum 600mm diameter x 6m length. Alternatively, place concrete no post barriers at approaches. The current load rating of L75 or 68 tonnes to continue.

Grade approaches

Replace fender logs with min 600mm diameter x 6m length

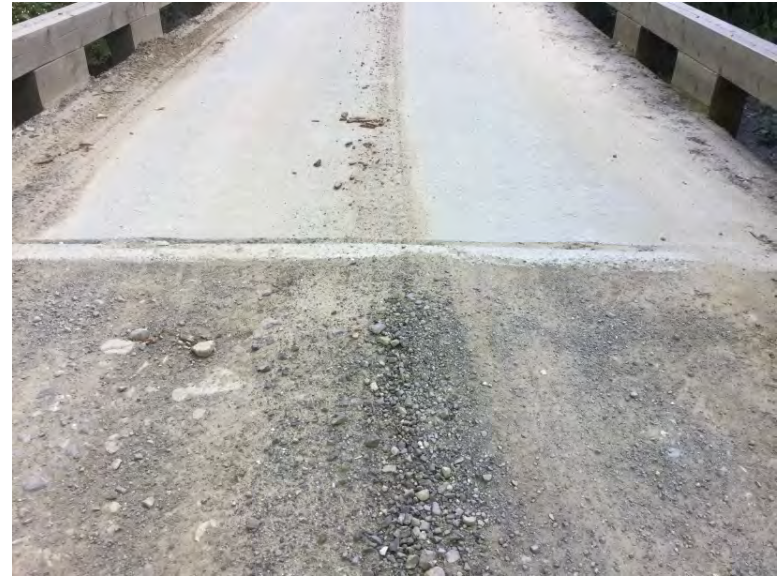
Ballast Wall Fair Minor damage noted at right bank

Minor damage noted to top of ballast wall and panel 1 at right bank

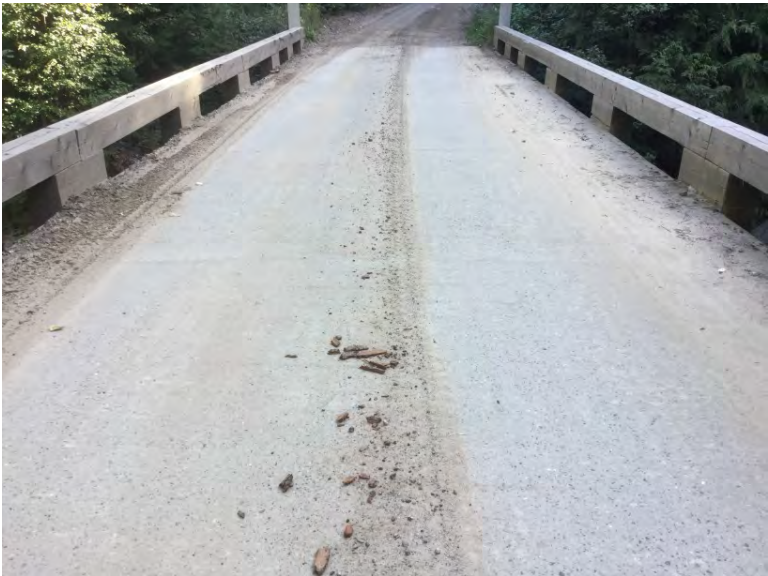
Concrete Deck Fair Minor damage noted to surface from track equipment

Deck Joints Fair Hairline cracks noted at surface

Overall Deck Condition Fair
