CK-2299

UZTLIUS 28.1km

2019 Inspection

| Crossing Name | Uztlus Creek | | |

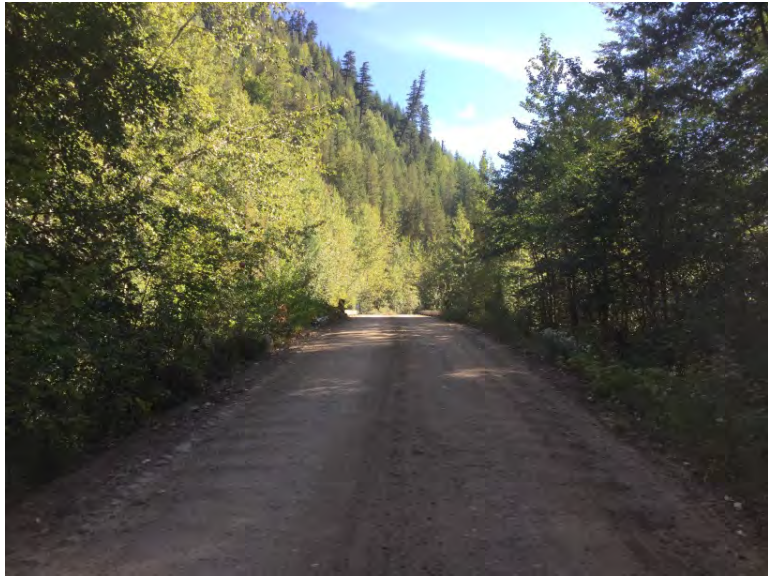
Approach from Left Bank when facing downstream

Fender Condition Poor

Small logs

| Repair | | Repair Description |
|---|---|---|
| 2 | Medium | Replace fender logs with appropriately sized ones - 600mm diameter x 6m length or with concrete no post barriers |

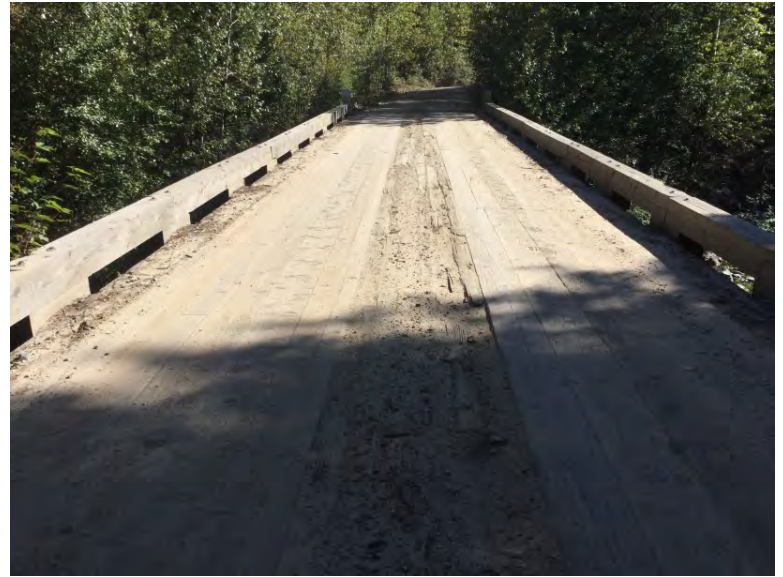
Deck

Middle 3 and outside 2 runs were not replaced and in poor condition

Some starting to protrude

| Repair | | Repair Description |
|---|---|---|
| 1 | Low | Hammer down protruding nails and replace missing bracing washer and nut |
| 3 | Medium | Replace running planks on middle and outer runs |

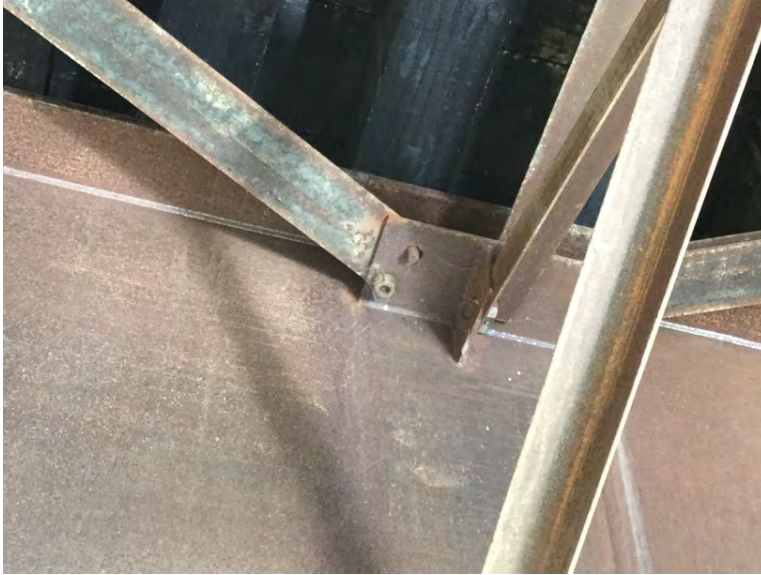
Hardware Fair Only a single nut noted to be missing

Missing bracing nut

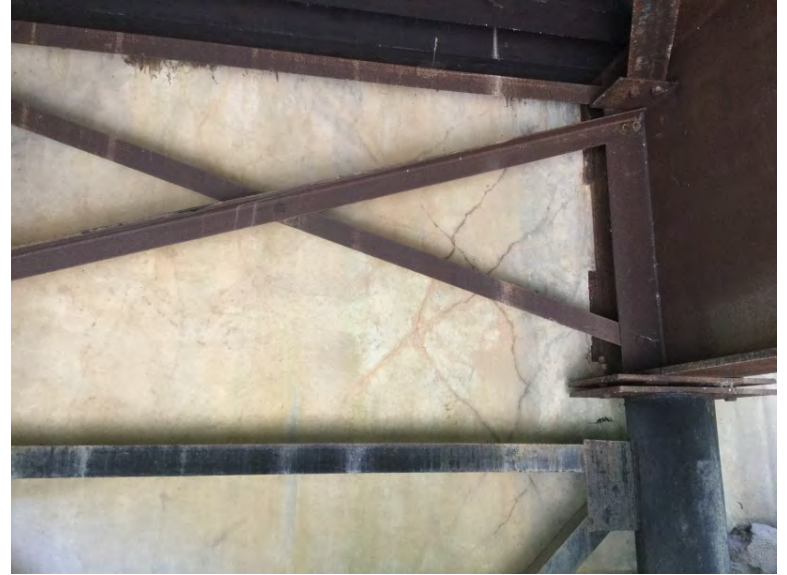
Hairline cracks noted on left bank

Hairline cracks noted on left bank ballast wall

| Item | Monitor Description | Frequency |
|---|---|---|
| 1 | Hairline cracks in left bank ballast wall | |
