CK-2301

UZTLIUS 32.7km

2019 Inspection

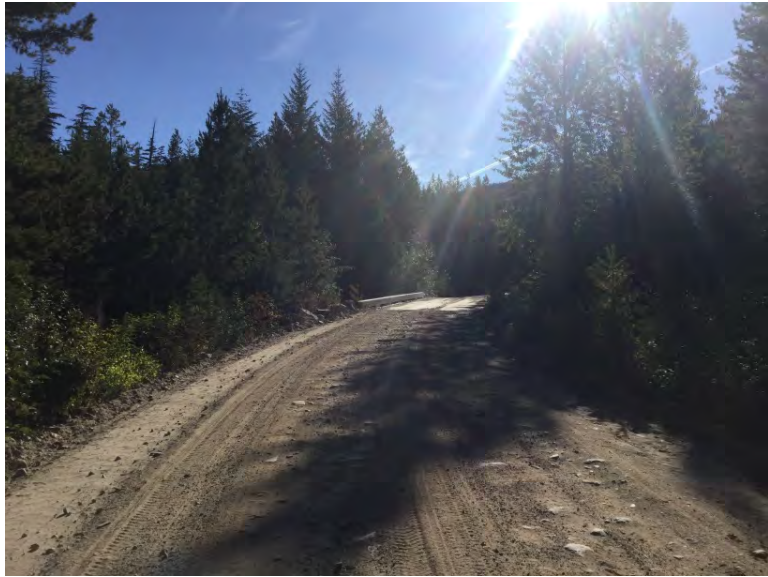
Approach from Right Bank when facing downstream

HC right approach

Fender Condition Poor

None but lined with round boulders

| Repair Item | Priority | Repair Description |
|---|---|---|
| 1 | Low | Install log fenders or concrete no posts at all 4 corners |

| 2 | Low | Grade approaches |

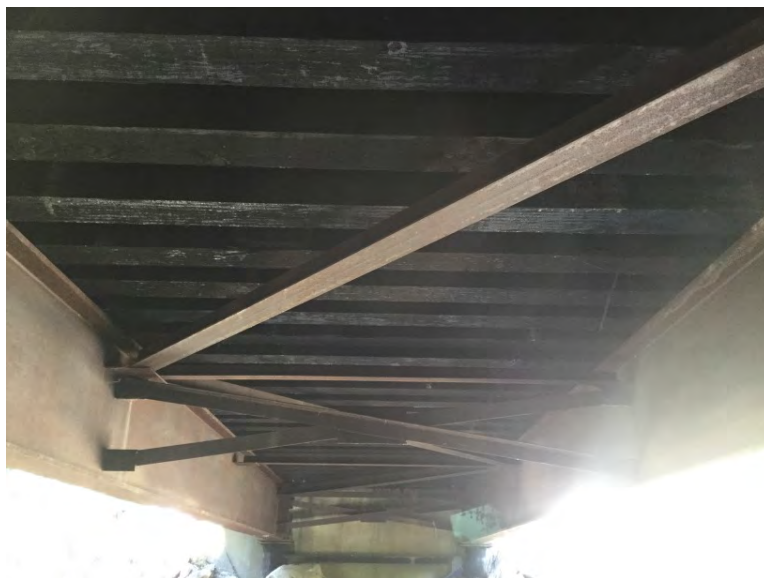
Superstructure

Diaphragms Good 3 welded bays
