CK-2304

EAST ANDERSON 6.6km

2019 Inspection

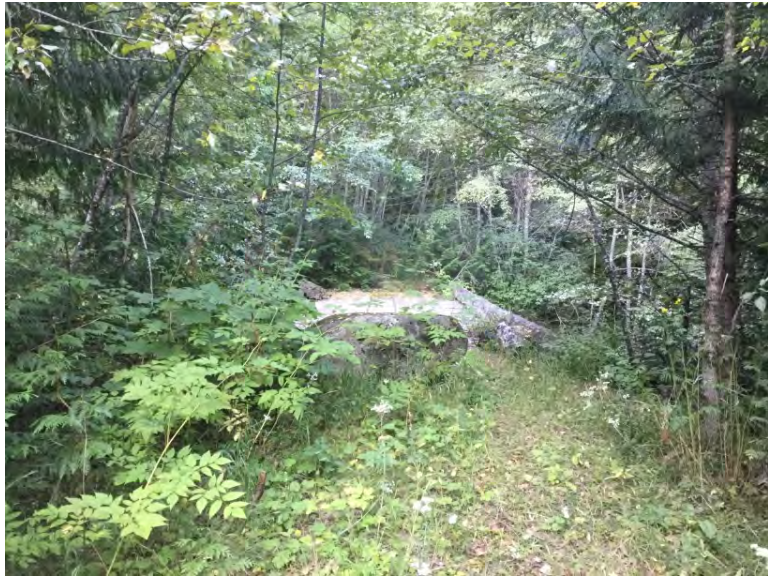
Approach from Right Bank when facing downstream

Road Surface Fair Old bushed in road

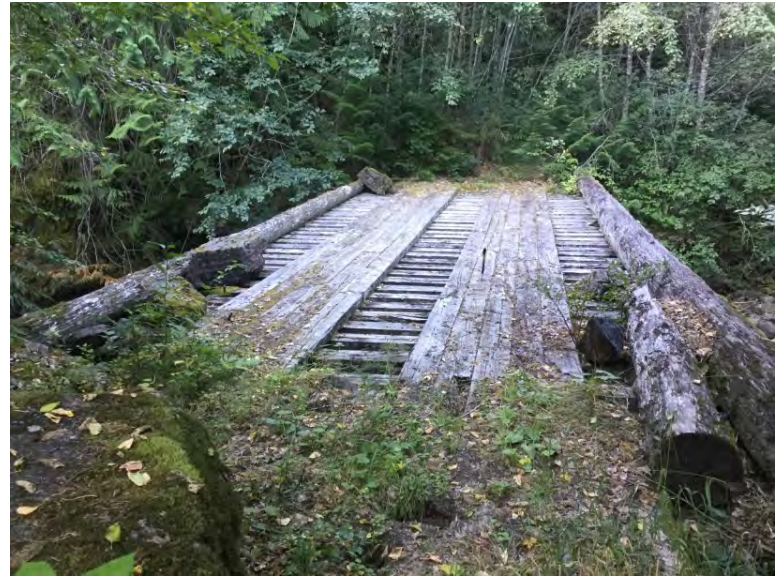
| Running Planks | Poor | Rotten |

| Overall Deck Condition | Poor | All components rotten |

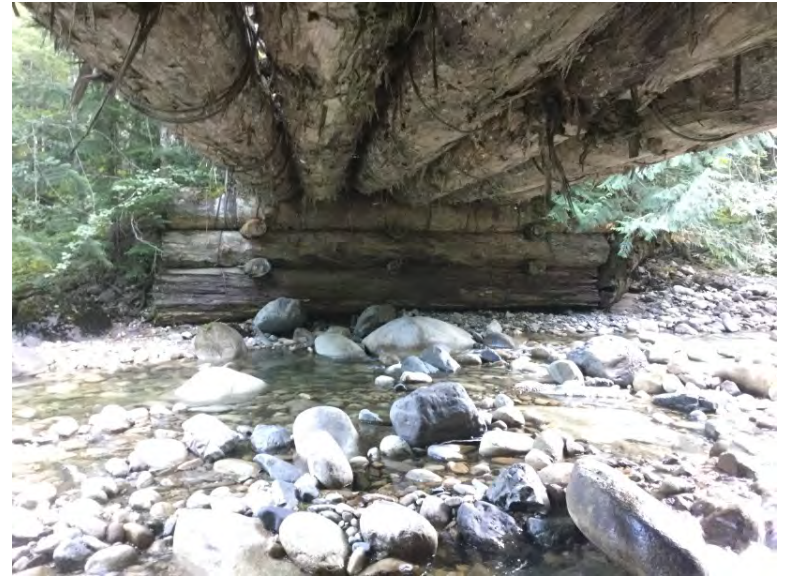
Right Bank Abutment when facing downstream

Log/Timber Cribs Poor Rotten

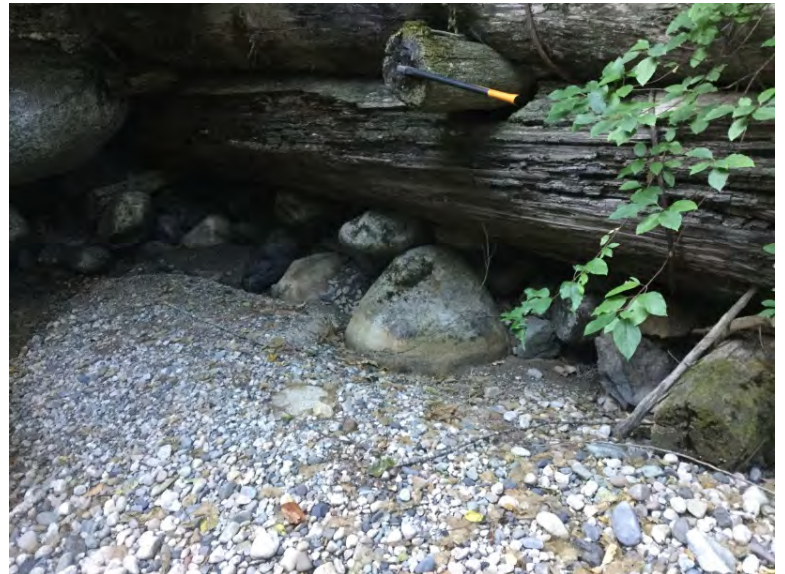
Left abutment downstream scour

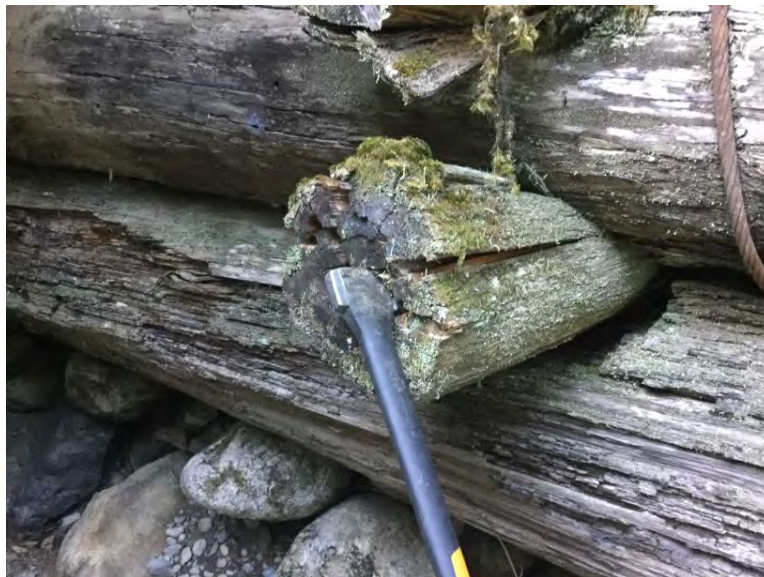
Tie Backs Poor Rotten

Tieback condition

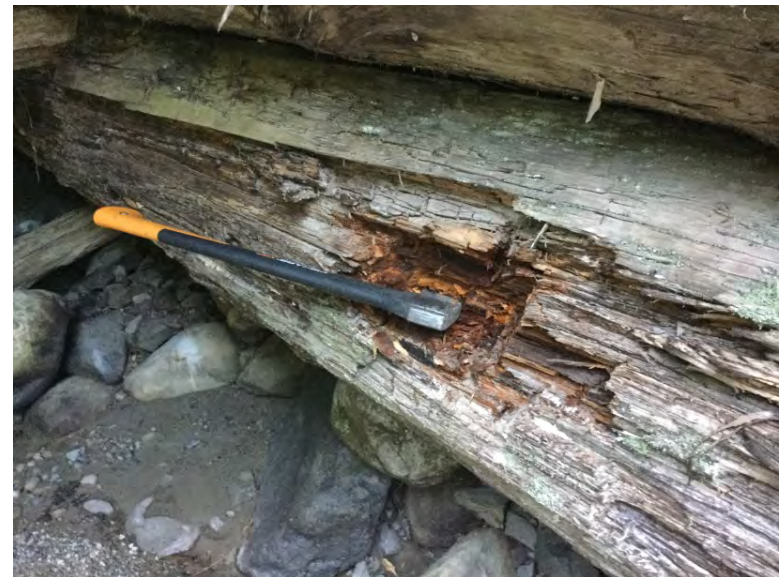
Face log condition

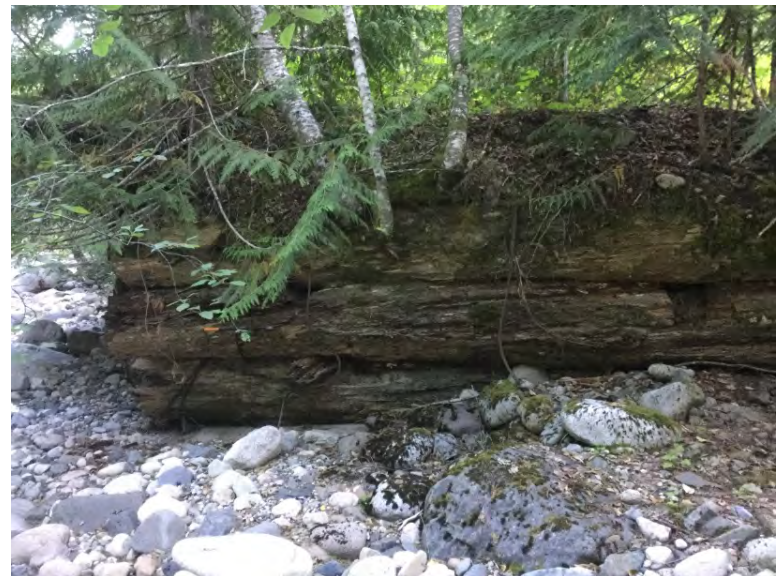
Wing Wall Poor Rotten

Upstream right bank wingwall condition
