CK-2305

EAST ANDERSON 11.7km

2019 Inspection

| Crossing Name | East Anderson Creek |

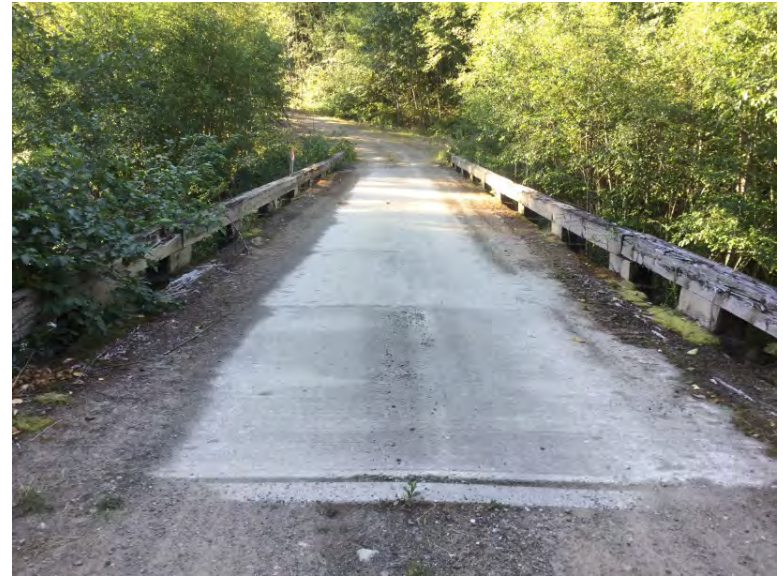
Concrete Deck Fair Minor damage from track equipment and 2 panels with hairline cracks at the surface

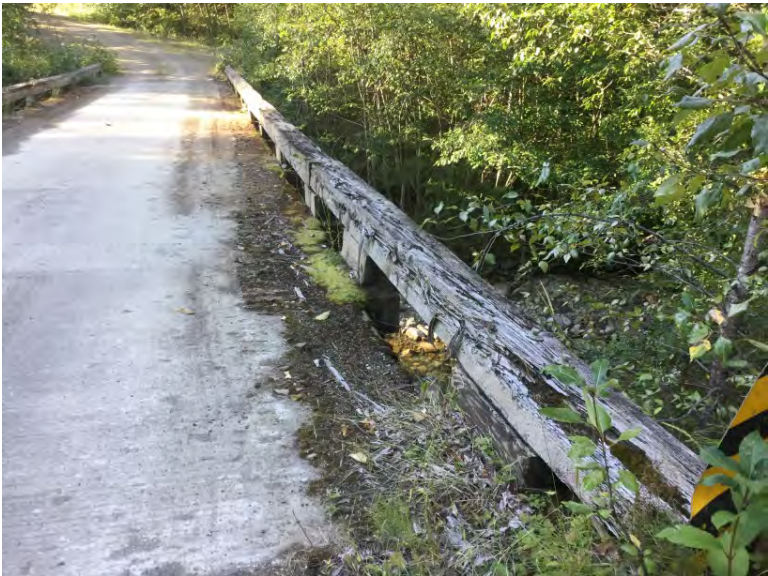
Guard Rail

Curb Rail/Blocks/Posts Poor Rotten

Hardware Poor Loose rail bolts

| 1 | High | Replace guardrail, risers and blocks |

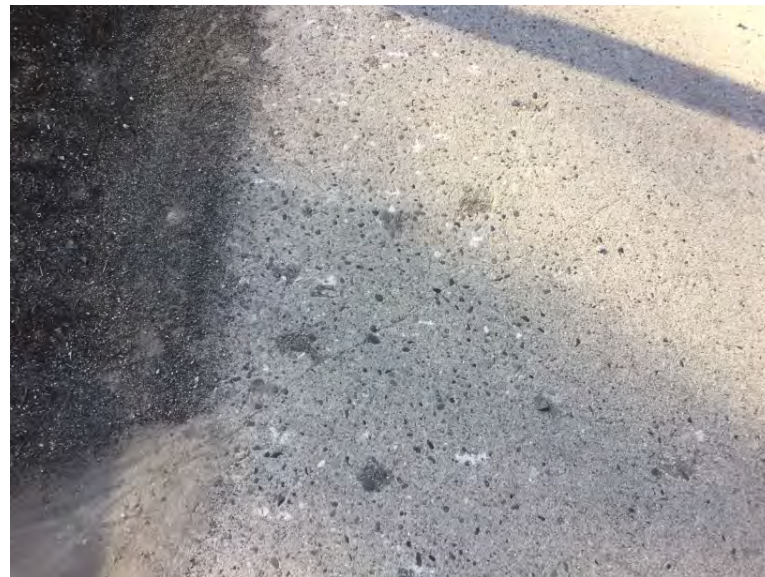
The structure requires new guardrail prior to industrial use. The 4th and 5th panels from the left end have diagonal cracks 3.3m long on the surface but those cracks are not visible on the underside of the panels. Deck surface is worn and pitted. Left bank panel 1 is chipped underneath, exposing rusting rebar. Monitor panel condition.

Hairline cracks noted on top of 2 deck panels

| Item | Monitor Description | Frequency |
|---|---|---|
| 1 | Cracks in deck panels and ballast walls | Every inspection |

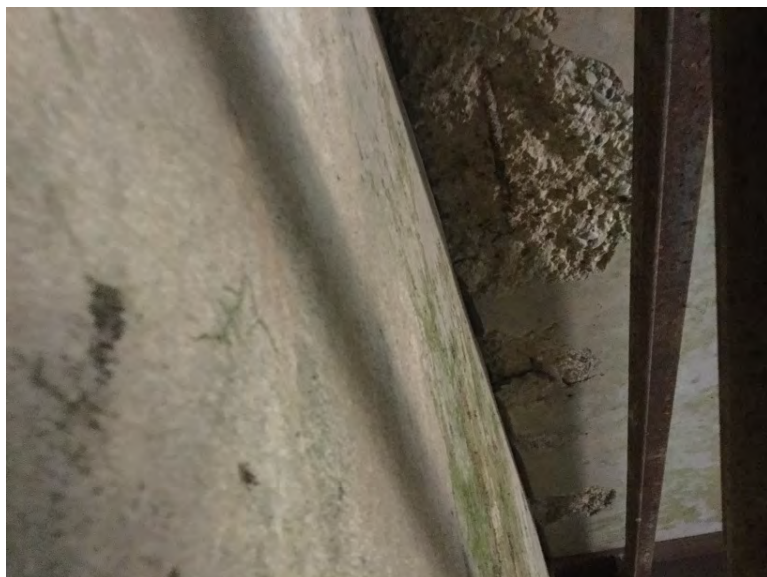
Damage under deck panel 1 on left bank

Repair the damaged deck panel (visible from underneath) consistent with the MoFLNRO Concrete Repair Guide for Concrete Bridge Components (2017); replace guardrail, risers and blocks; brush approaches; replace missing delineator; and post bridge ahead signs. Deck panels 4 and 5 and the right bank ballast wall have hairline cracks on the surface that require monitoring. The current load rating of L75 or 68 tonnes can continue.

| 3 | Medium | Repair damaged concrete |

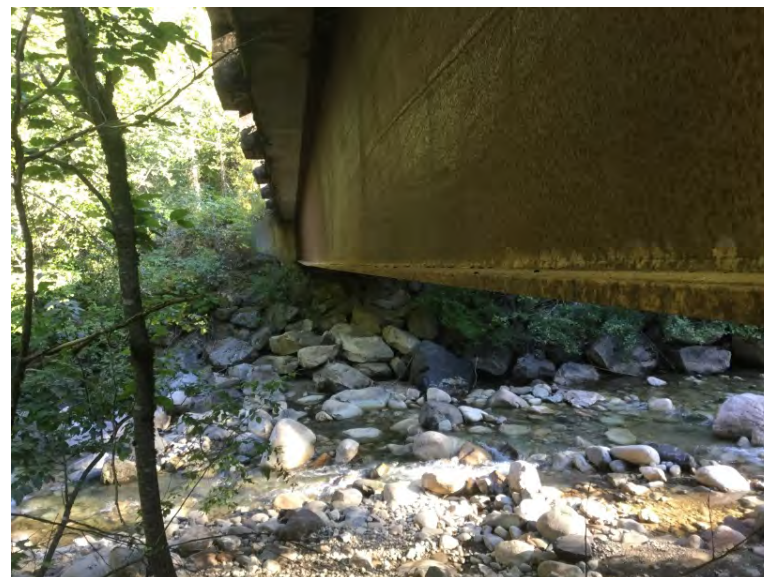
minor sag in girders with minor corrosion

Sag in girders, downstream girder shown above

| Item | Monitor Description | Frequency |
|---|---|---|
| 2 | Sag in girders | Every inspection |

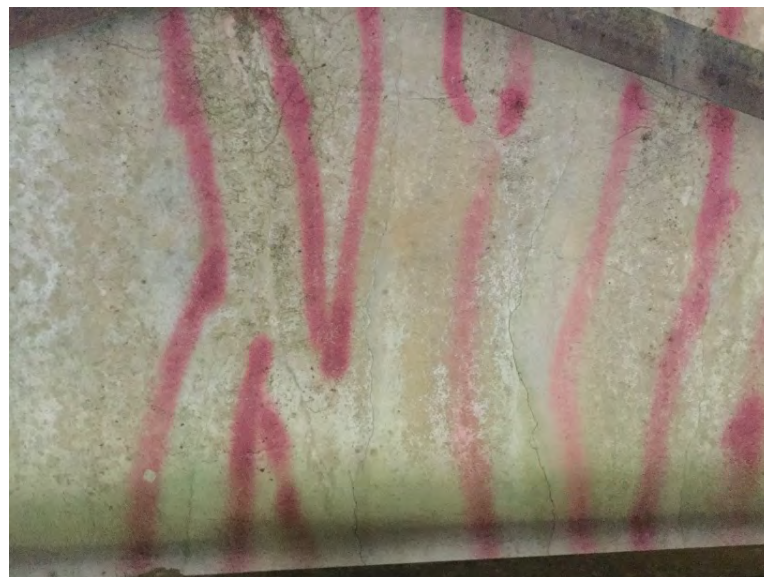
Hairline cracks at right bank

Hairline cracks in right bank ballast wall
