CK-2319

GARNET 9km

2019 Inspection

| Crossing Name | Side Creek |

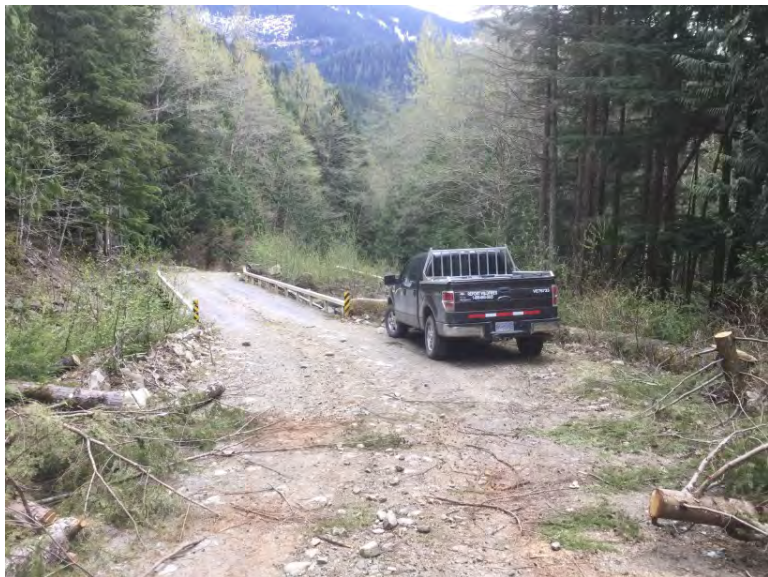
Approach from Right Bank when facing downstream

Brush approaches. The current load rating of BCL-625 or 63 tonnes to continue.

| 1 | Low | Brush approaches |

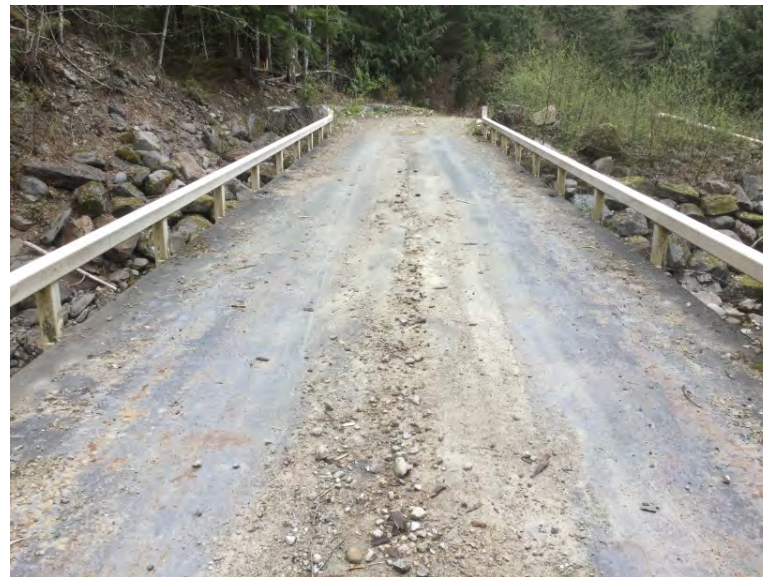
Overall Deck Condition      **Good**

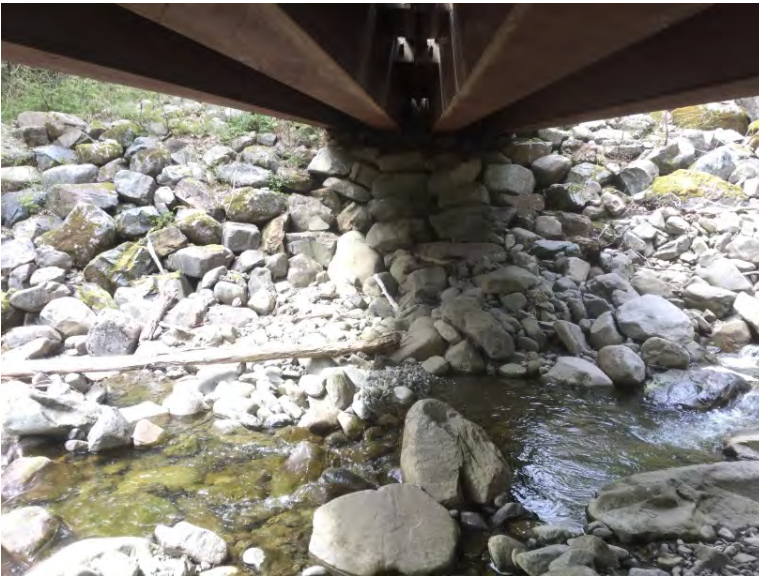
Right Bank Abutment when facing downstream

Log sill with timber plank left bank, log sill right bank

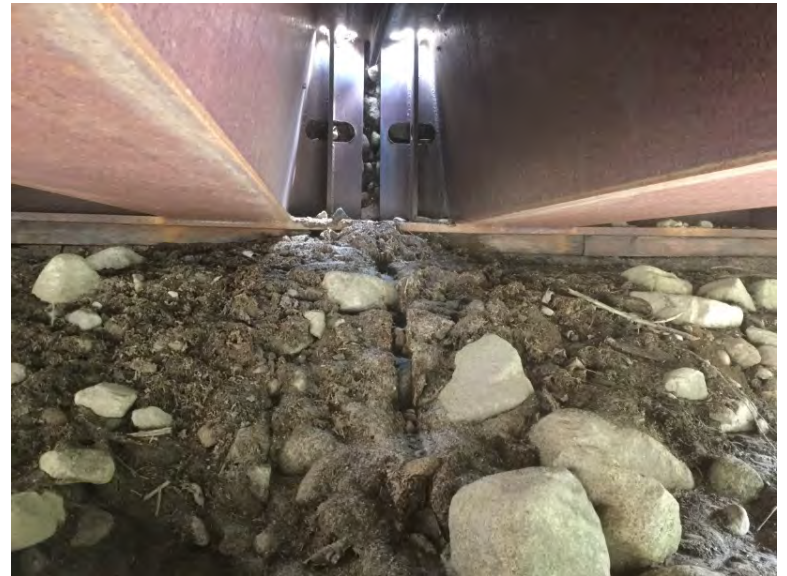
Timber on top of log sill at left bank

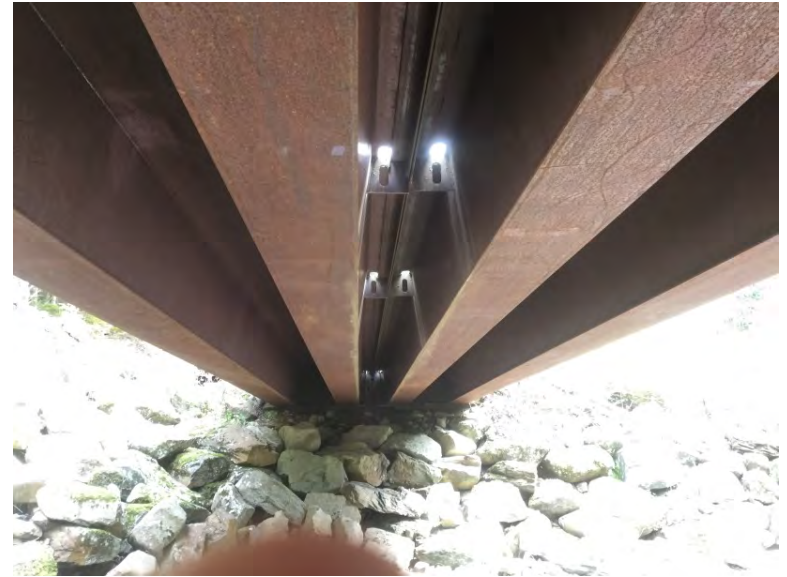
Superstructure

Girders Good Twin box beam

Diaphragms Unrated Internal but no signs of deformation
