CK-2329

LOST 7300 1.1km

2019 Inspection

| Structure Class | Major Culvert |

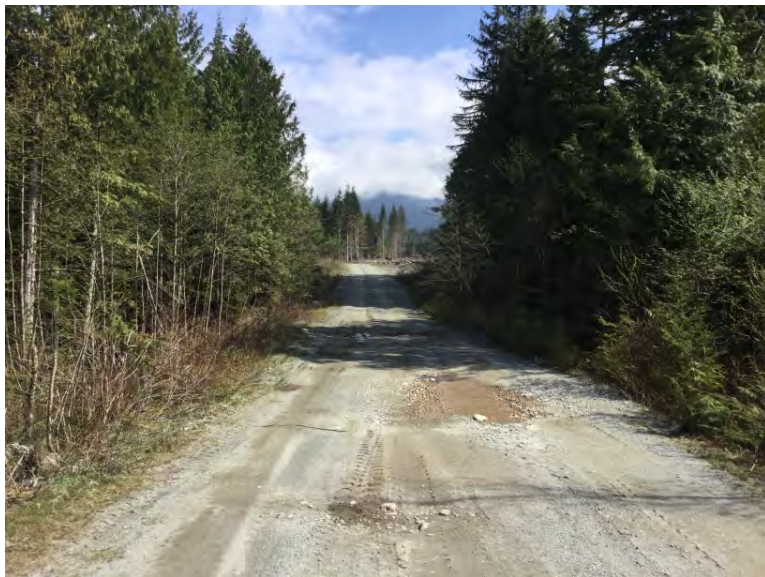
Approach from Left Bank when facing downstream

Road Surface Fair Potholes

Grade approaches. The current load rating of BCL-625 or 63 tonnes to continue.

| 1 | Low | Grade approaches |

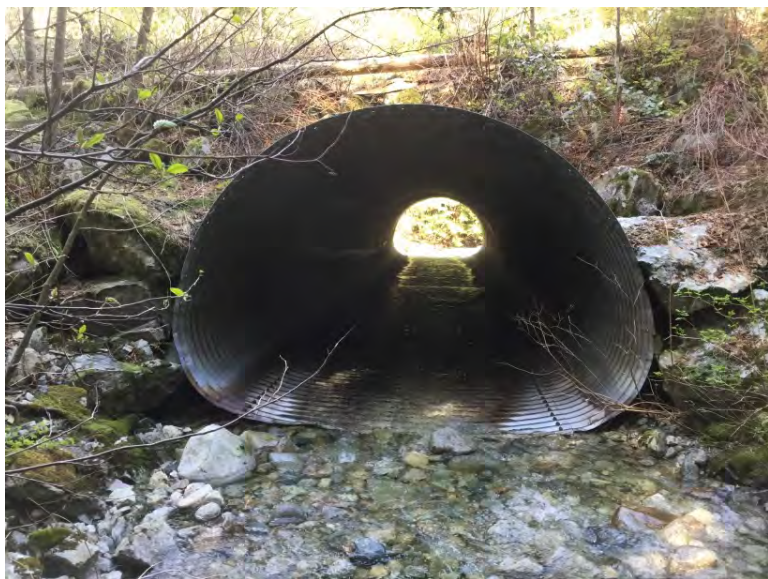
Inlet

Good

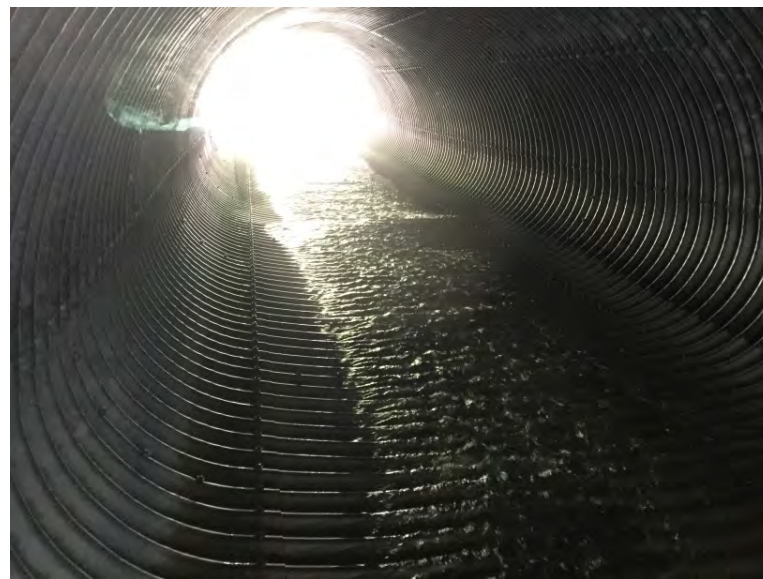
Fair

Minor deformation noted at midspan

Deformation on culvert floor at midspan

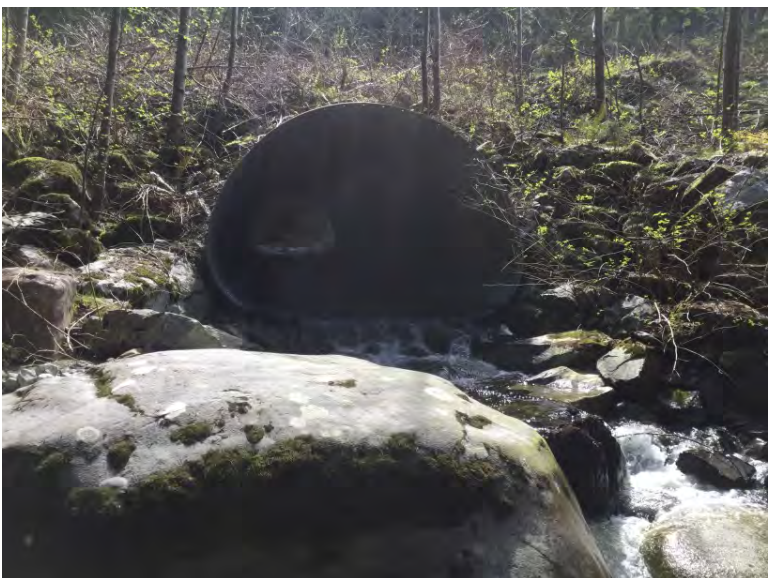
Outlet

Good

Minor scour
