CK-2330

TEREPOCKI 1.3km

2019 Inspection

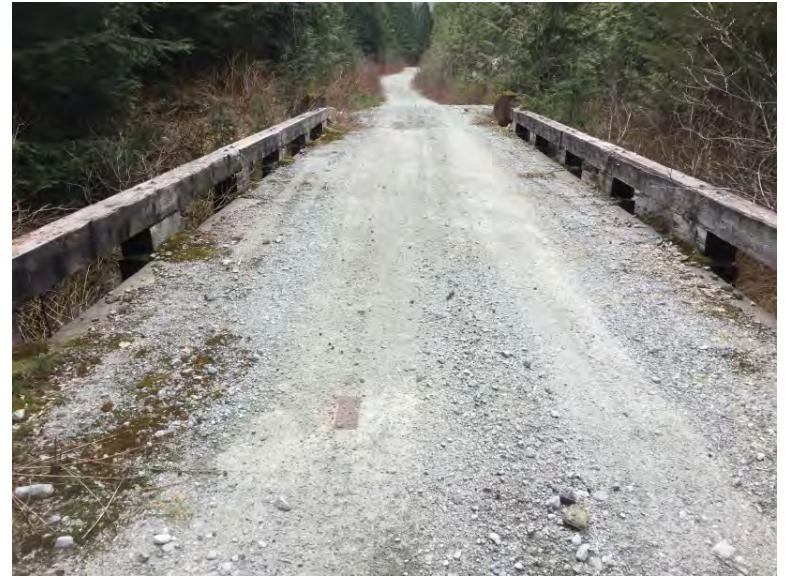
Deck

Poor

Rotten

Loose rail bolts

Due to rail condition

| Repair Item | Priority | Repair Description |
|---|---|---|
| 1 | High | Replace guardrail, risers and blocks and place delineators |
| 2 | Medium | Replace paraseal between slabs |

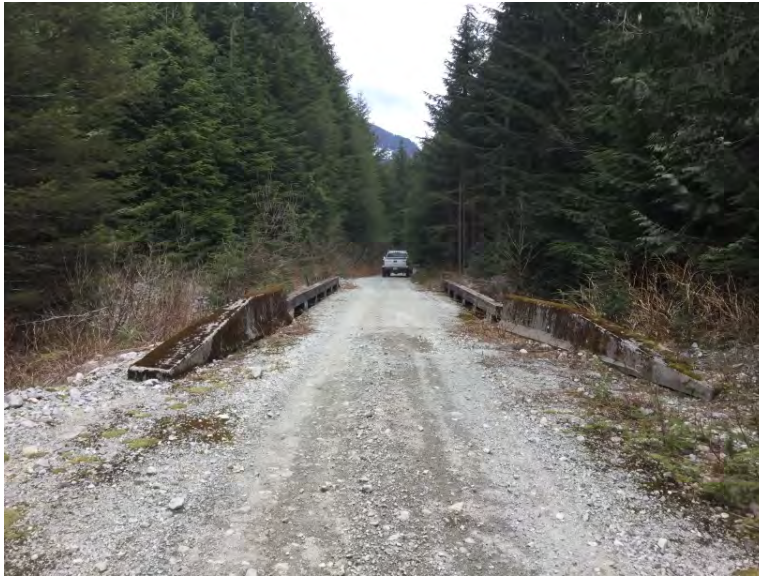
Approach from Right Bank when facing downstream

Road Surface Poor Large potholes

| Repair Item | Priority | Repair Description |
|---|---|---|
| 3 | Medium | Brush and grade approaches and post bridge ahead signs |

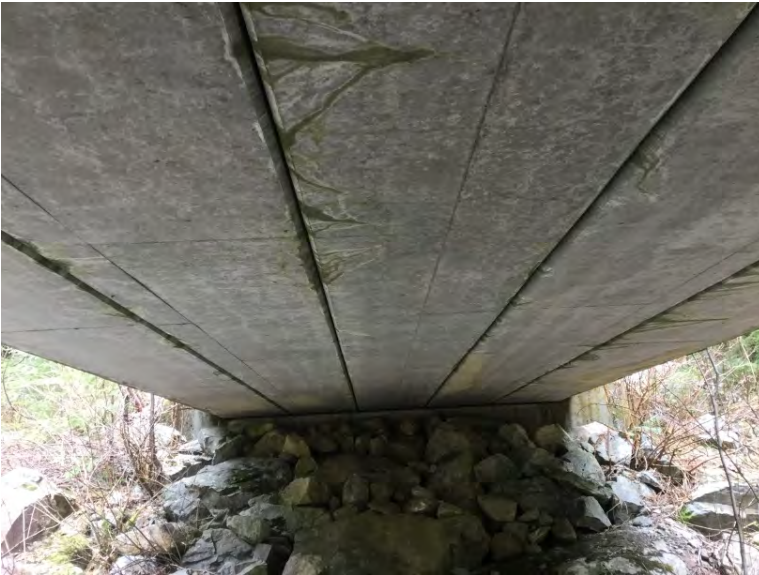
Superstructure

Girders Good

5 concrete slabs
