CK-2334

STAVE 3.7km

2019 Inspection

| Structure Class | Major Culvert |

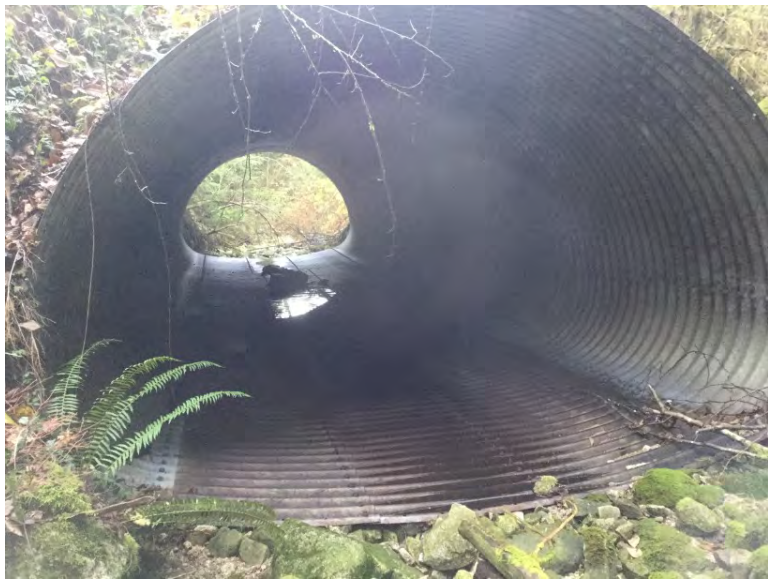
| Inlet | Good |

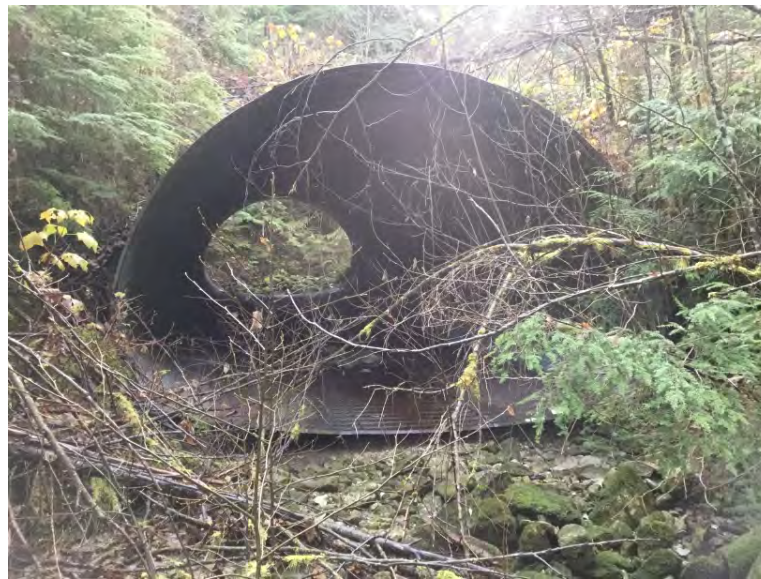
| Outlet | Fair | Minor corrosion |

Eroding fill material under outlet of culvert

Monitor the fill under the the outlet of the multiplate culvert. The current load rating of L75 or 68 tonnes to continue.

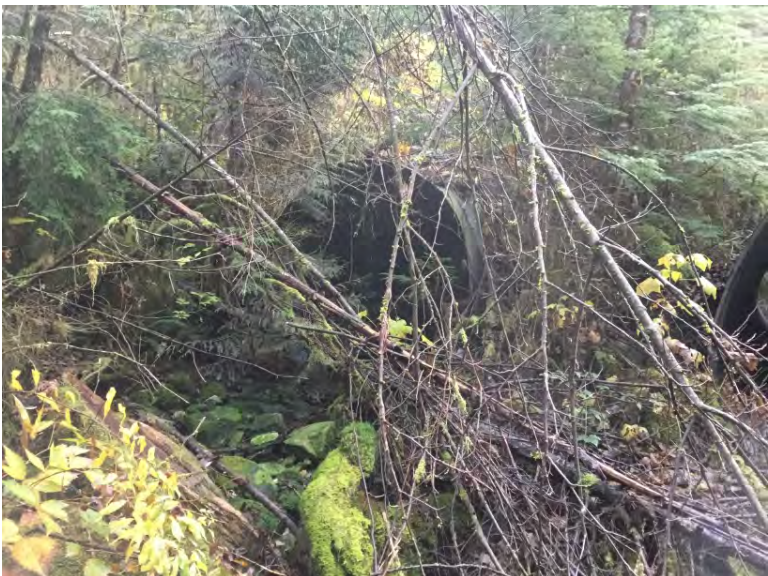
Comments Back up culvert is a 2200mm CSP in good condition with minor corrosion on floor. 150mm gap between underside of culvert and ground - extends approximately 1.0m

Outlet of 2000mm over flow culvert

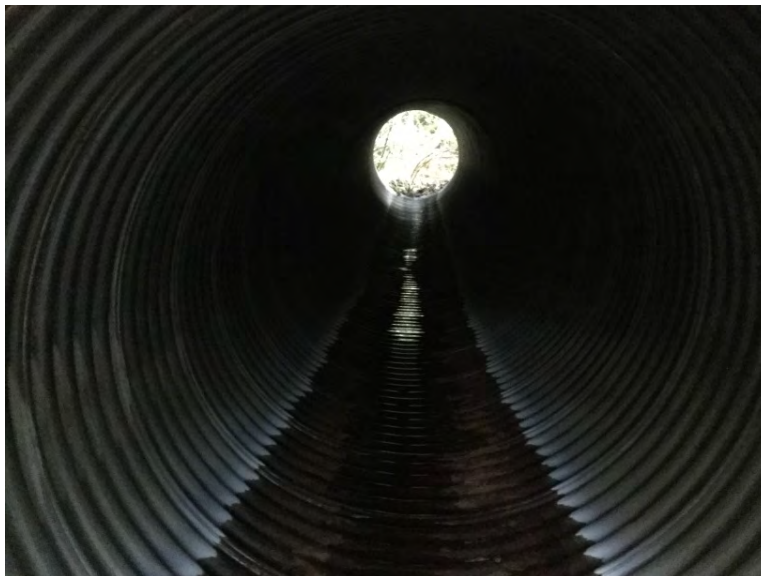
Looking through overflow culvert from outlet

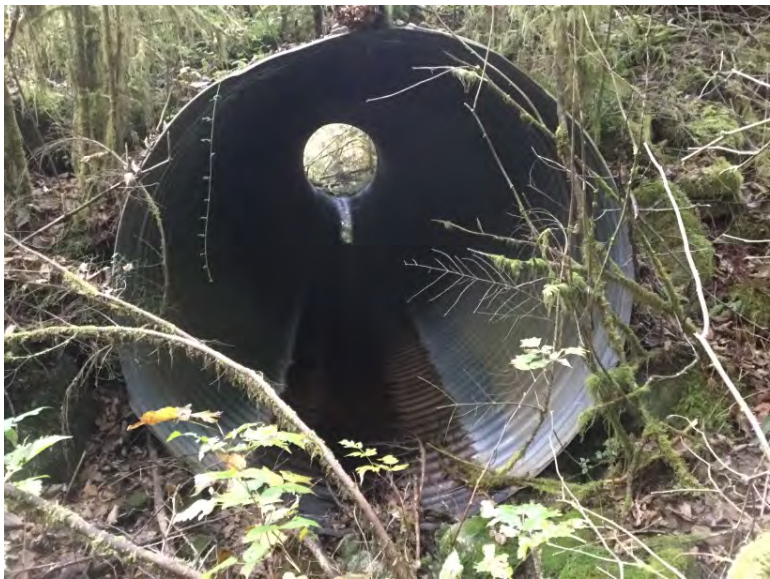
Inlet of overflowing of culvert
