CK-2338

STAVE 12.2km

2019 Inspection

| Structure Class | Major Culvert |

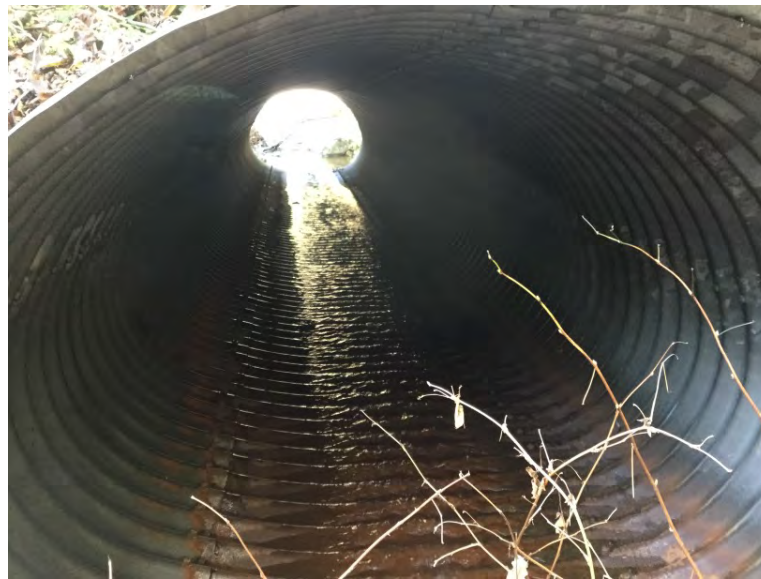
Looking through culvert from inlet

Floor

Fair

Minor corrosion

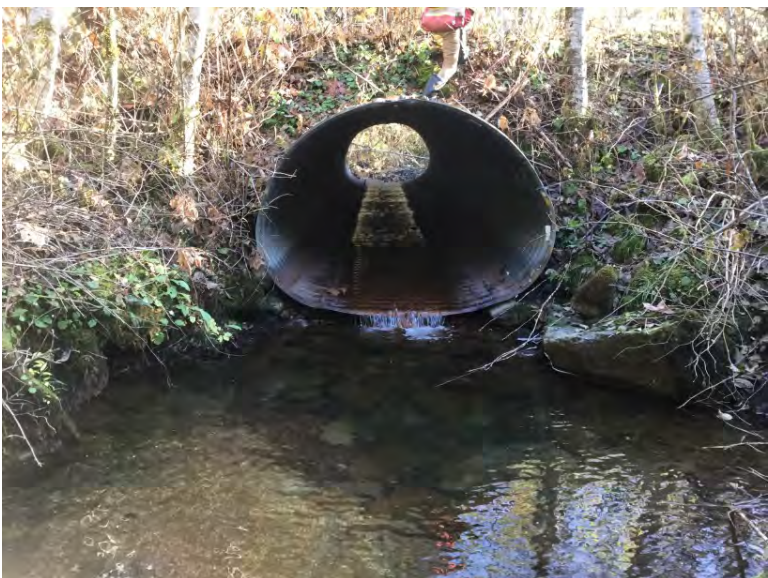
Outlet

Fair

Minor drop in elevation
