CK-2339

STAVE 12.4km

2019 Inspection

| Structure Class | Major Culvert |

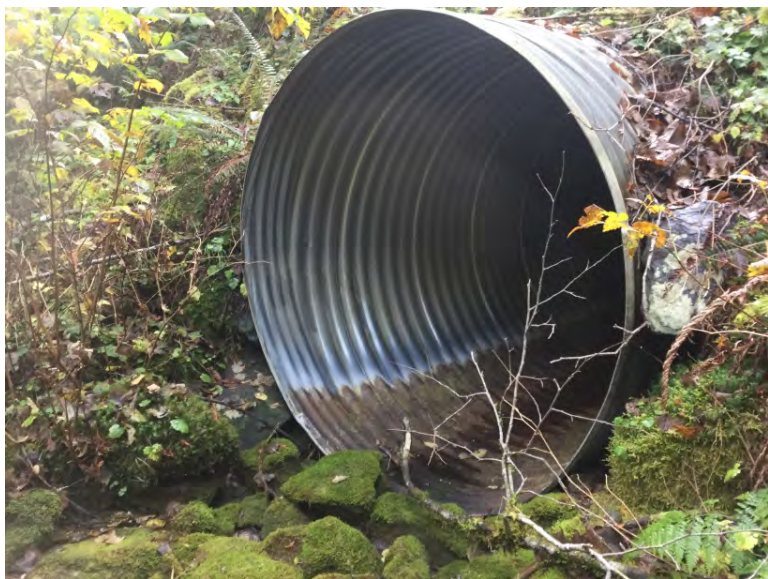
Inlet

Good

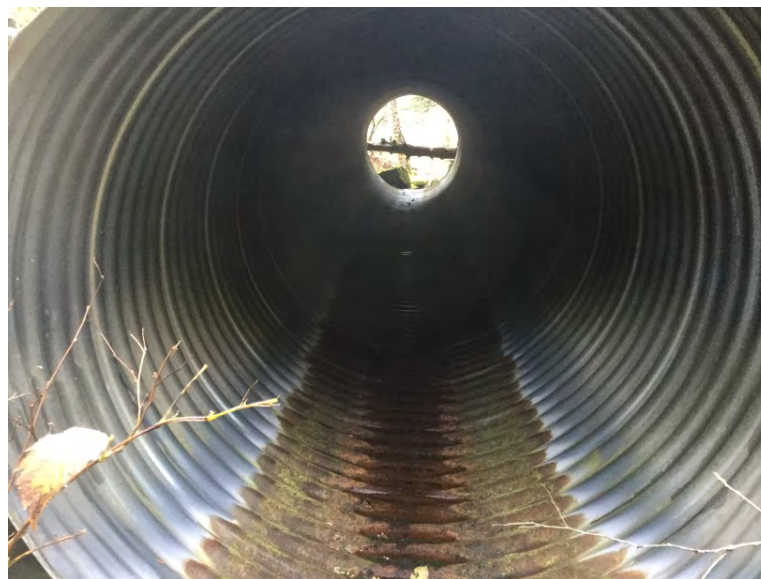
Looking through culvert from inlet

Minor corrosion on floor

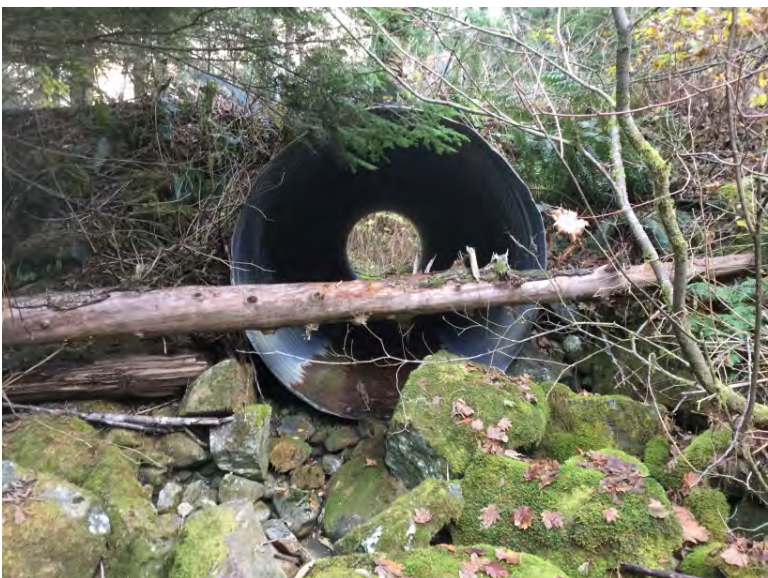
Outlet

Fair

Minor damage noted
