CK-2343

STAVE 26.4km

2019 Inspection

| Structure Class | Major Culvert |

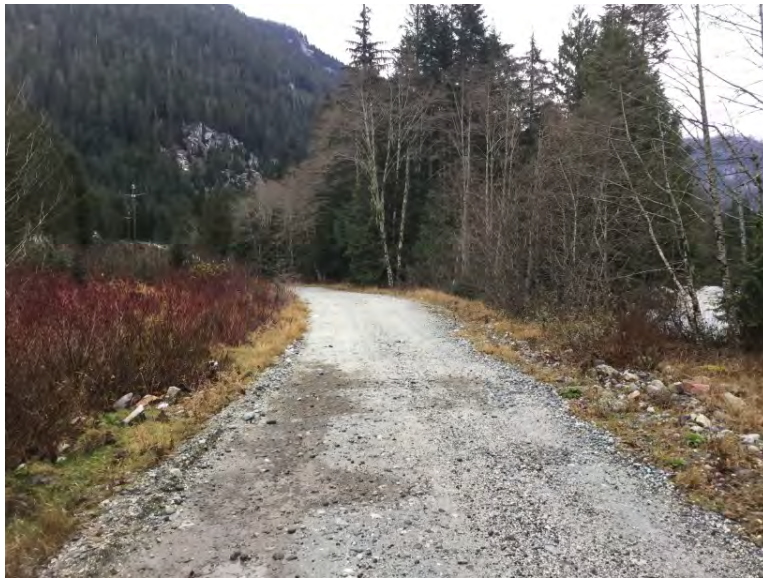
Approach from Right Bank when facing downstream

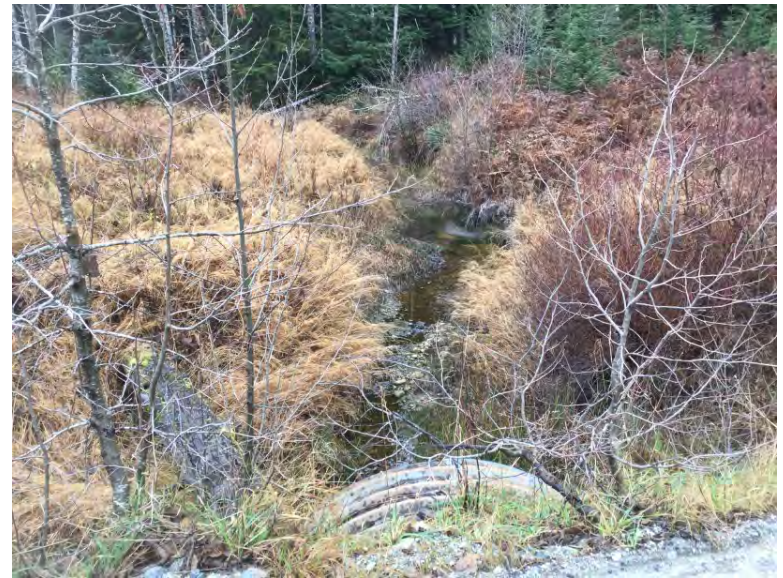
Upstream from Crossing

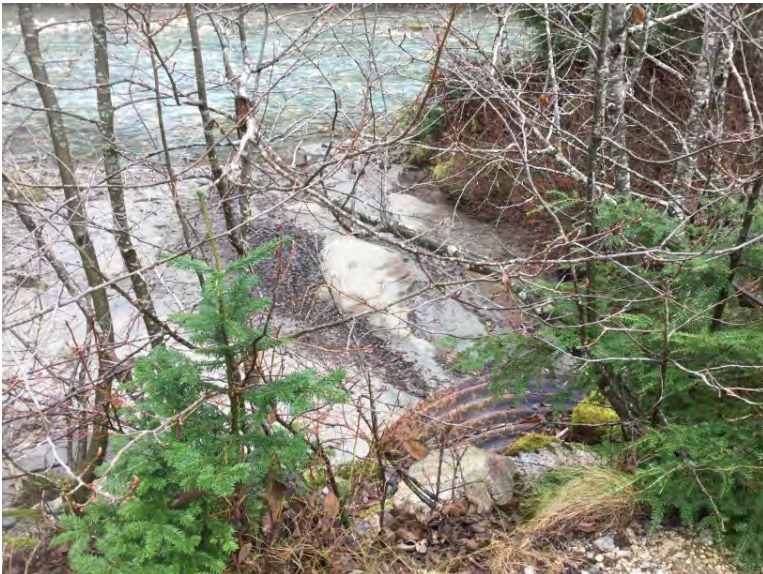
Downstream from Crossing

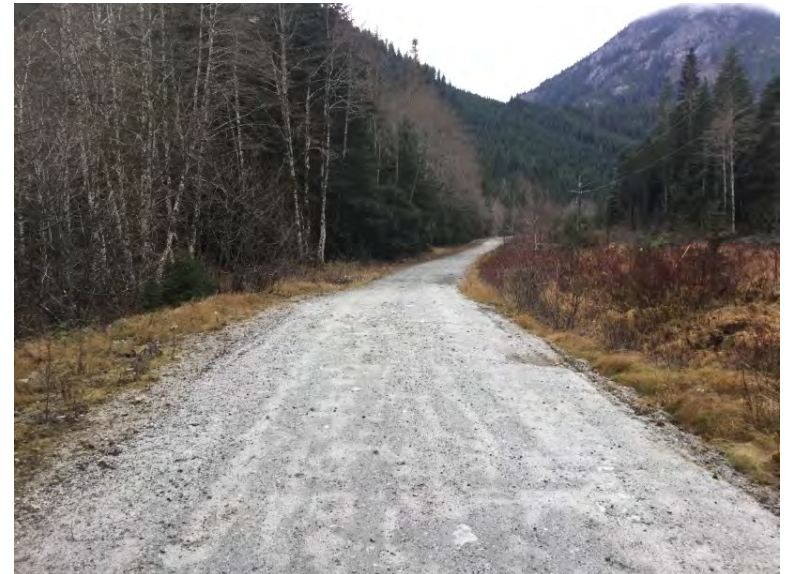
Approach from Left Bank when facing downstream

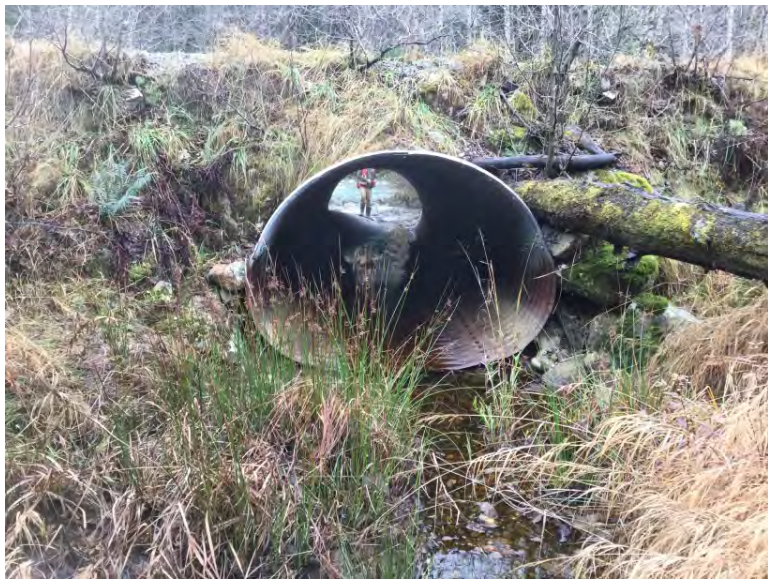
Inlet

Fair

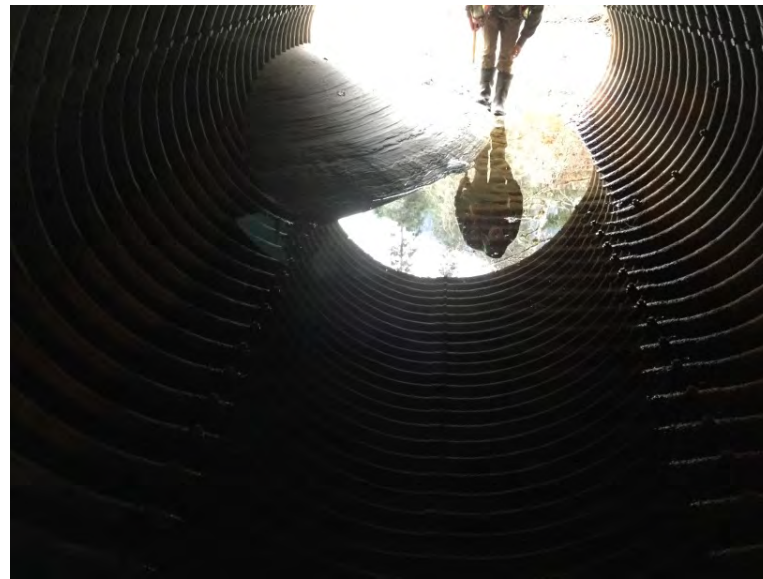
Aggrading and partially obstructing flows

Comments    Aggradation is from the Stave River

Aggrading material at outlet

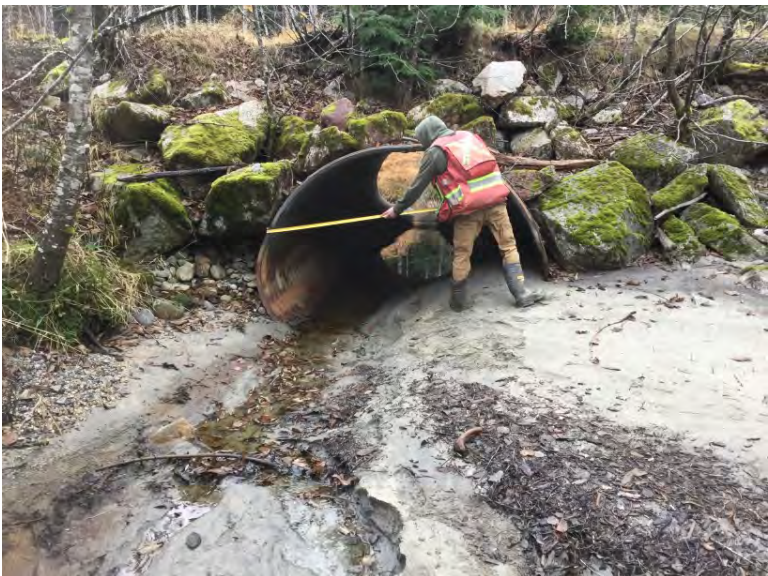
Outlet

Fair
