CK-2348

COGBURN 4.8km

2019 Inspection

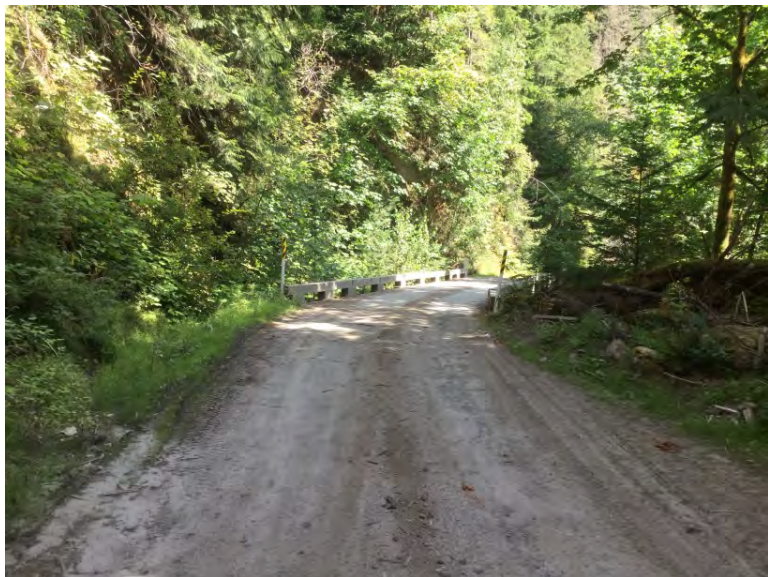
Approach from Right Bank when facing downstream

HC right approach

Bridge Ahead Signs  
Missing ☐ 0 ☐ 1 ☒ 2

| Item | Priority | Repair Description |
|---|---|---|
| 1 | Low | Post bridge ahead signs |

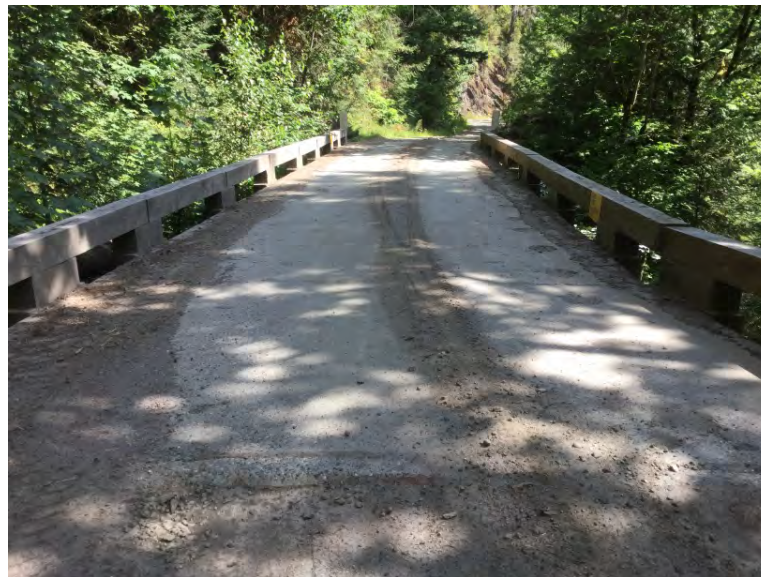
Concrete Deck      Fair

Grout Pockets      Fair      Appears as though water is getting through to girders

Deck Joints      Fair      Appears as though water is getting through to girders and bracing

| Item | Monitor Description | Frequency |
|---|---|---|
| 1 | Monitor corrosion on girders and bracing at deck panel joint and grout pocket locations | Routine Inspection |

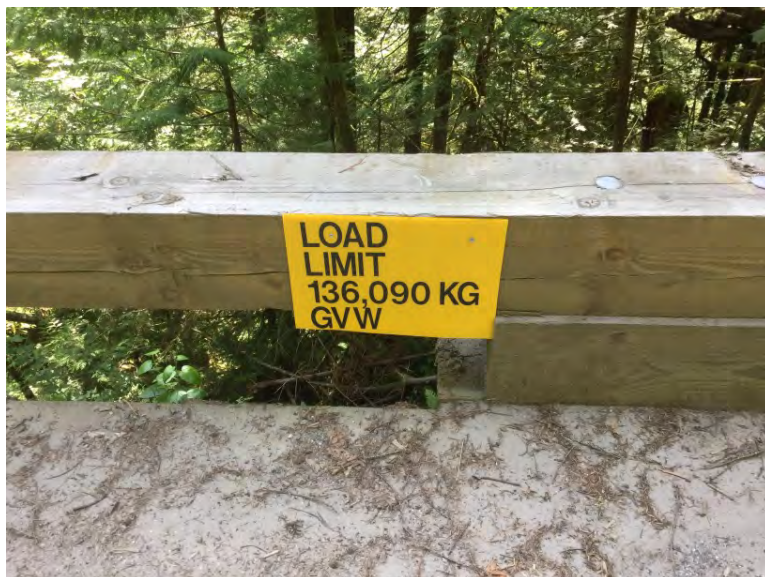
Load Rating Sign

Not posted

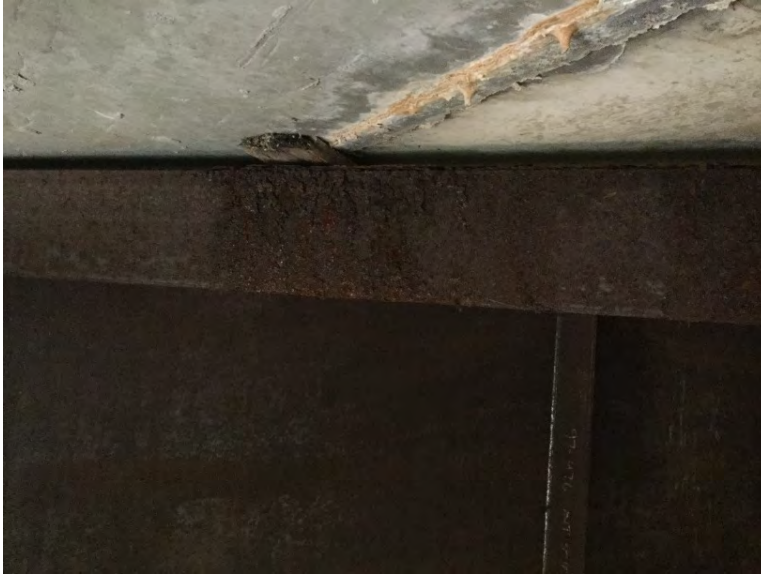
Minor corrosion noted at grout pocket locations

Bracing Fair

Minor bracing corrosion
