CK-2351

STOYOMA 6200 3.5km

2019 Inspection

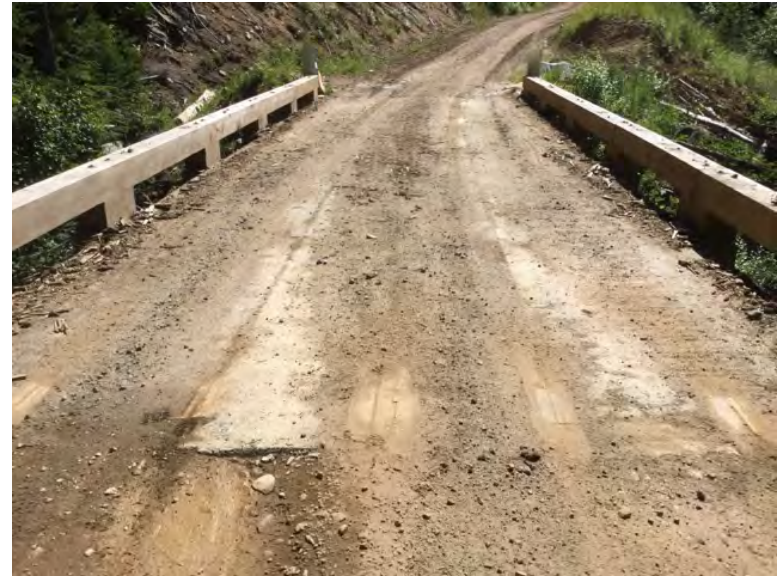
Deck

Sediment on deck

| 2 | Medium | Clean sediment from the deck |

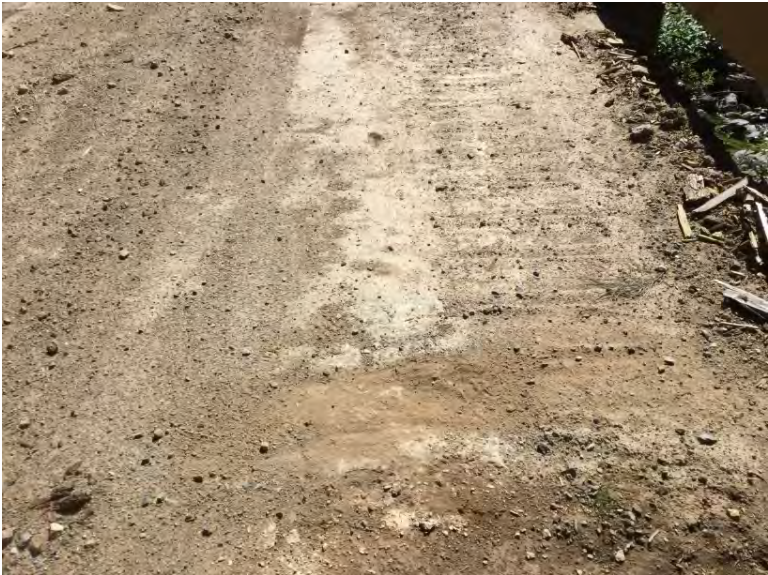
Damage noted on wheel path due to track equipment

Damage noted to deck due to track equipment

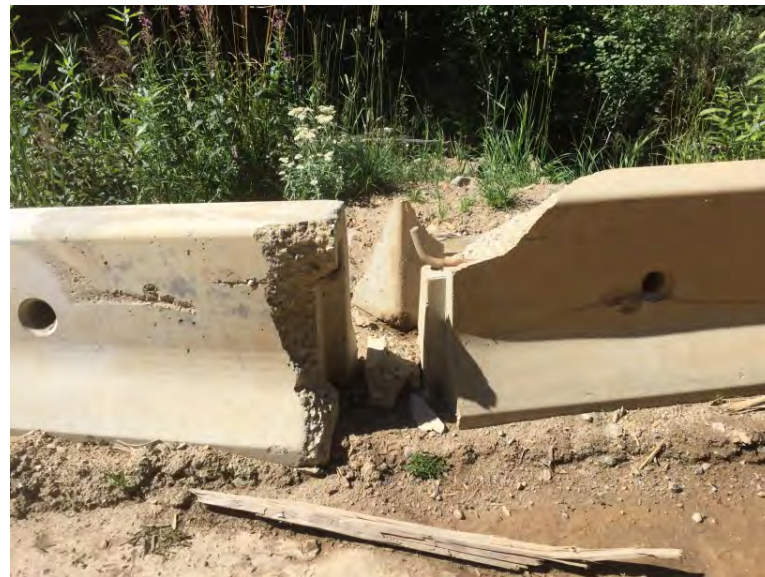
Damage to downstream left bank approach barriers

Reconnect and repair the concrete no post barrier damage noted at downstream left bank approach and clean the sediment from the deck. The current load rating of L75 or 68 tonnes to continue.

| Item | Priority | Repair Description |
|---|---|---|
| 1 | Medium | Reconnect and repair the downstream left bank concrete no post barriers |
