CK-2358

LOST CREEK 3.1km

2019 Inspection

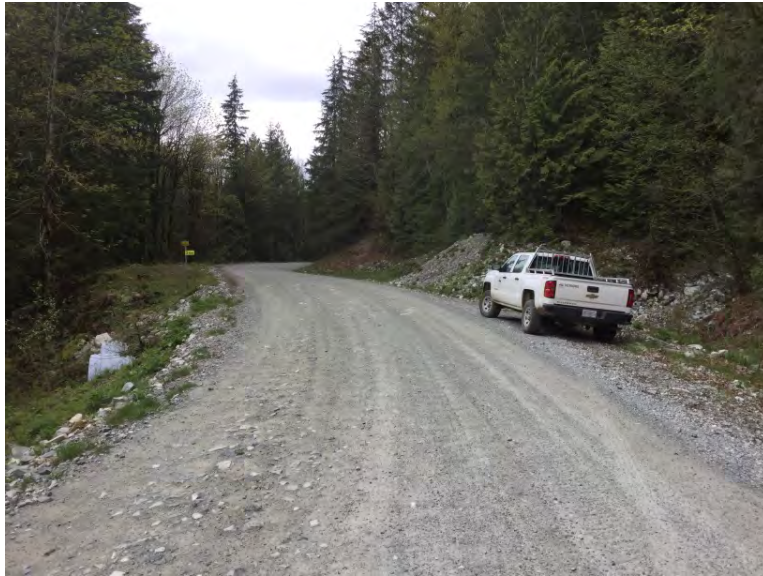
Approach from Left Bank when facing downstream

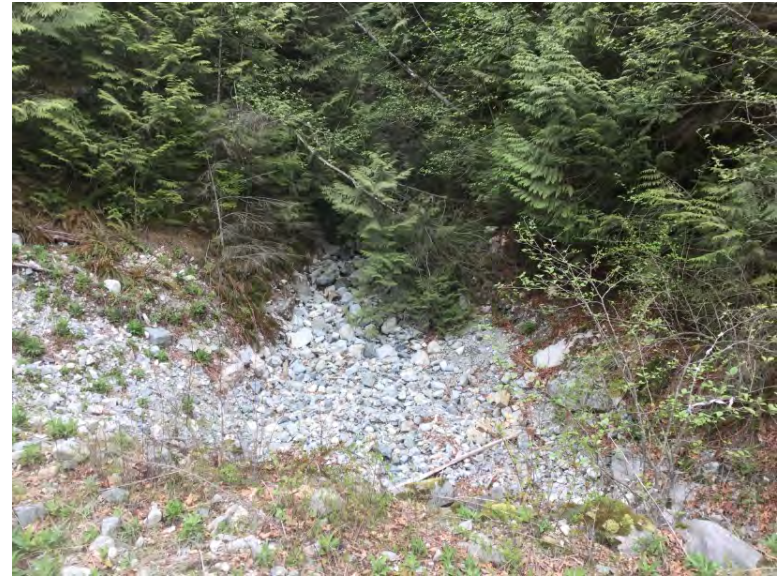
Upstream from Crossing

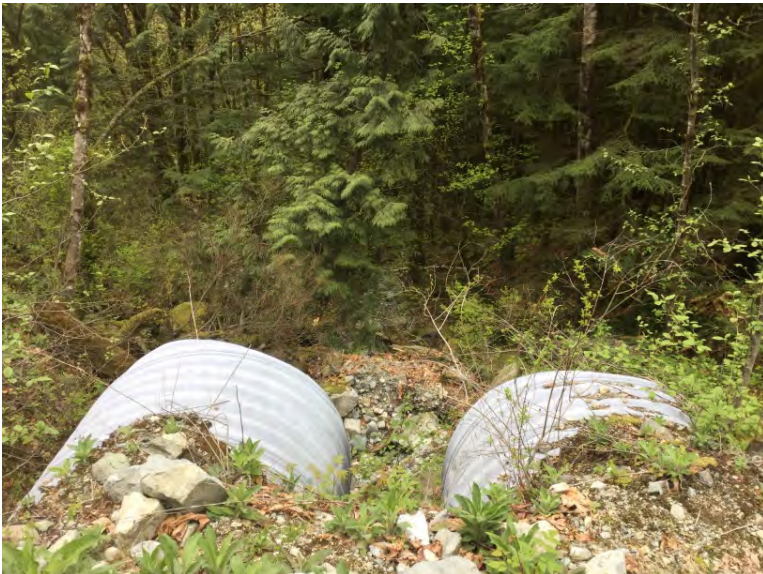
Downstream from Crossing

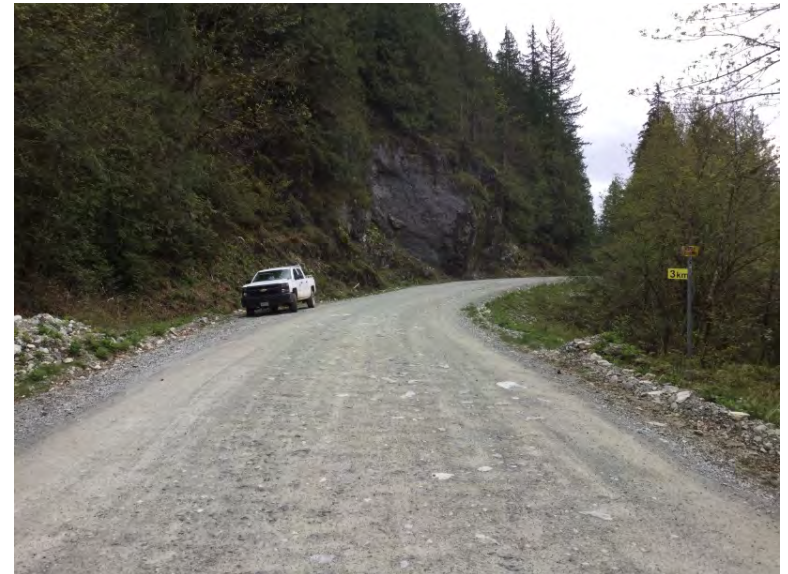
Approach from Right Bank when facing downstream

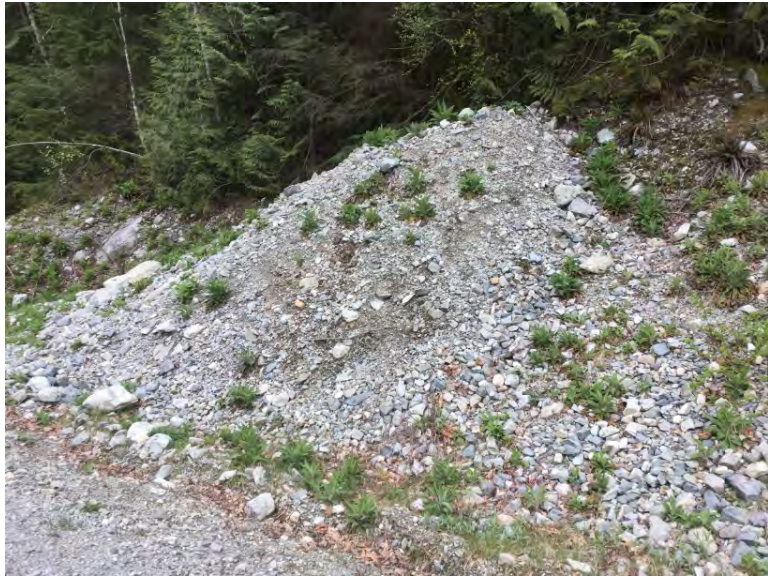
Inlet      Fair      Subject to aggradation

Comments    2 x 1800mm CSPs  
                   1 culvert 80% plugged

Inlet consistently being cleaned

| 1 | Medium | Clean plugged culvert and dig large sump |

| 1 | Inlet aggradation | Routine Inspection |

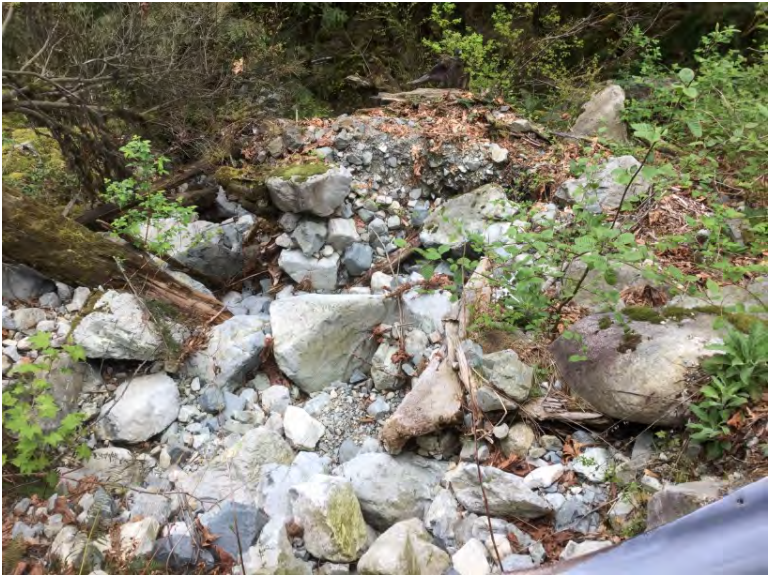
Outlet      Fair      Scouring

| 2 | Outlet scour | Routine Inspection |
