CK-2363

SPUZZUM 25.2km

2019 Inspection

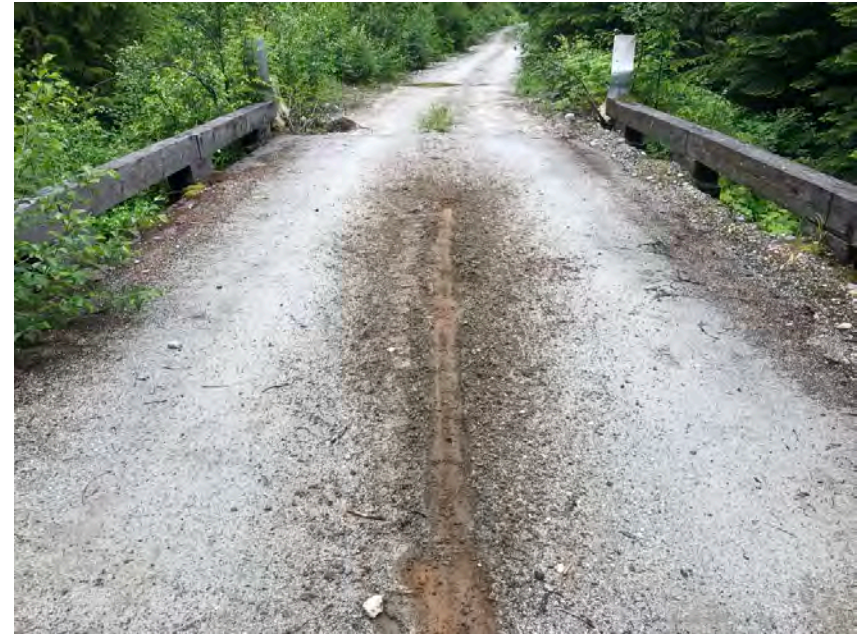
Curb Rail/Blocks/Posts      **Poor**      Rotten risers and blocks

Hardware      **Fair**Overall Deck Condition      **Poor**      Due to rail condition

| Repair Item | Priority | Repair Description |
|---|---|---|
| 1 | Medium | Replace guardrail, risers and blocks |

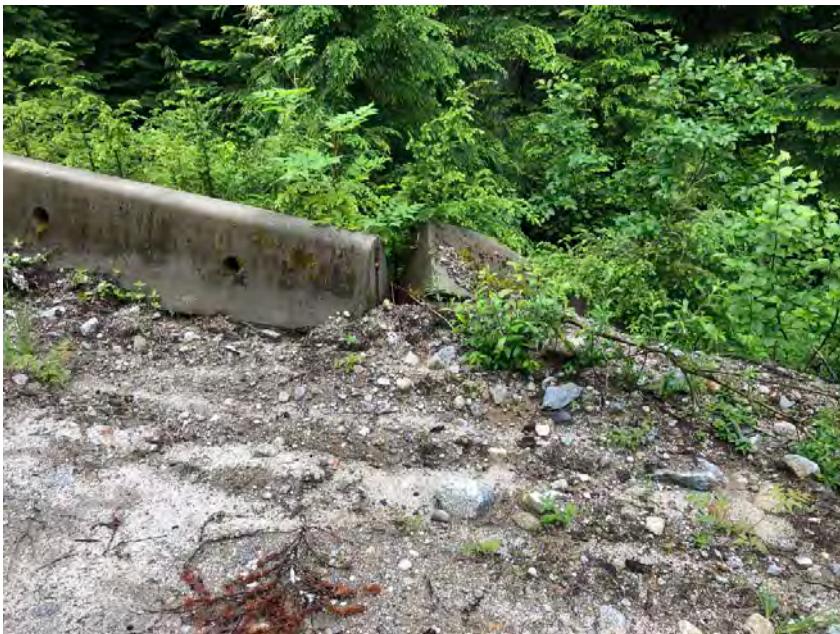
Bullnose downstream right bank not connected

Downstream right bank bullnose not connected

| Repair Item | Priority | Repair Description |
|---|---|---|
| 3 | Low | Reconnect bullnose |

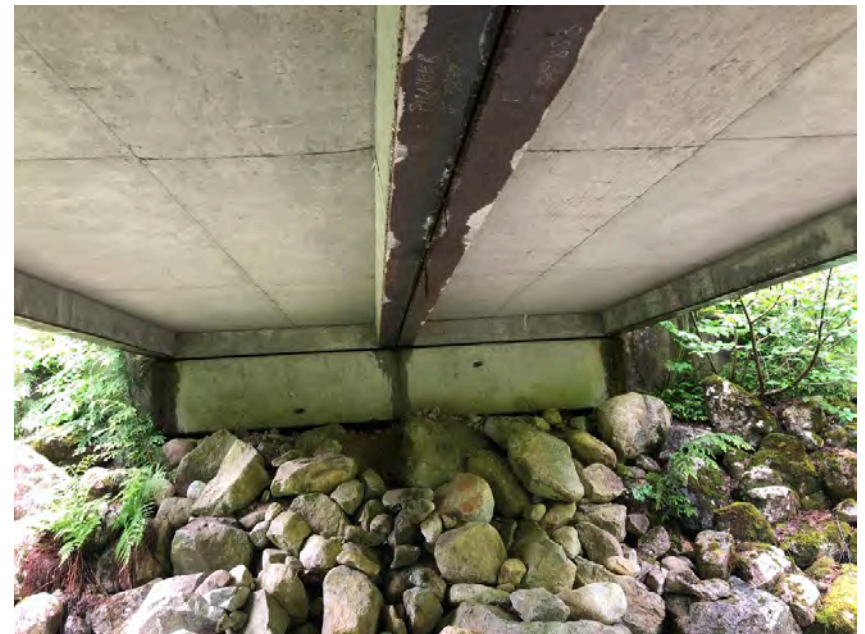
Superstructure

Girders Good 2 inverted C channel
