CK-2368

KAREN 0.2km

2019 Inspection

Crossing Name Dewdney Creek

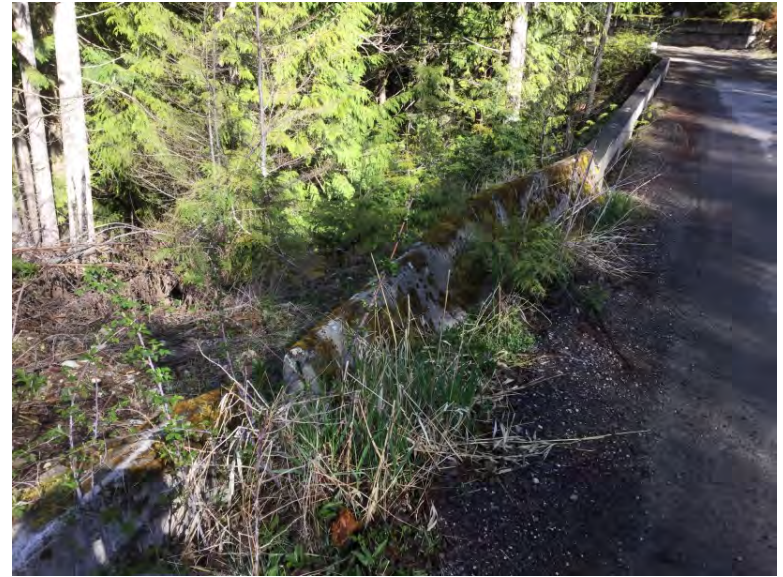
No post barriers falling off road and or unconnected

| Item | Priority | Repair Description |
|---|---|---|
| 1 | Medium | Reset all concrete no post barriers prior to industrial traffic |

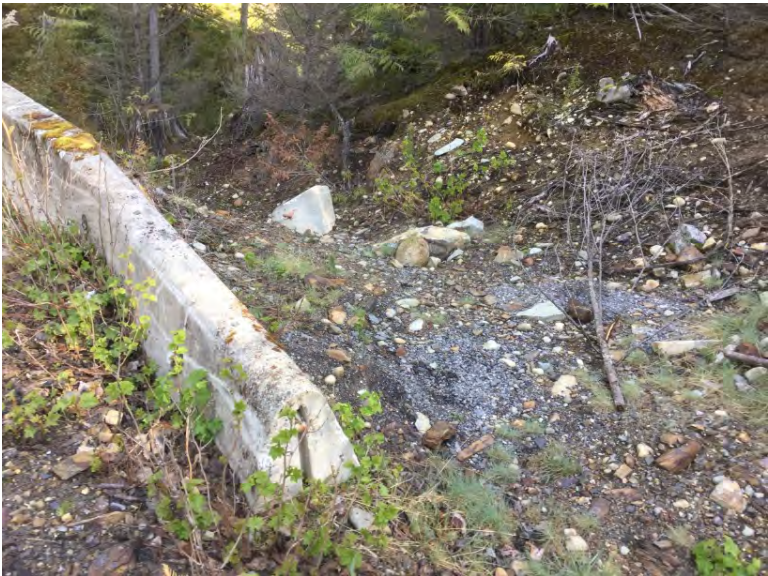
Missing bullnose at upstream left bank

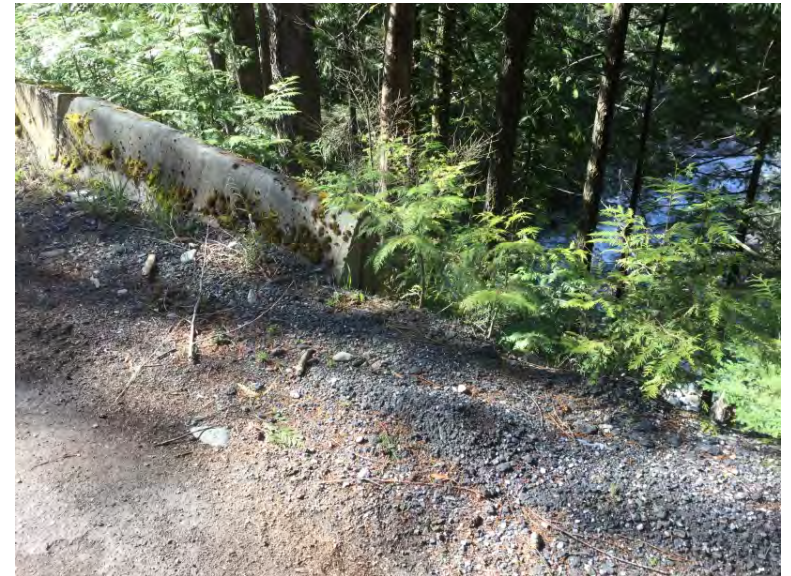
Missing bullnose at downstream right bank, it's over the bank

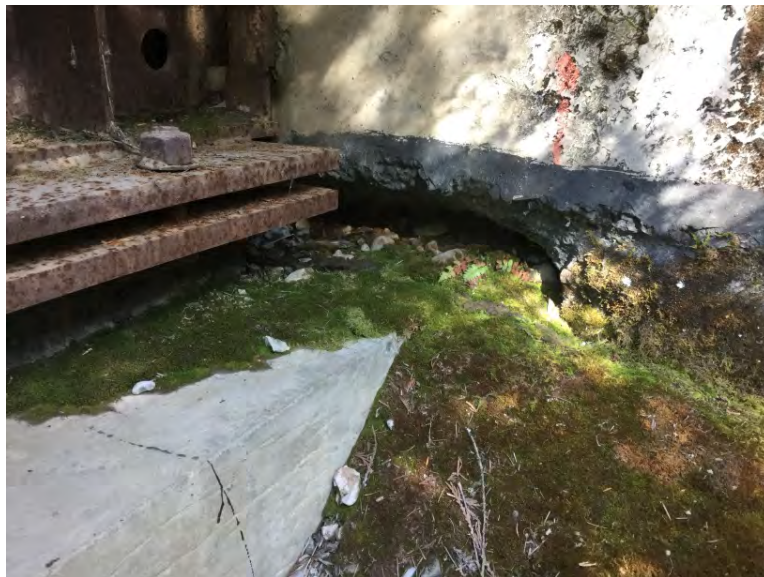
Minor damage noted and had to shaped to fit over CIP at upstream right bank

Ballast wall appears to have been cut to fit over CIP at upstream right bank

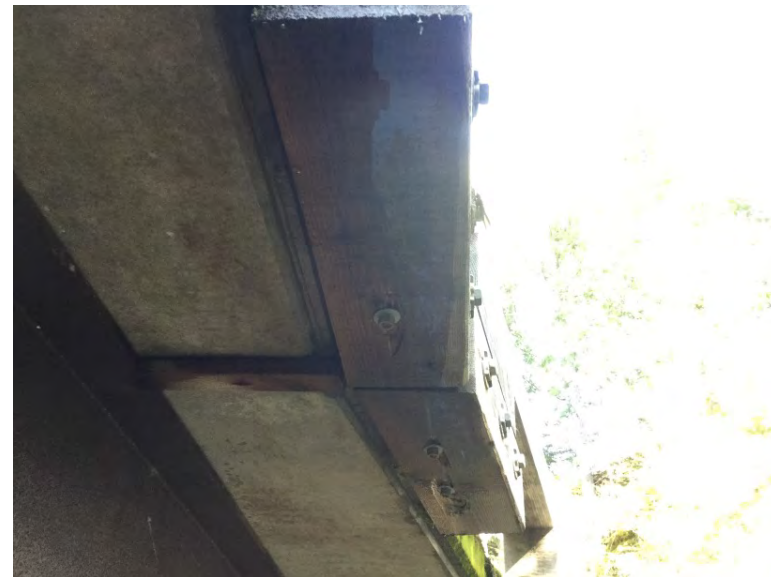
Curb Rail/Blocks/Posts Fair Timbers do not appear that old but missing bolts and not using correct washer size

Missed rail bolt and only small washers used

| Item | Priority | Repair Description |
|---|---|---|
| 2 | Medium | Replace delineators, post bridge ahead signs, and replace missing rail bolts and small washers with correct size |

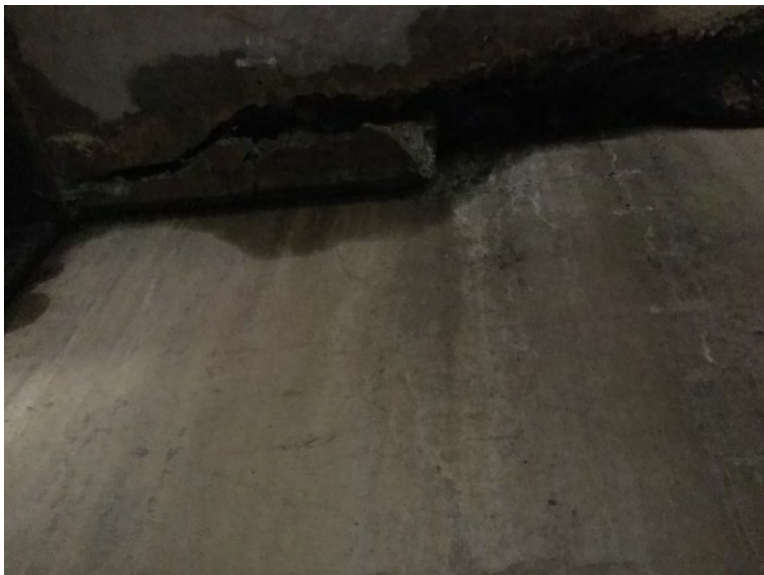
Damage to panel 1 at right bank

| Item | Priority | Repair Description |
|---|---|---|
| 3 | Medium | Repair damage to concrete and clean debris and sediment from bearing locations |

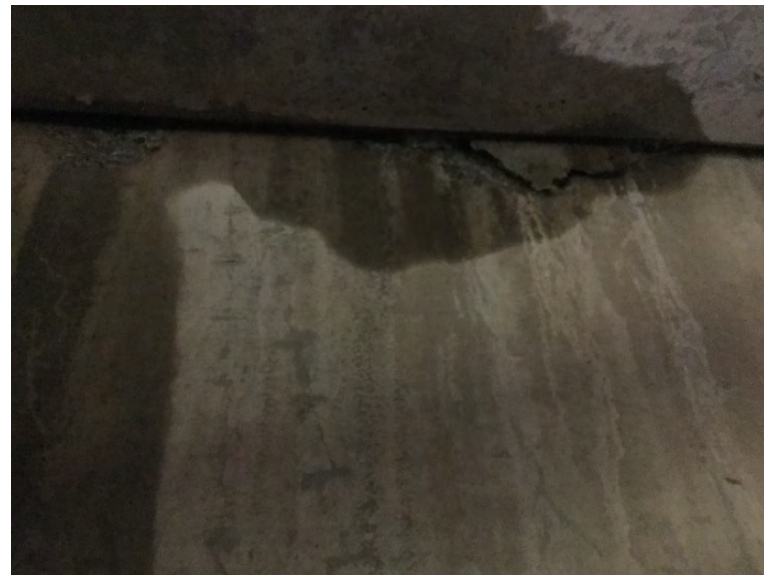
Damage to ballast wall at right bank

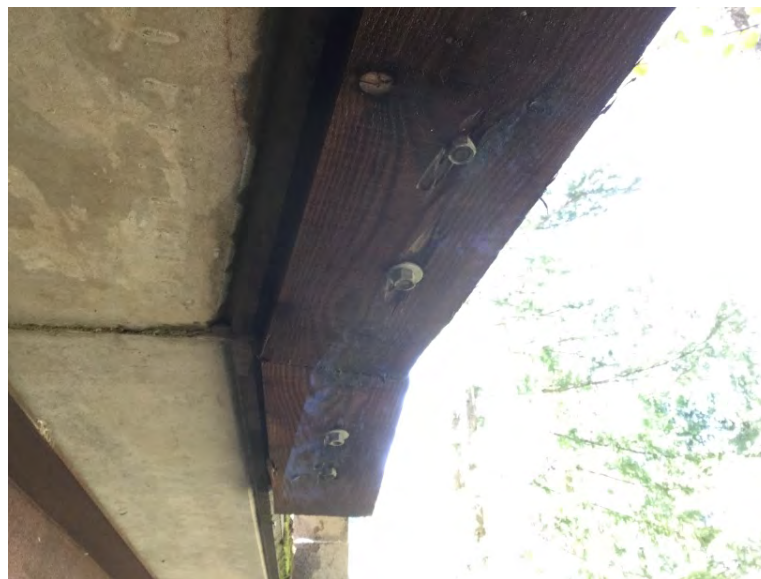
Missing washers on rail bolts
