CK-2369

SPUZZUM 24000 2.3km

2019 Inspection

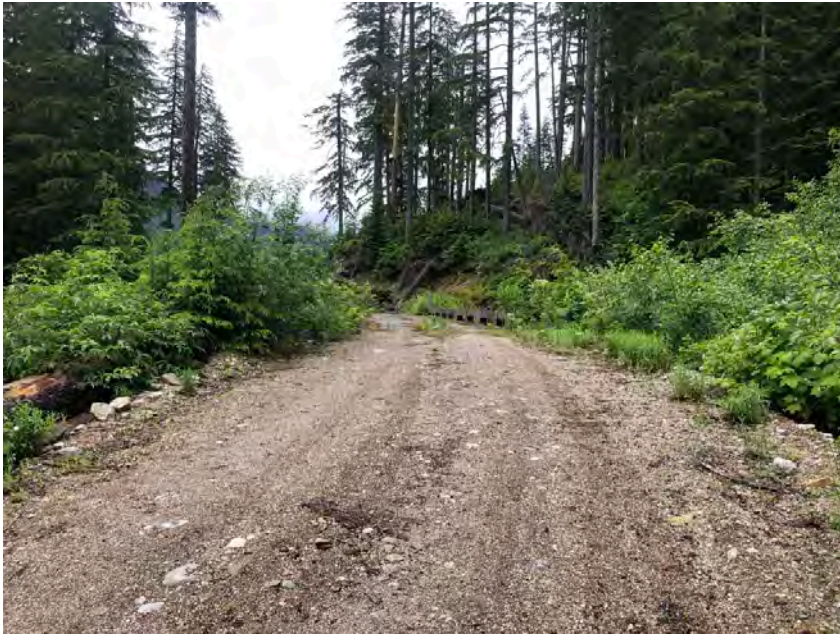
Approach from Left Bank when facing downstream

VC and HC left approach, HC right approach

Potholes at both approaches

| 3 | Low | Brush and grade approaches and post bridge ahead signs |

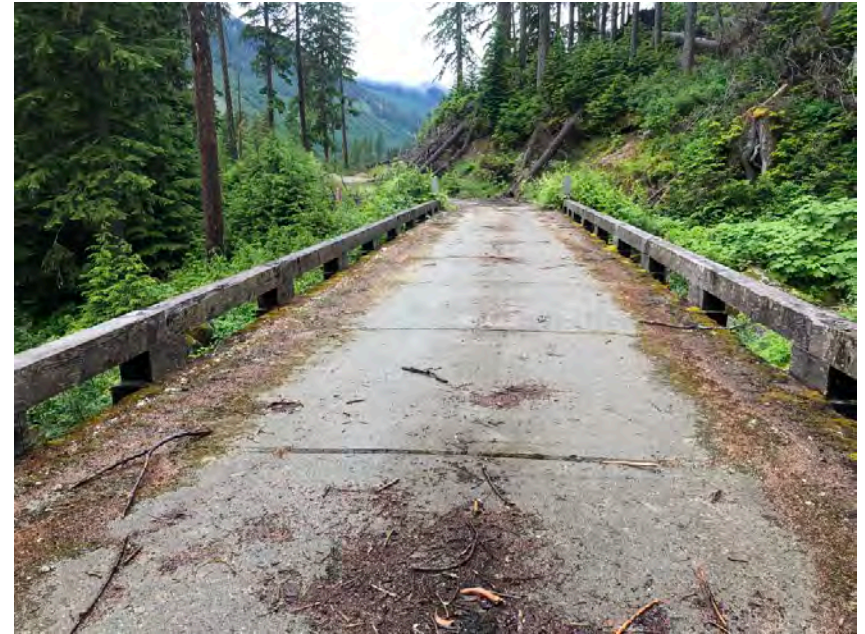
Deck Joints    Poor    All compression seals missing

Curb Rail/Blocks/Posts    Poor    Rotten

Overall Deck Condition    Poor    Due to rail and deck joint condition

| 1 | Medium | Replace guardrail, risers and blocks |

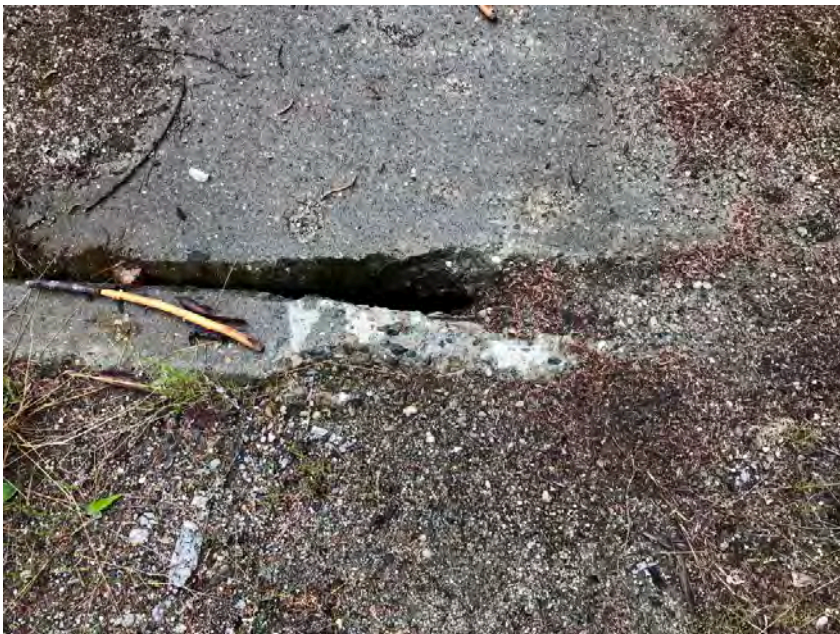
Ballast Wall Fair Damage at tops of both abutments

Concrete Deck    Fair    Damage to various panels

Damage to deck panel and ballast wall

Repair all damaged deck panels and both ballast walls; replace all okum and deck sealant at all deck joints; replace guardrail, risers and blocks; grade and brush approaches; post bridge ahead signs; all these maintenance activities are required prior to industrial activity. The present load rating of L75 or 68 tonnes is conditional on the above works being completed.

| 2 | Medium | Repair damage to deck panels and both ballast walls and add material to both approaches |

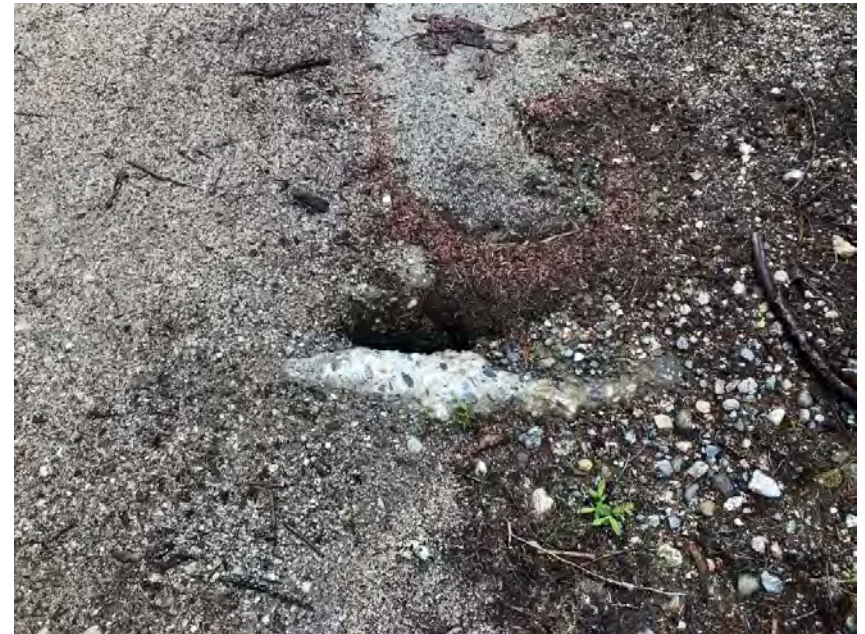
More damage to deck panels and ballast wall

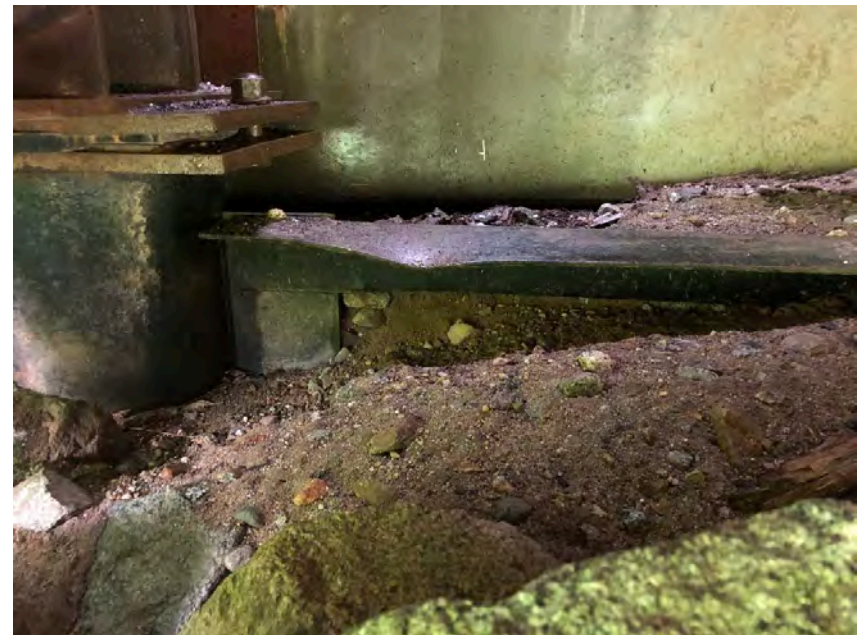
Minor damage to right bank abutment bracing
