CK-2370

KAREN 1.81km

2019 Inspection

| Crossing Name | Karen Creek |

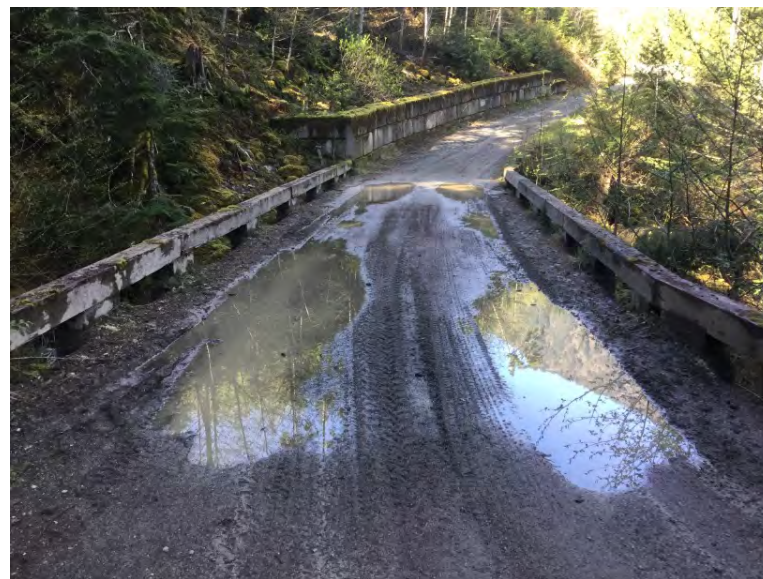
| Running Surface | Poor | Due to sediment and water pooling on deck |

| Overall Deck Condition | Poor | Due to rail condition and sediment on deck |

| Item | Priority | Repair Description |
|---|---|---|
| 2 | High | Clean sediment off deck |

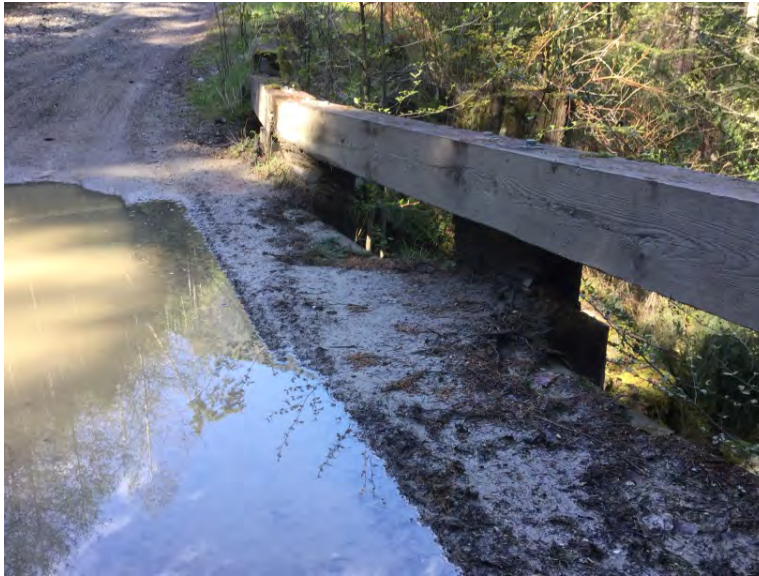
| Curb Rail/Blocks/Posts | Poor | Rotten |

| Hardware | Poor | Loose rail bolts |

Rail condition

| Item | Priority | Repair Description |
|---|---|---|
| 1 | High | Replace guardrail, risers and blocks prior to industrial activity |

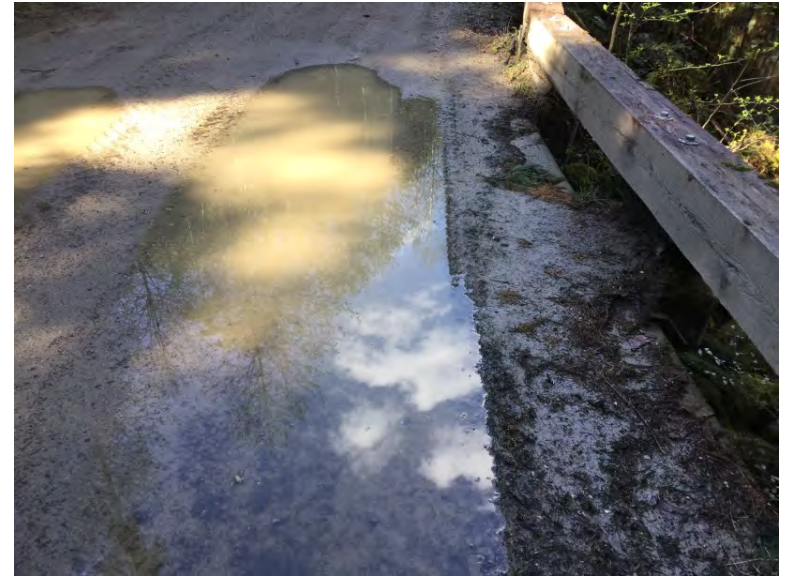
Water pooling deck due to sediment accumulations

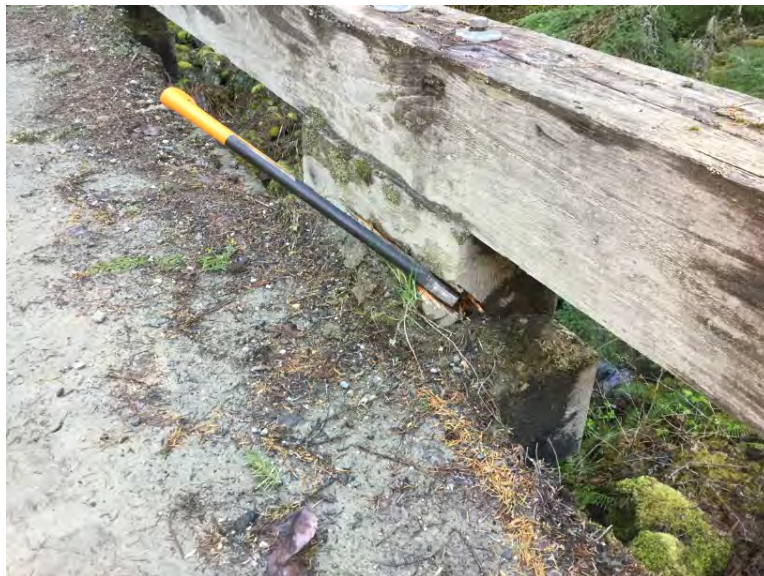
Rail condition

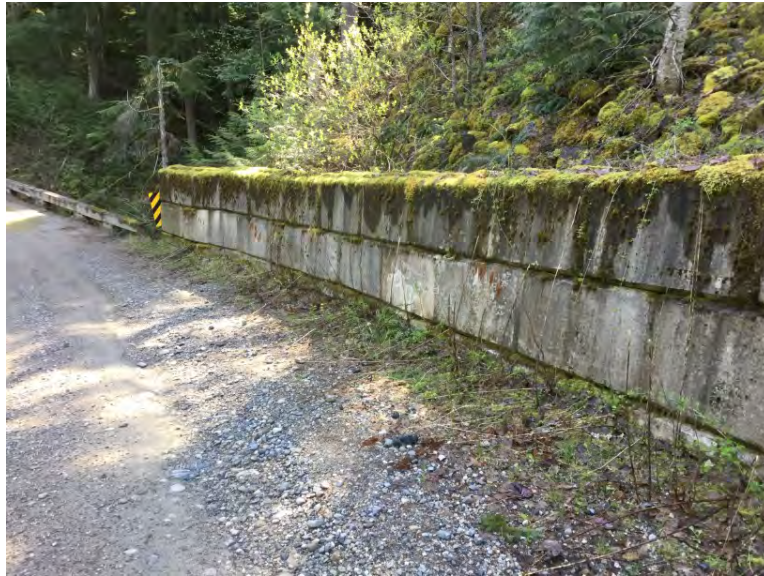
Fill retainment at upstream left approach, appears to be 3 blocks high

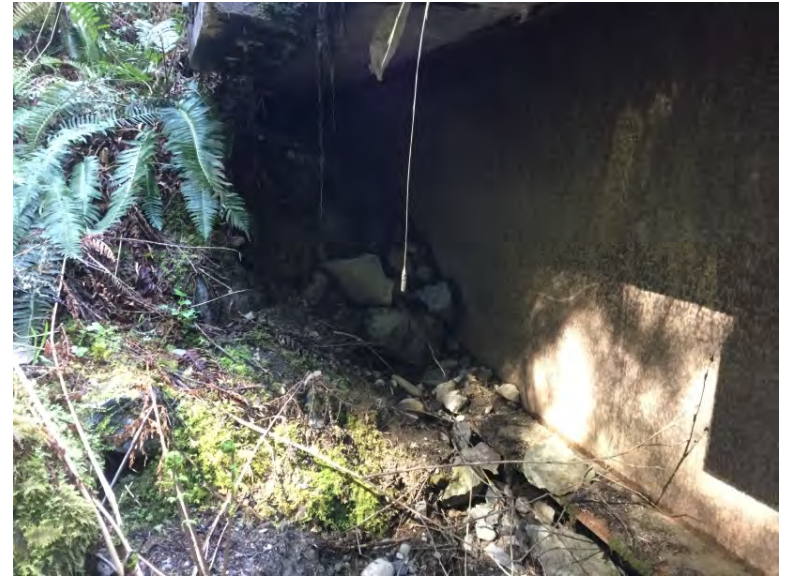
Bearings Fair Sediment burying upstream left location

Upstream left bearing buried with sediment

| Item | Priority | Repair Description |
|---|---|---|
| 3 | Medium | Clean bearings, replace missing delineators and post bridge ahead signs |

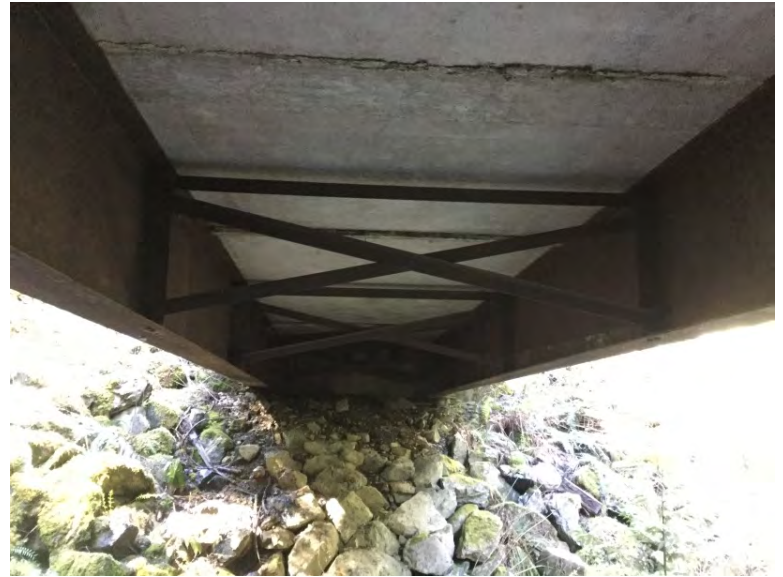
Superstructure

Girders Good

Diaphragms Good 5 bolted bays
