CK-2371

KAREN 2.26km

2019 Inspection

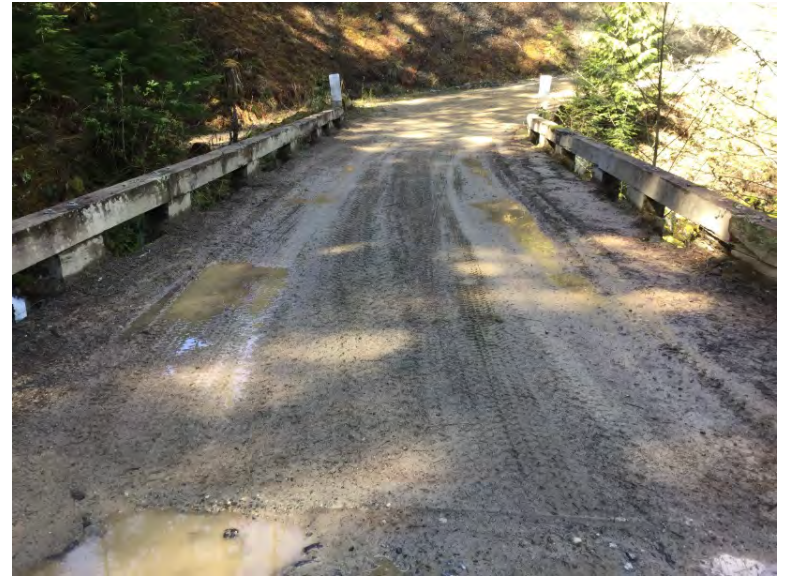
Concrete Deck      Unrated      Buried in sediment

Overall Deck Condition      Poor      Due to rail condition and sediment on deck

| Repair | | Repair Description |
|---|---|---|
| 3 | High | Clean sediment from deck and post bridge ahead signs |

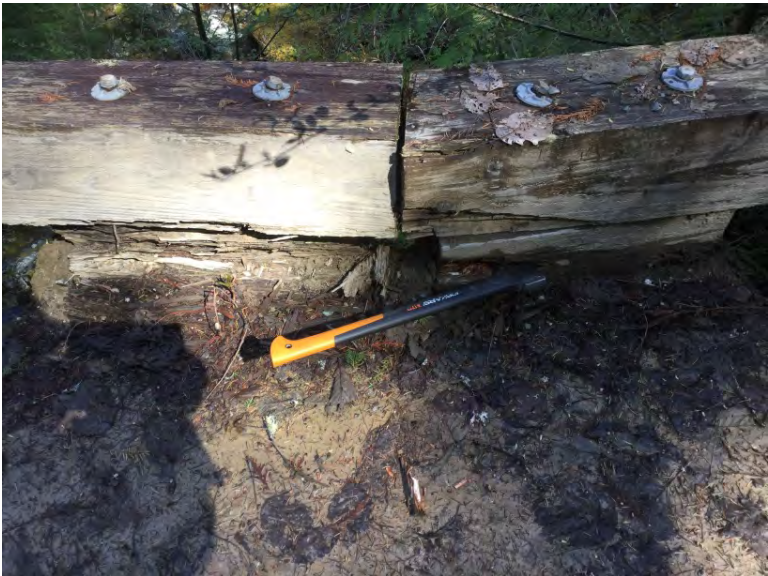
Curb Rail/Blocks/Posts      Poor      Rotten

Hardware      Poor      Loose rail bolts

Rail condition

| Repair | | Repair Description |
|---|---|---|
| 1 | High | Replace guardrail, risers and posts |

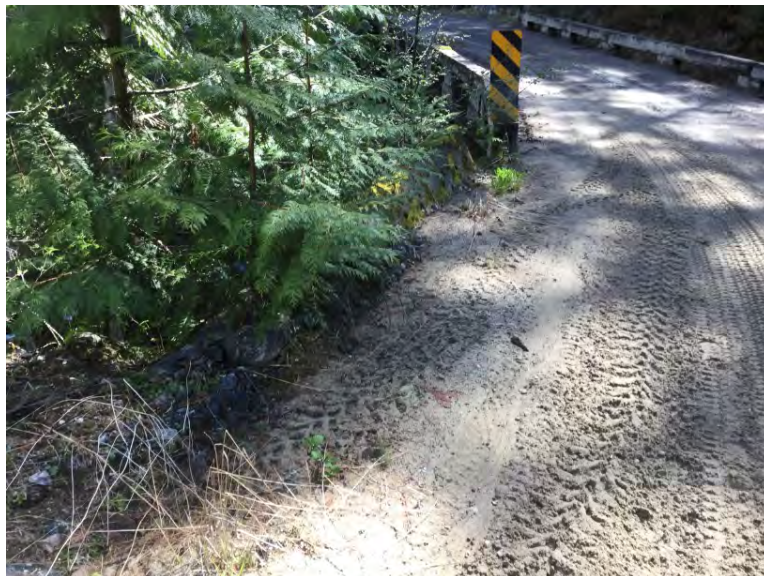
BABs falling off-road

| Repair | | Repair Description |
|---|---|---|
| 2 | Medium | Reset failing BABs |

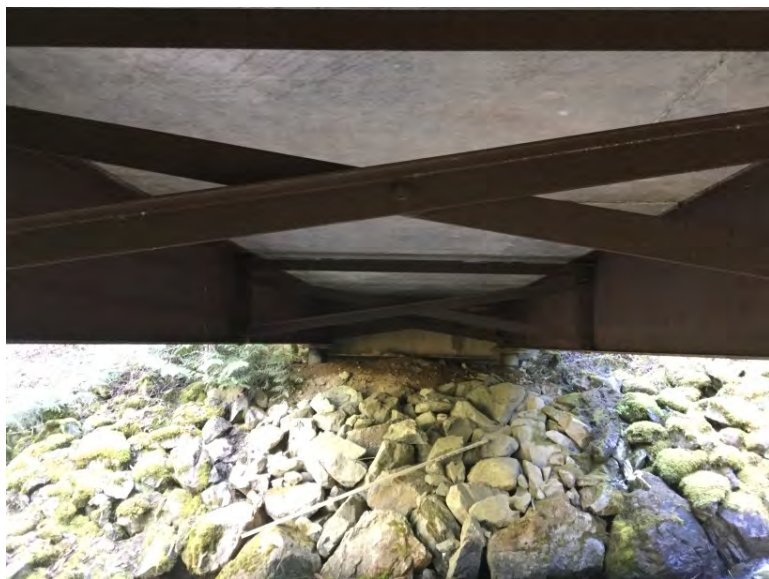
Superstructure

Girders Good

Diaphragms Good 4 bolted bays

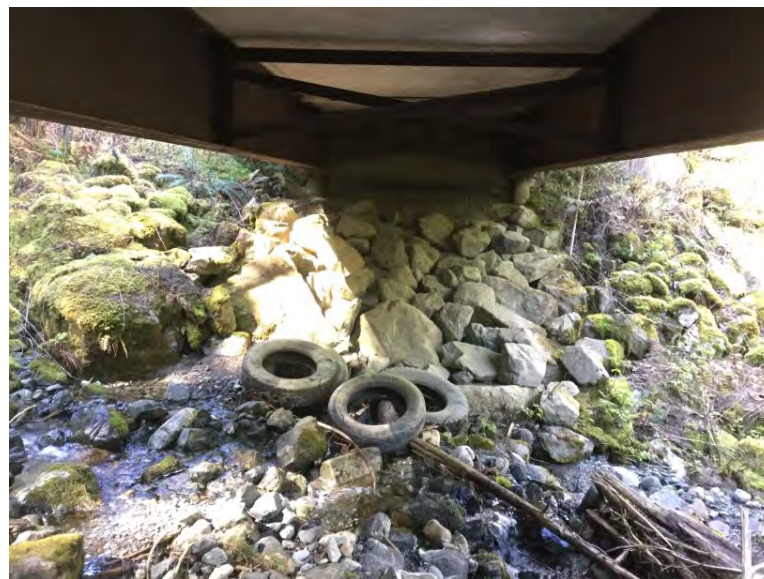
Left Bank Abutment when facing downstream

Bracing Good Small damage to top chord at left bank

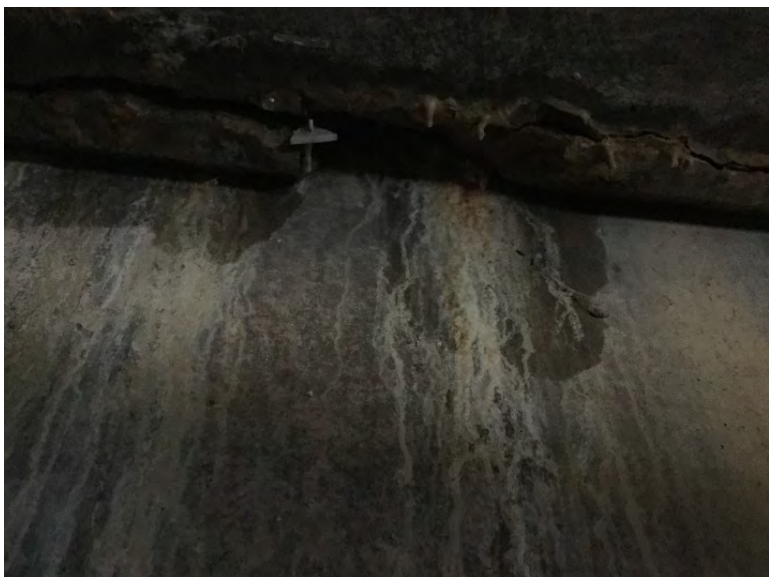
Damage to panel 1 right bank

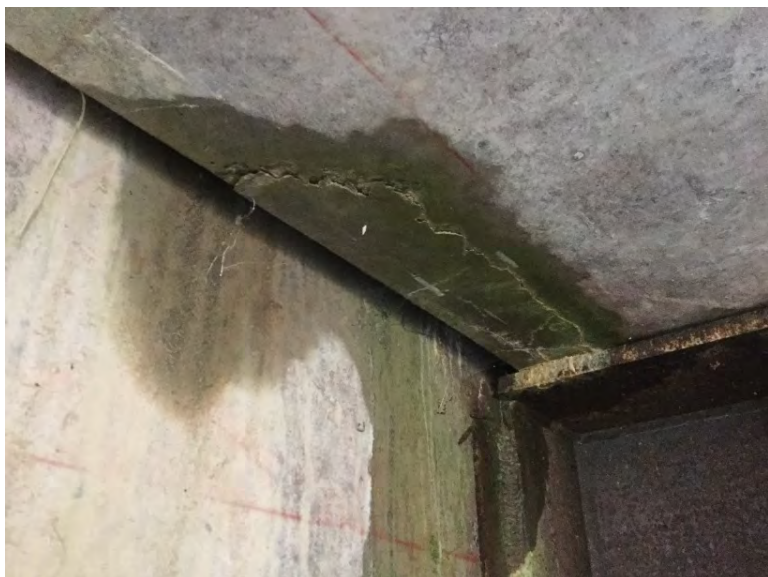
Damage to panel 1 at right bank

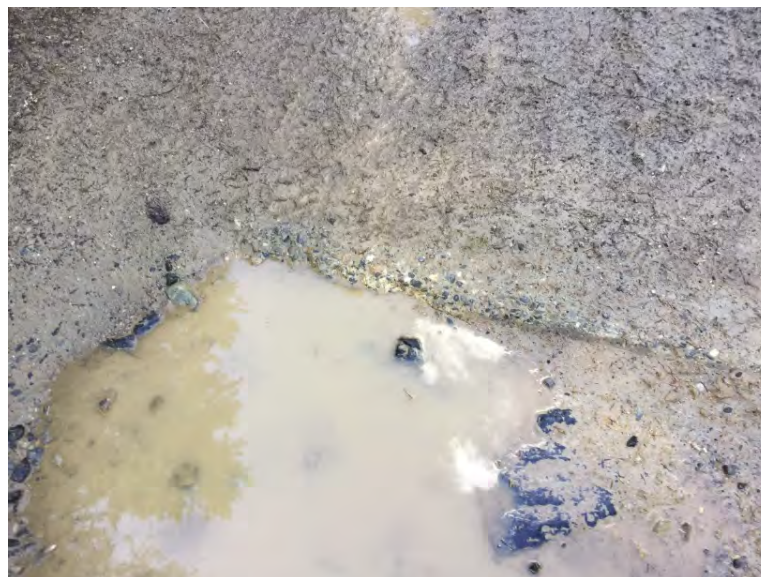
Ballast Wall Fair Some surface damage noted to top of right bank wall

Damage noted to top of right bank ballast wall
