CK-2378

STAVE 7.7km

2019 Inspection

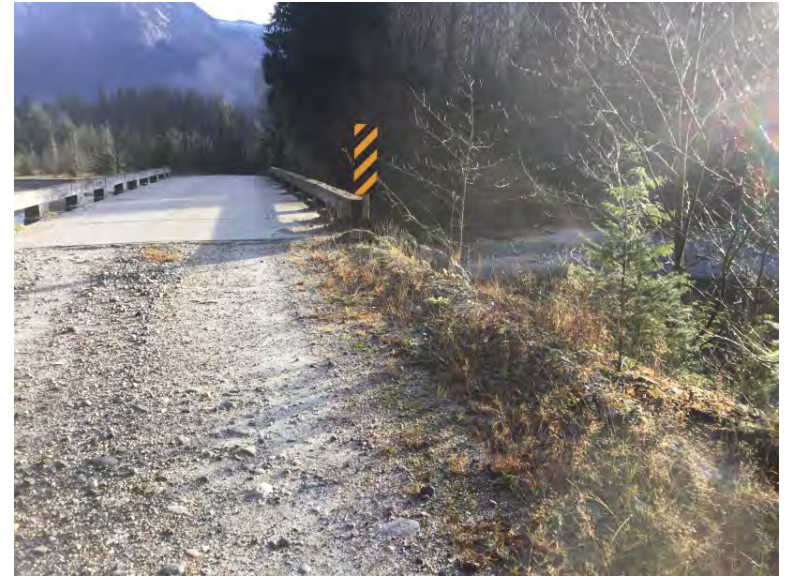
Concrete no post barriers should be reset at U/S left bank and D/S right bank

Missing downstream right bank concrete no post barriers

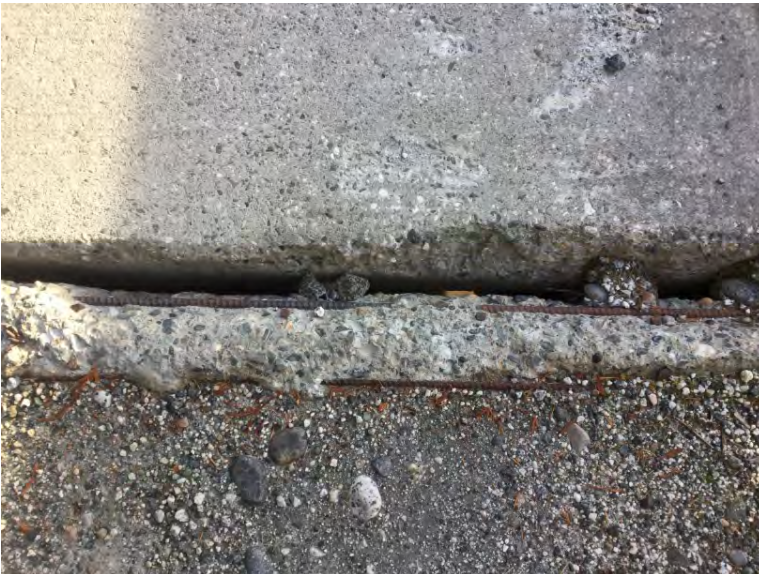
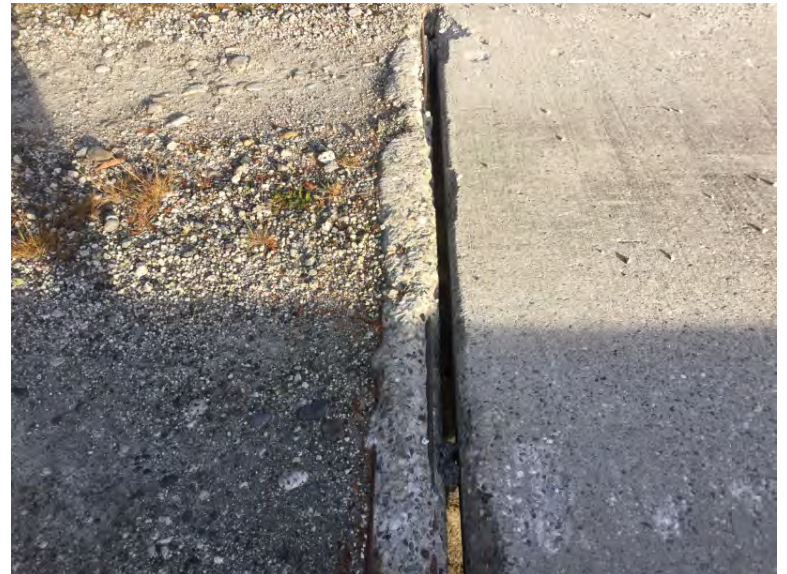
Both walls are spalling with exposed rebar

Concrete Deck Fair Damage noted throughout especially at ballast wall location

Ballast wall and deck damage

| Item | Priority | Repair Description |
|---|---|---|
| 4 | High | Repair the damage to the ballast walls and deck panels |

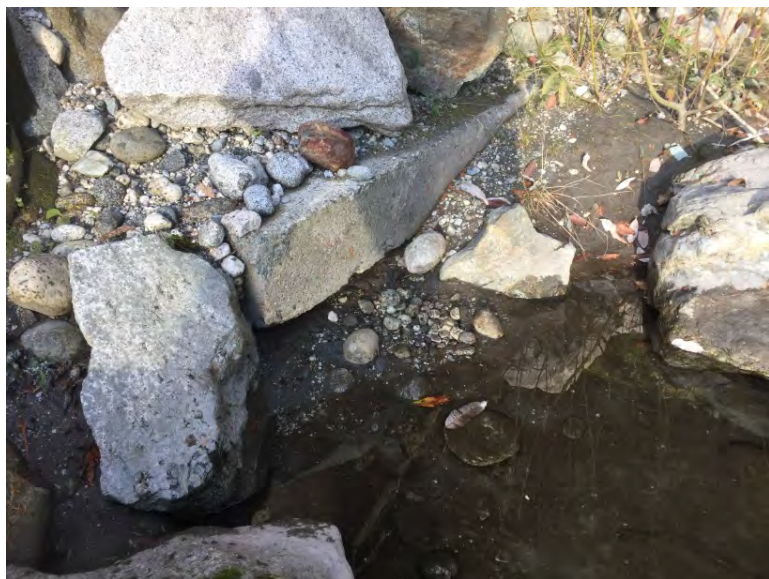
Downstream right bank concrete precast footing is exposed and scoured; 100mm height x 200mm depth x 600mm width scour in front of footing

Scoured downstream right bank

Downstream right bank footing exposed

| Item | Priority | Repair Description |
|---|---|---|
| 2 | High | Replace scoured riprap at downstream right bank and ensure bearing under footing is complete and consistent |

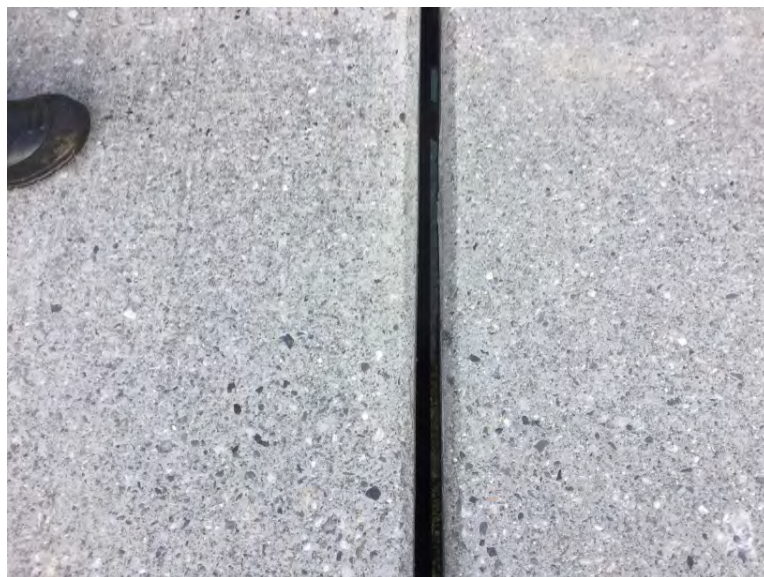
Deck Joints Poor All compression seals have fallen out or are damaged

All rubber joint seals failing

| Item | Priority | Repair Description |
|---|---|---|
| 5 | High | Replace all the deck panel compression seals |

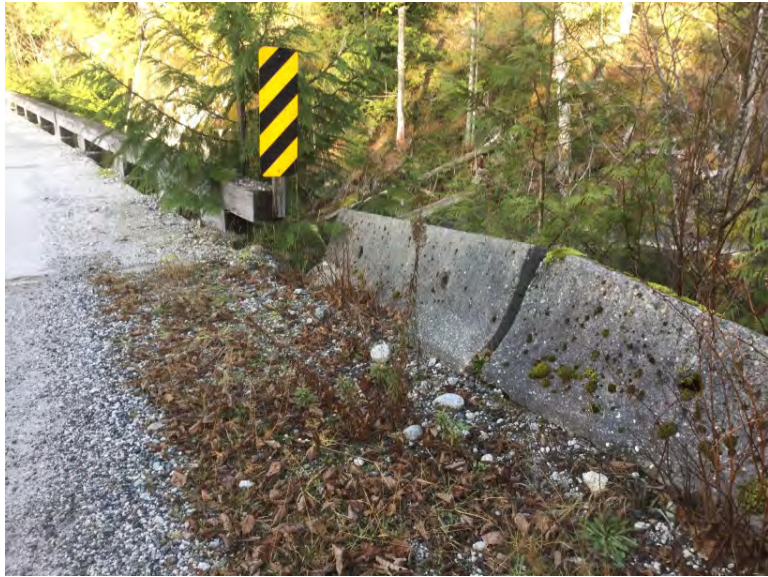
Upstream left approach concrete no posts failing
