CK-2386

CENTRE 5.1km

2019 Inspection

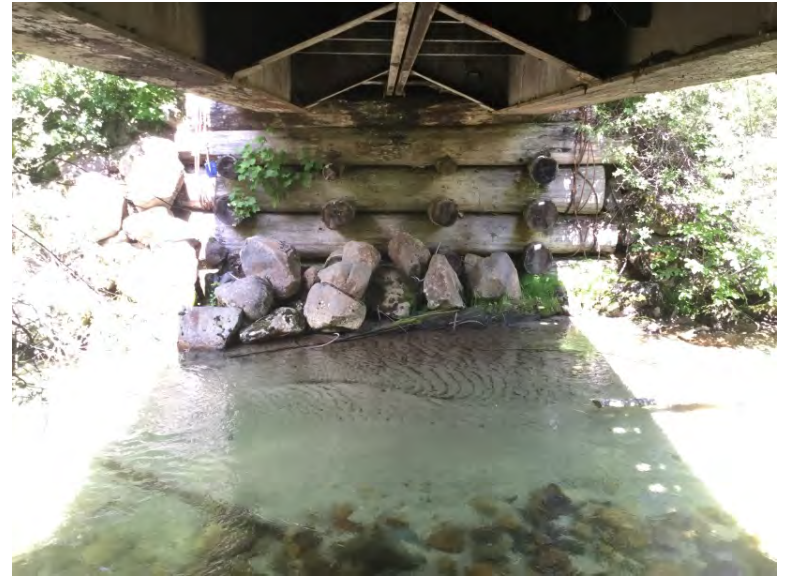
Left Bank Abutment when facing downstream

Log/Timber Cribs Poor 5 face logs left abutment, 3 face logs right abutment - right abutment crib in front of bearing crib completely rotten

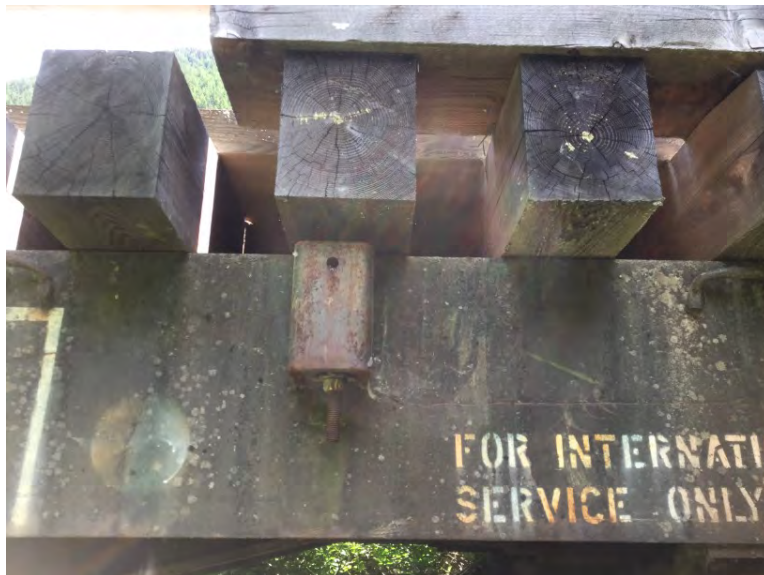
Deck fasteners

Deck to Girder Bolts      **Fair**      **Modified**

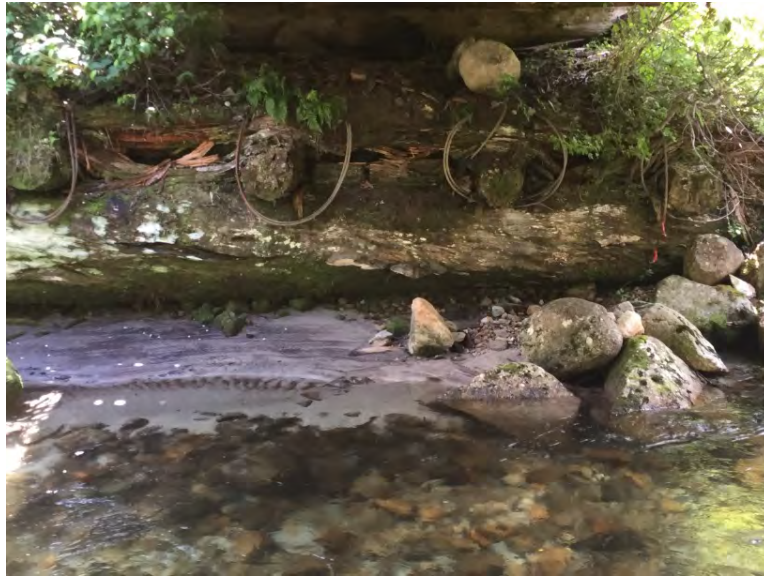
Old crib condition on right abutment condition is poor

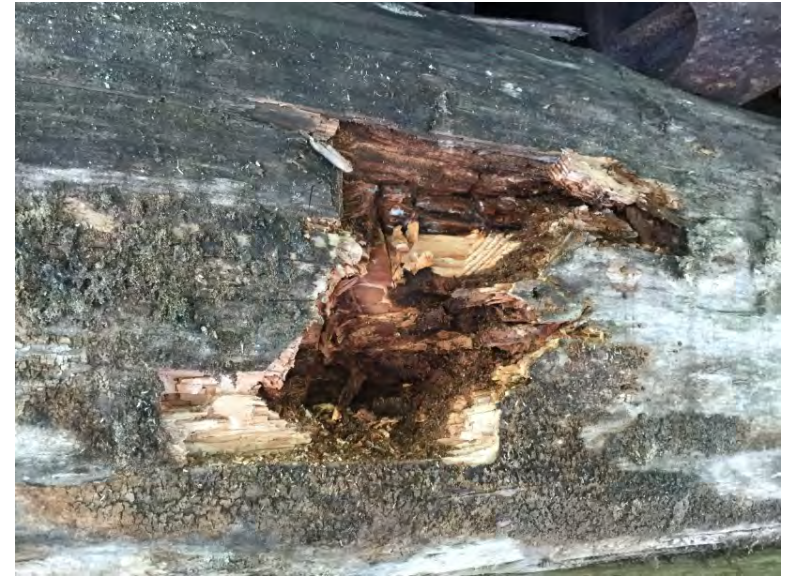
The top face log in both bearing cribs in poor condition, see pictures. The structure now requires replacing prior to the next industrial activity. Limit loading to L30 or 27 tonnes. Post load rating signs.

Top face log condition on left abutment 70mm rot at upstream girder bearing location

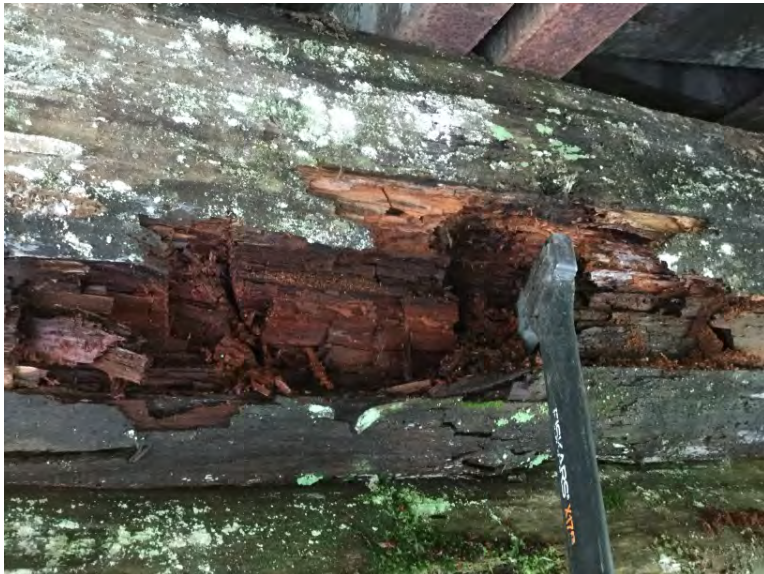
Top face log condition at center left abutment

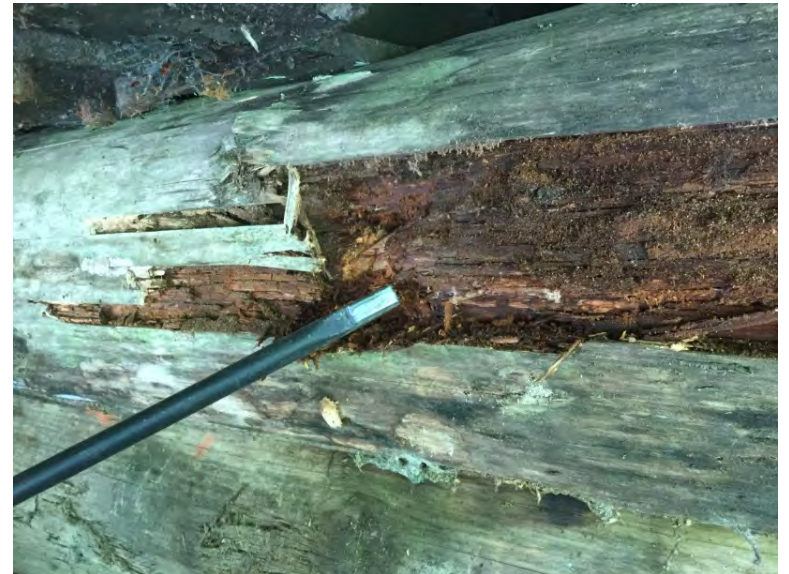
Top face log condition on right abutment

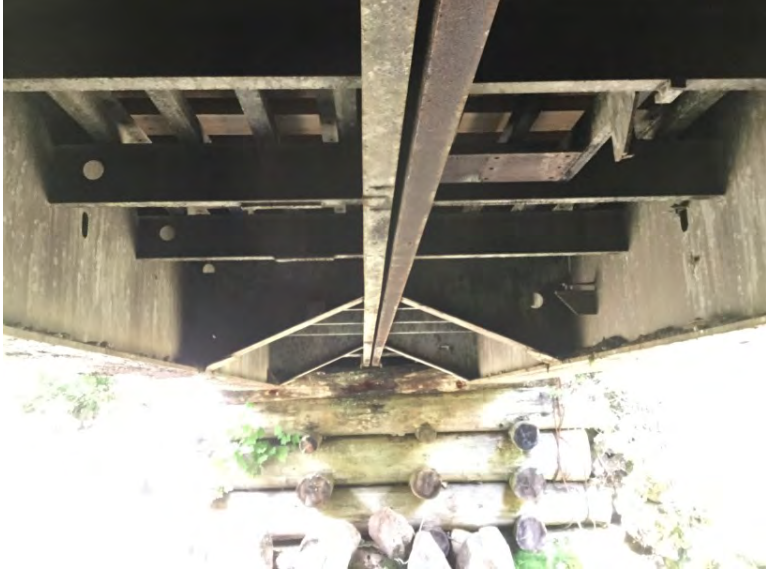
Superstructure

Girders Fair
