CK-2406

PITT RIVER 18.5km

2019 Inspection

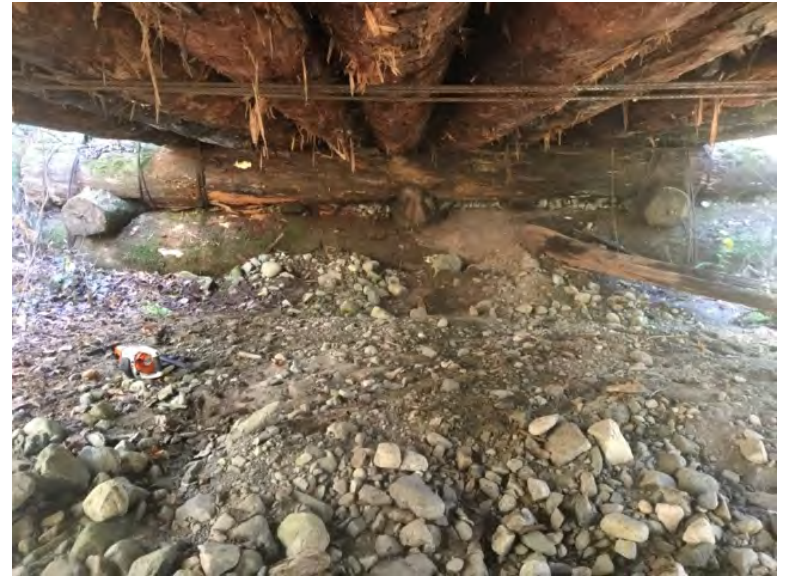
Left Bank Abutment when facing downstream

3x right bank, 2x left bank with large diameter Cy up to 20mm sap rot

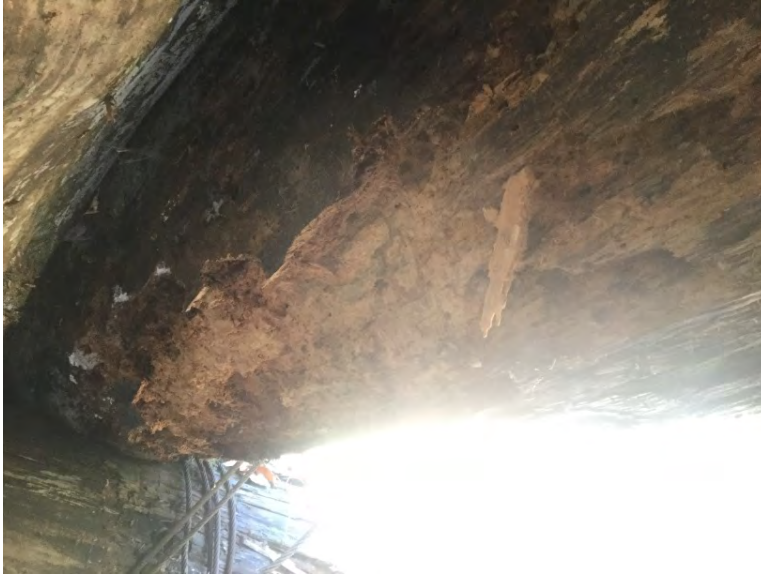
Stringer 1 condition

Stringers 3 - 8 are relatively new  
Stringers 1, 2, 9, 10 are old, in poor condition but not load bearing  
11.4m span upstream  
11.5m span downstream

| Stringer<br>Number | Species | Peeled | Diameter<br>(mm) | Rot Depth<br>(mm) | Condition | Comment |
|---|---|---|---|---|---|---|
| 1 | | | 620 | 120 | Poor | 60mm sap rot |

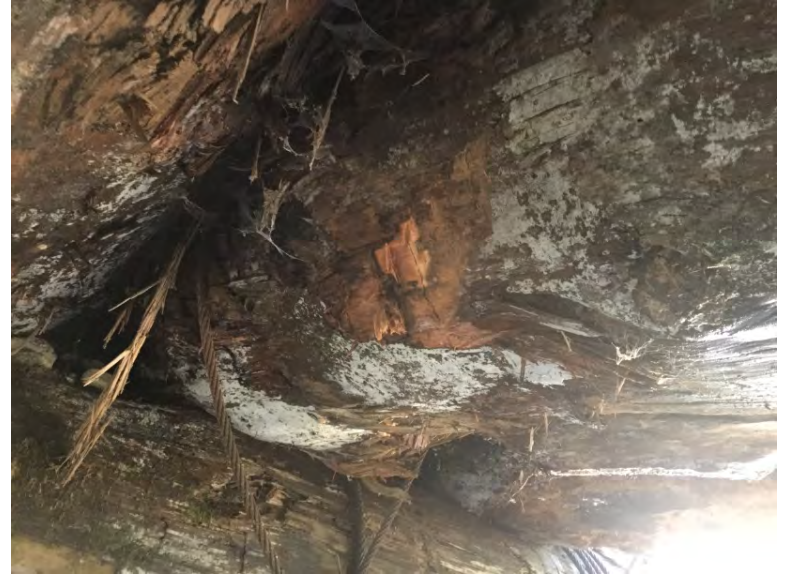
Stringer 2 condition

| Stringer<br>Number | Species | Peeled | Diameter<br>(mm) | Rot Depth<br>(mm) | Condition | Comment |
|---|---|---|---|---|---|---|
| 2 | | | 710 | 80 | Fair | 40mm sap rot |

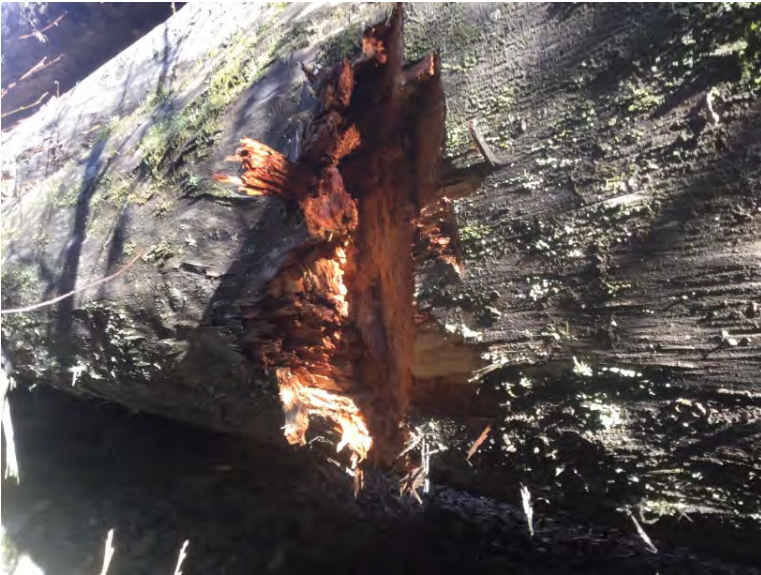
Stringer 10 condition

| Stringer<br>Number | Species | Peeled | Diameter<br>(mm) | Rot Depth<br>(mm) | Condition | Comment |
|---|---|---|---|---|---|---|
| 10 | | | 530 | 160 | Poor | 80mm sap rot |

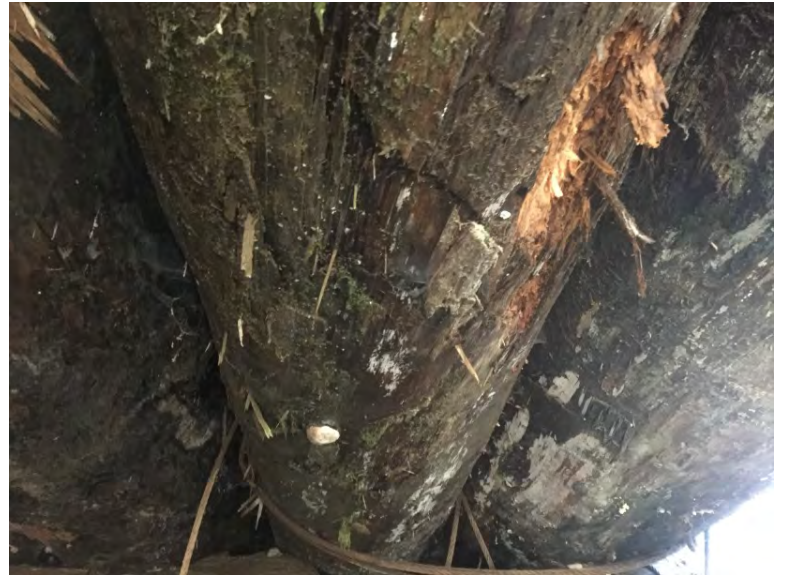
Stringer 9 condition

| Stringer<br>Number | Species | Peeled | Diameter<br>(mm) | Rot Depth<br>(mm) | Condition | Comment |
|---|---|---|---|---|---|---|
| 9 | | | 650 | 100 | Poor | 50mm sap rot with fruiting bodies |
