CK-2440

STAVE 29.9km

2019 Inspection

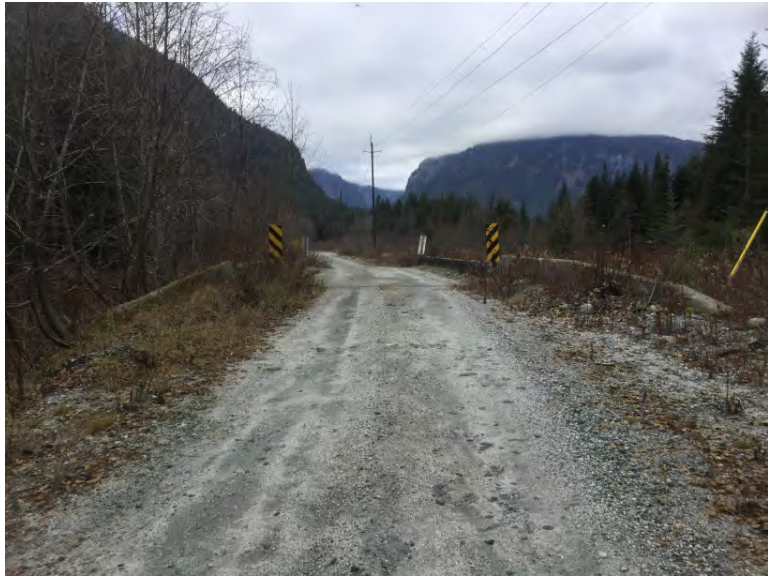
Approach from Left Bank when facing downstream

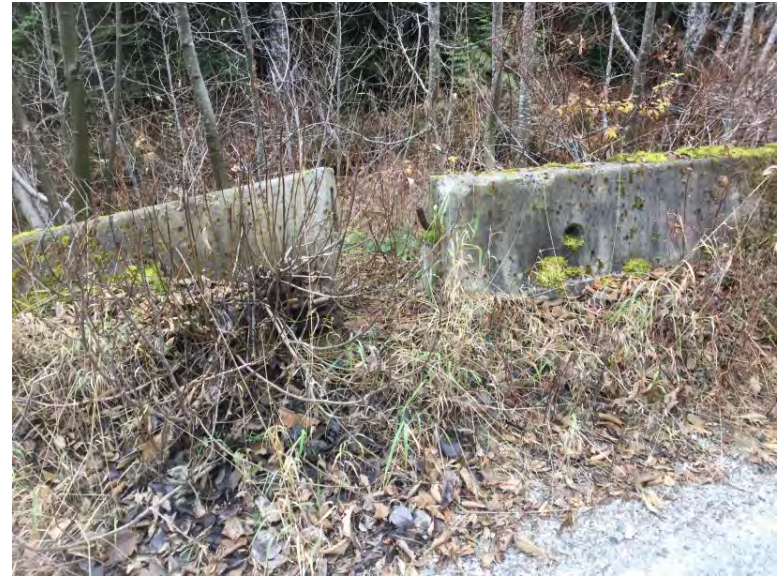
Disconnected transition at downstream left bank

| Repair | | Repair Description |
|---|---|---|
| 2 | Low | Reconnect transitions at downstream approaches |

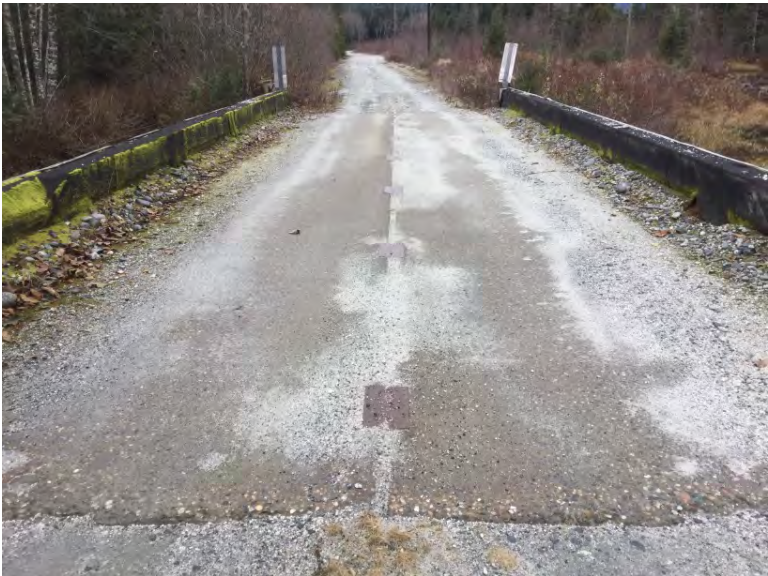
| Running Surface | Fair | Sediment built up against guardrail |

| Concrete Deck | Fair | Minor track damage |

Deck

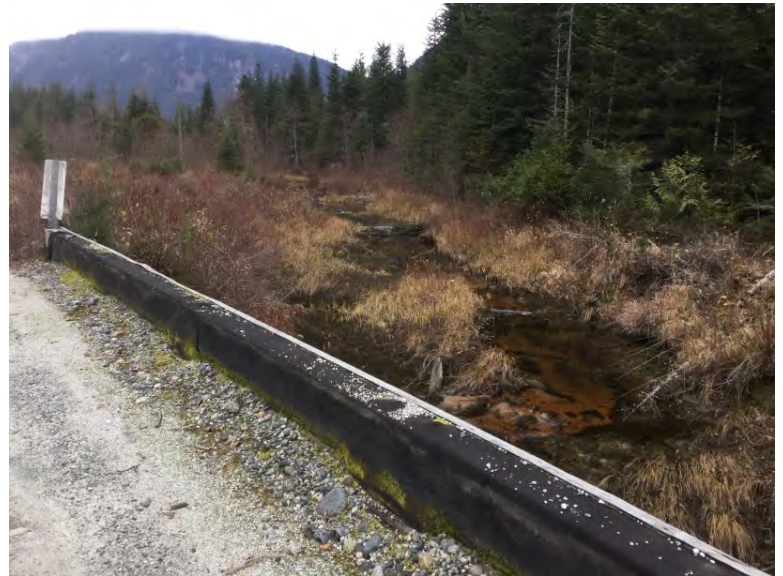
Upstream from Crossing

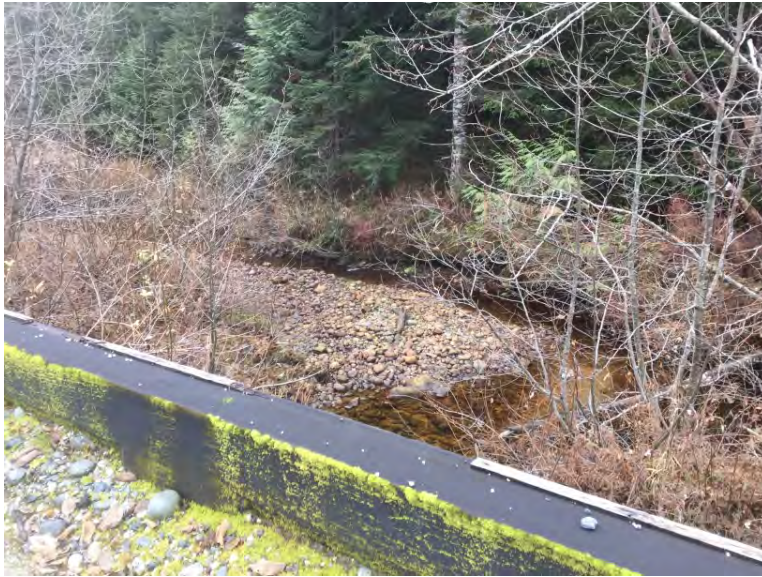
Downstream from Crossing

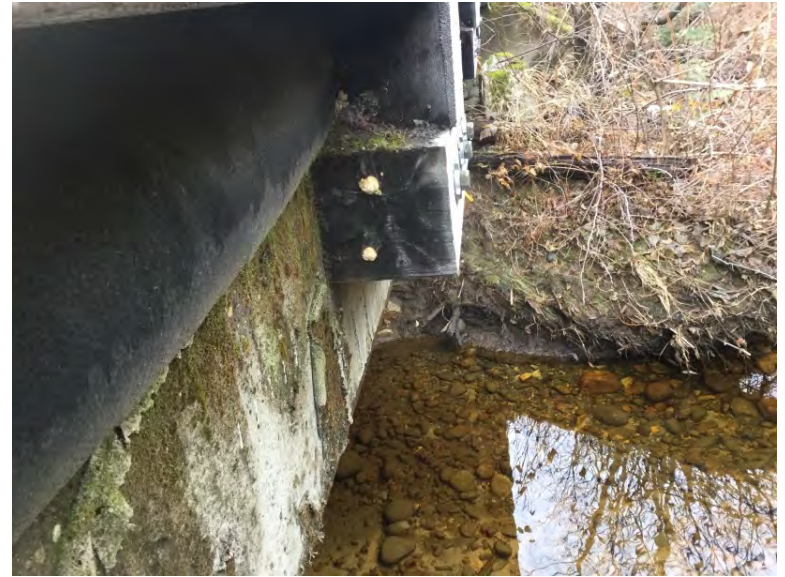
| Curb Rail/Blocks/Posts | Poor | Rotting risers and blocks |

| Overall Deck Condition | Poor | Due to rail condition |

Rider and sideblock condition

| Repair | | Repair Description |
|---|---|---|
| 1 | Medium | Replace guardrail, risers and blocks |

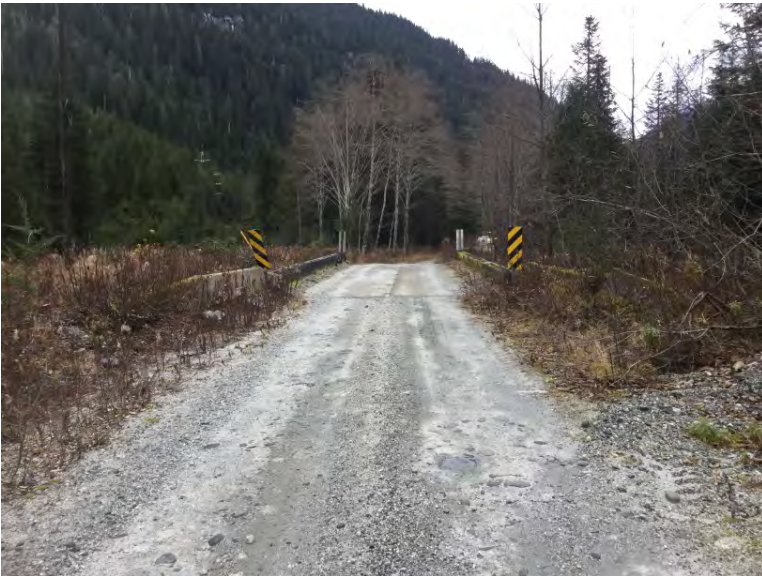
Approach from Right Bank when facing downstream

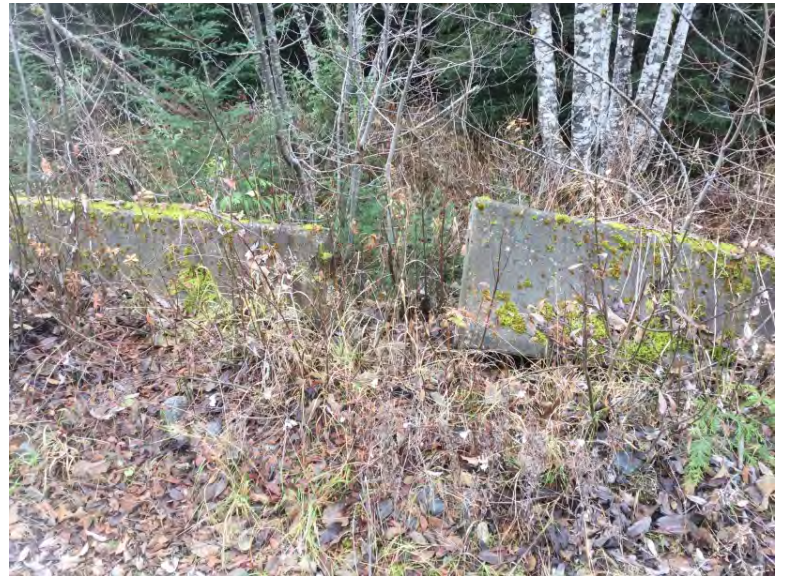
Disconnected transition at downstream right bank

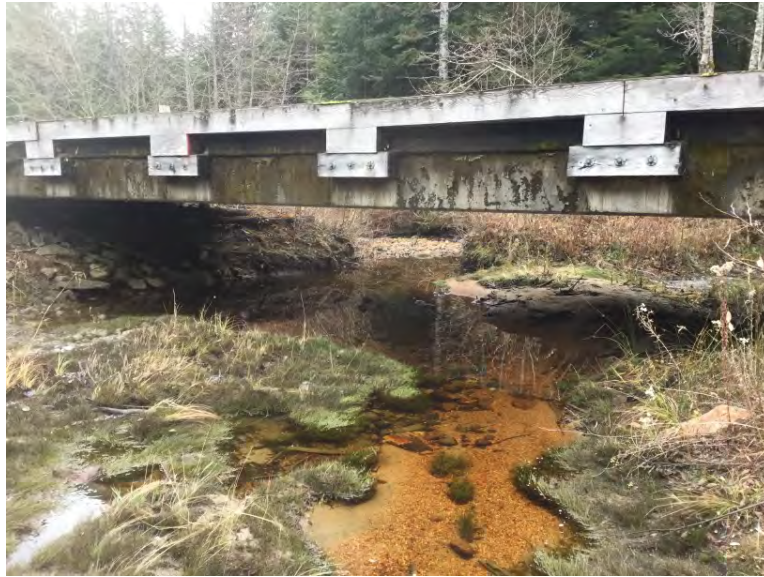
Upstream Profile

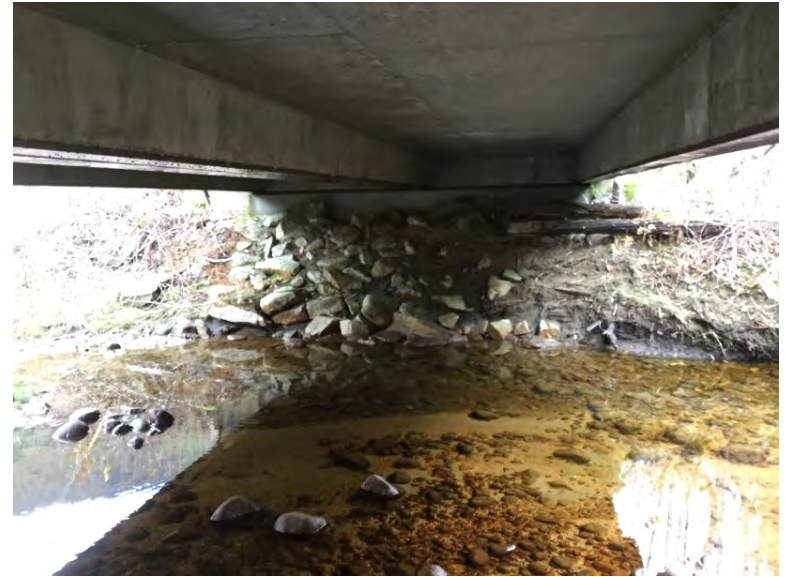
Left Bank Abutment when facing downstream

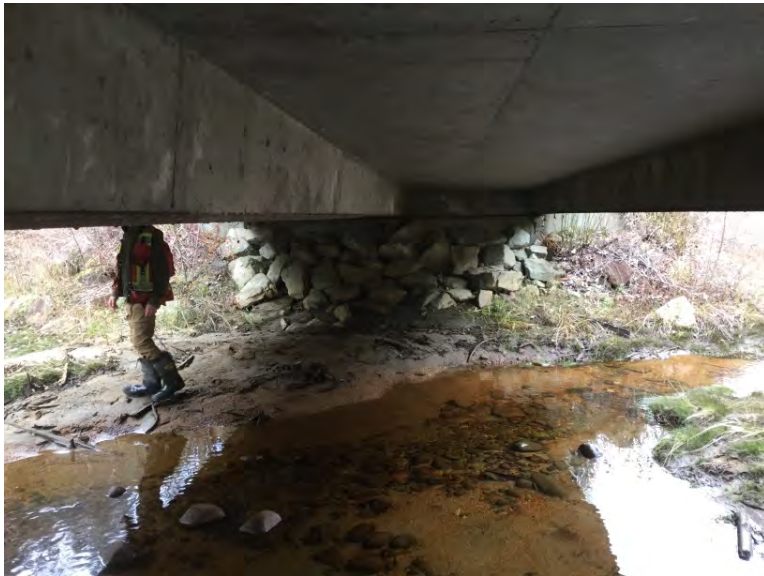
Right Bank Abutment when facing downstream

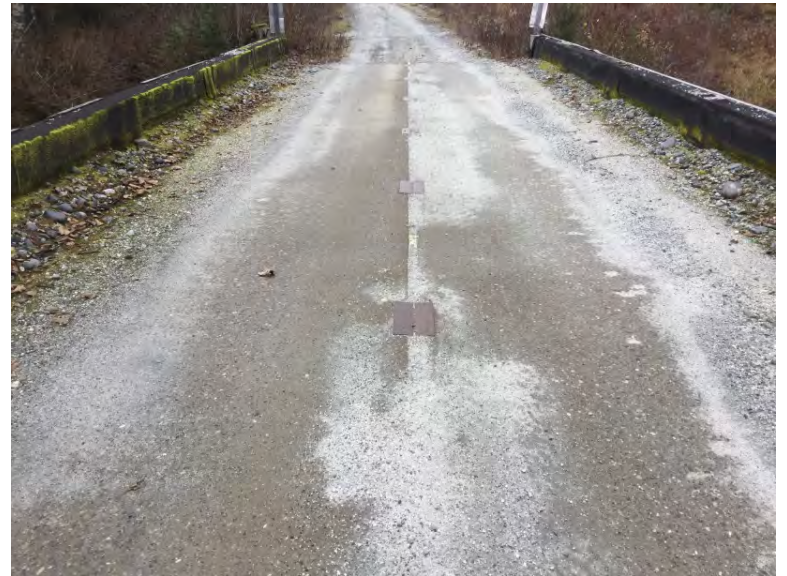
Welded/grouted  
shear connectors Good

Welded connectors
