CK-2449

NORRISH 3.6km

2019 Inspection

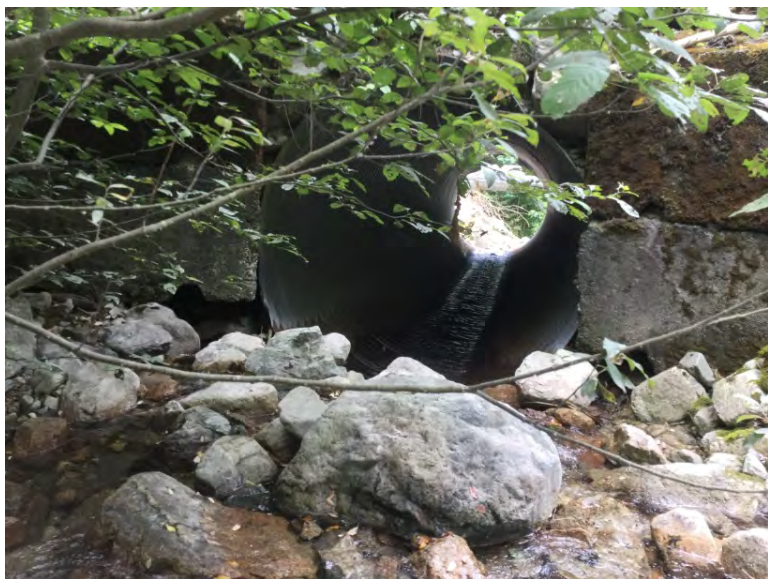
Lock blocks and riprap to retain fill, slight aggradation noted

Inlet aggrading

| Item | Priority | Repair Description |
|---|---|---|
| 2 | Medium | Remove the vegetation at the inlet and excavate a small sump |

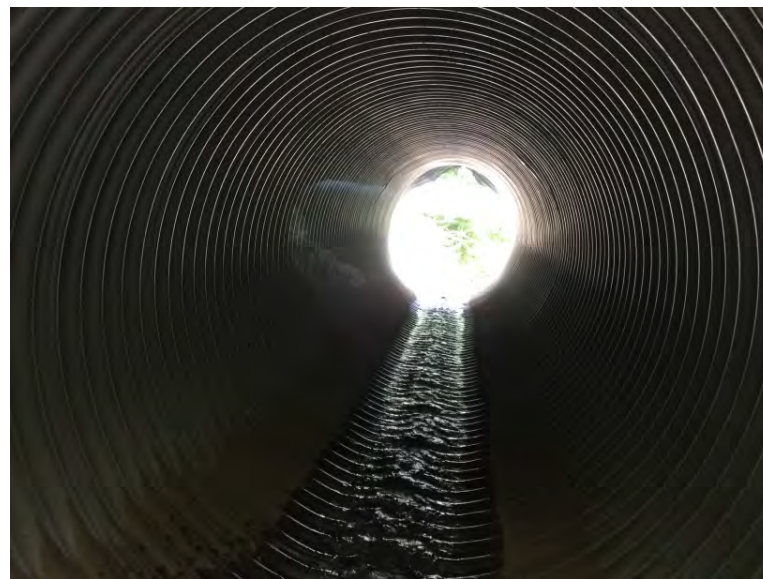
Minor deformation noted on the roof of culvert

Minor deformation at outlet

Damage to outlet

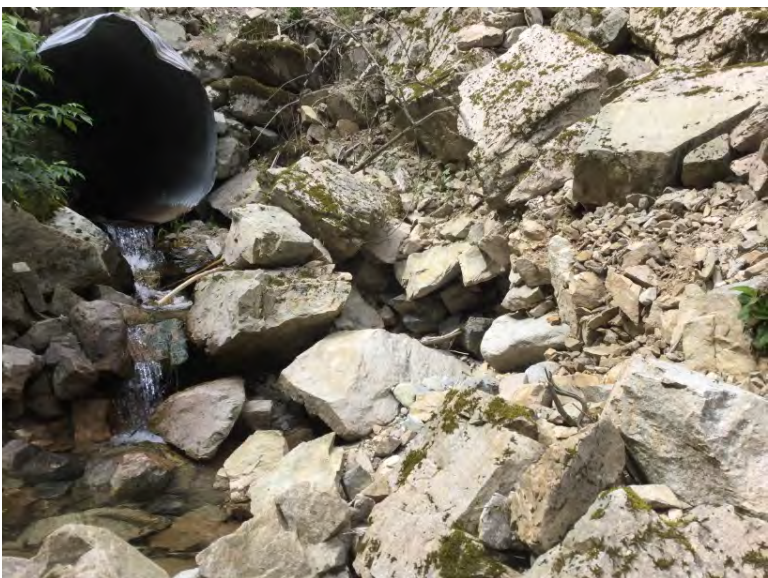
Downstream left approach riprap has scoured putting the fill in this location at risk to eroding

Riprap scoured at outlet, downstream left bank

Downstream left bank riprap scour

| Item | Priority | Repair Description |
|---|---|---|
| 1 | Medium | Repair the riprap at the downstream left bank |
