CK-2450

NORRISH 5.1km

2019 Inspection

| Structure Class | Major Culvert |

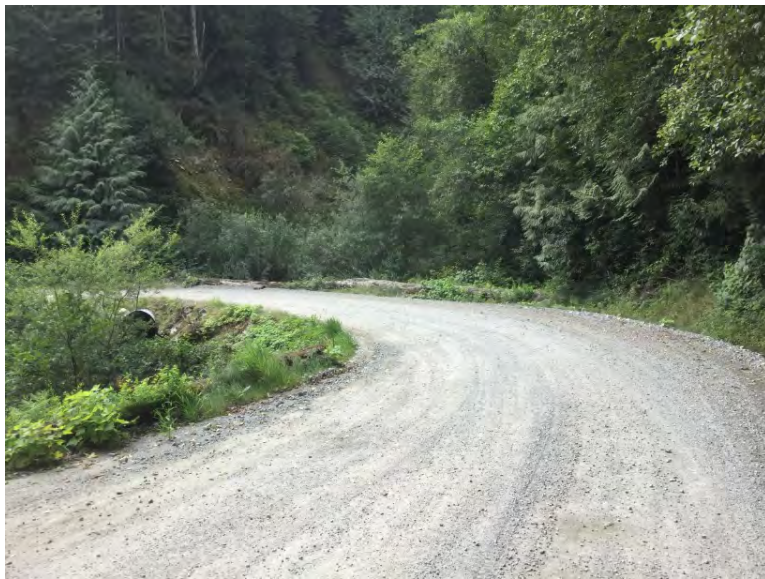
Approach from Left Bank when facing downstream

Inside of curve can be brushed to increase visibility

| Repair Item | Priority | Repair Description |
|---|---|---|
| 2 | Low | Brush the inside of the curve |

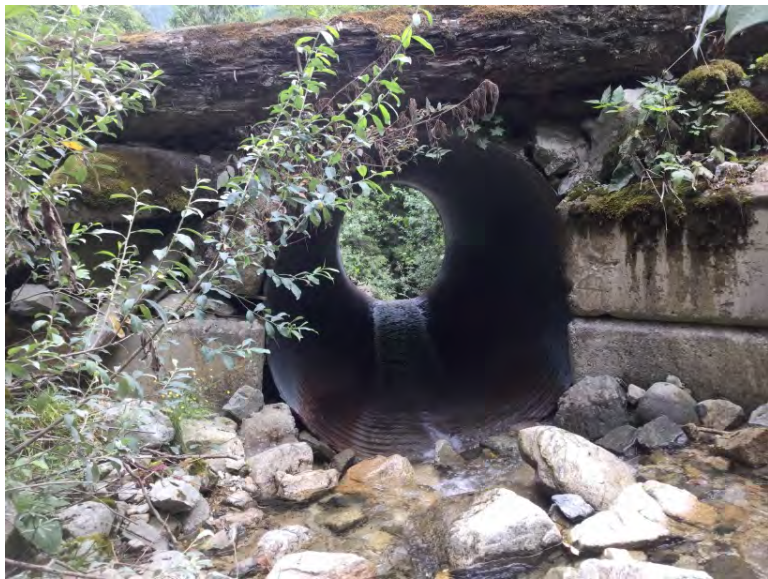
Inlet

Minor aggradation

Minor aggradation at inlet

| Repair Item | Priority | Repair Description |
|---|---|---|
| 1 | Medium | Remove the vegetation from the inlet and excavate a small sump |

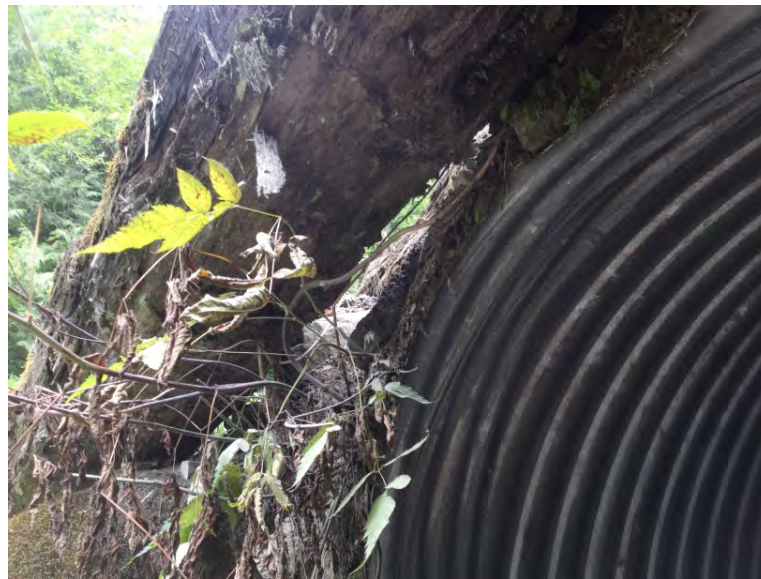
Eroding fill inlet

Lock blocks and rock retain fill at inlet

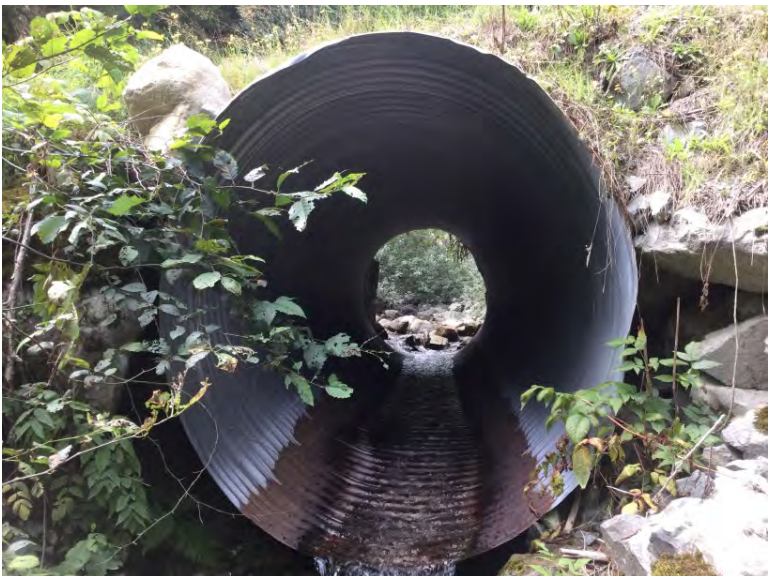
Outlet

1 m drop

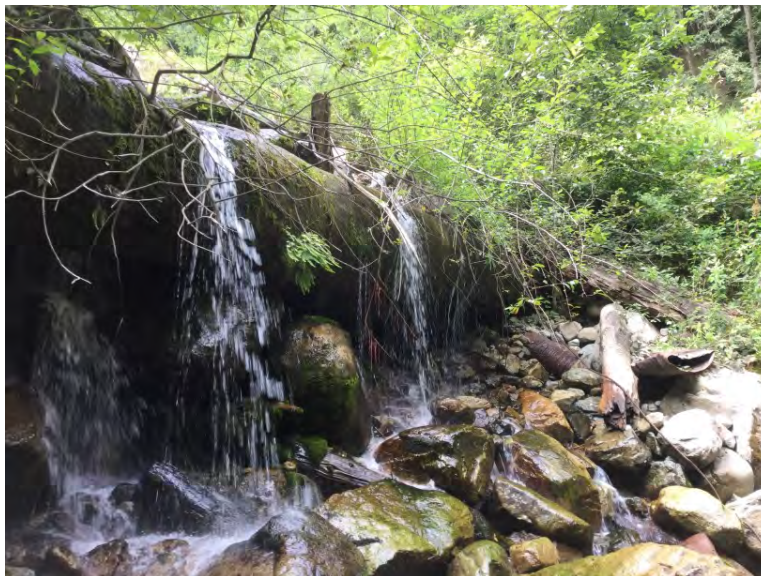
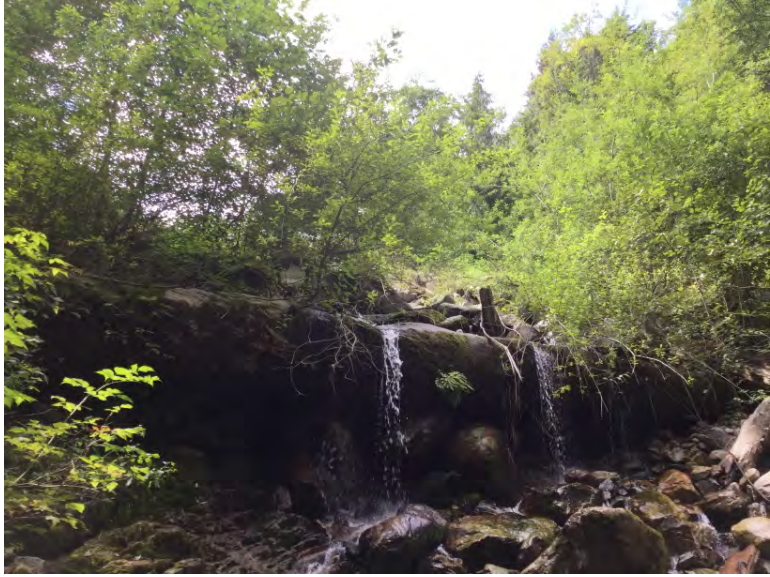
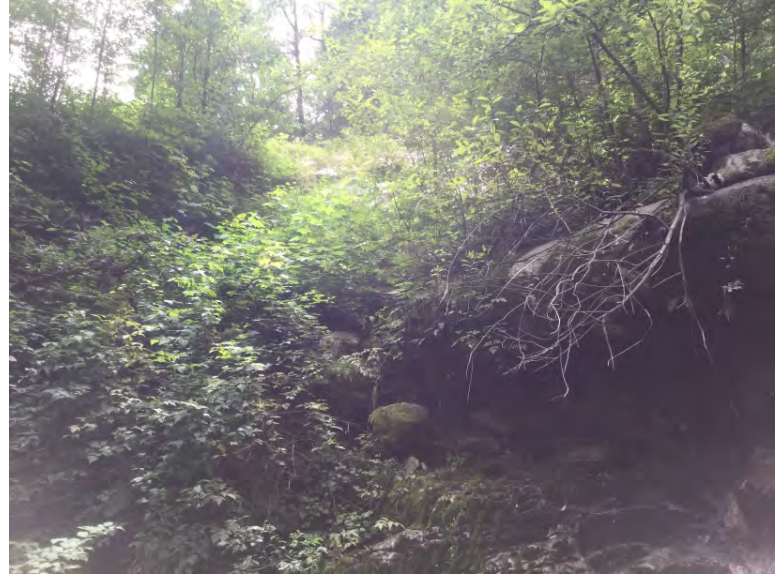
No indications that the large log at the outlet has moved since last inspection

Large log retaining fill at outlet

Continue to monitor the log retaining fill at the outlet. Brush approaches and remove the vegetation from the inlet. Excavate a small sump at the inlet. The current load rating of BCL-625 or 63 tonnes to continue.

| Item | Monitor Description | Frequency |
|---|---|---|
| 1 | Large large log retaining fill at outlet | Anually |
