CK-2457

NORRISH 13.6km

2019 Inspection

| Structure Class | Major Culvert |

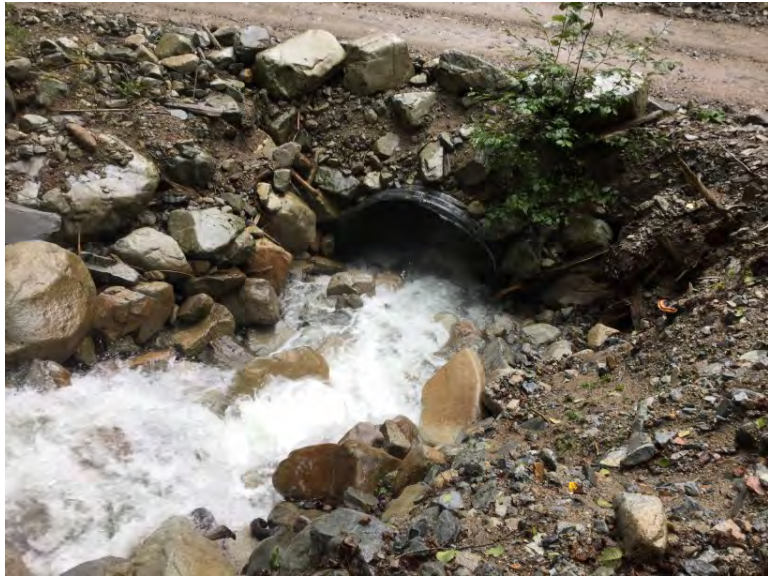
Inlet

Material aggrading at the inlet and eroding at the outlet

Aggrading

Clean the inlet and monitor future inlet aggradation and outlet scour, especially following heavy precipitation or rain on snow events. Consider replacing the structure. Current load rating of BCL-625 or 63 tonnes to continue.

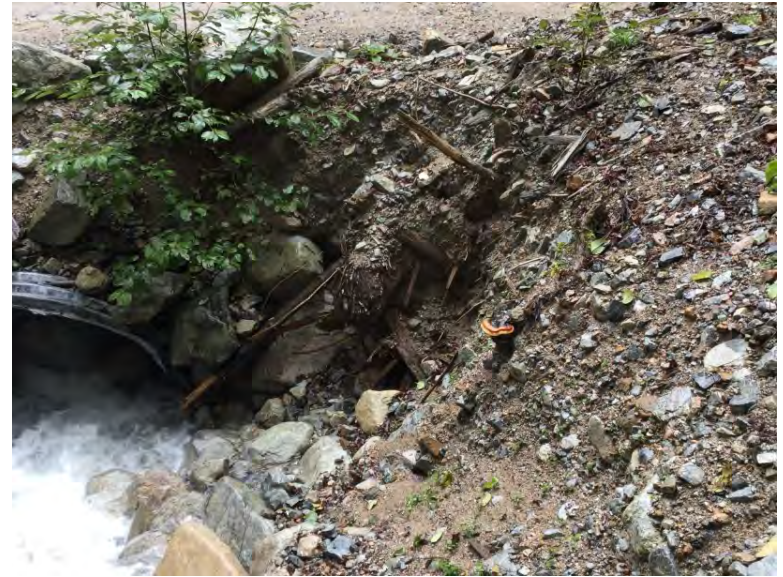
Riprap noted at the inlet that is smaller than what the stream transports

Right bank inlet armoring consists of material smaller than what the stream transports, plus organic material

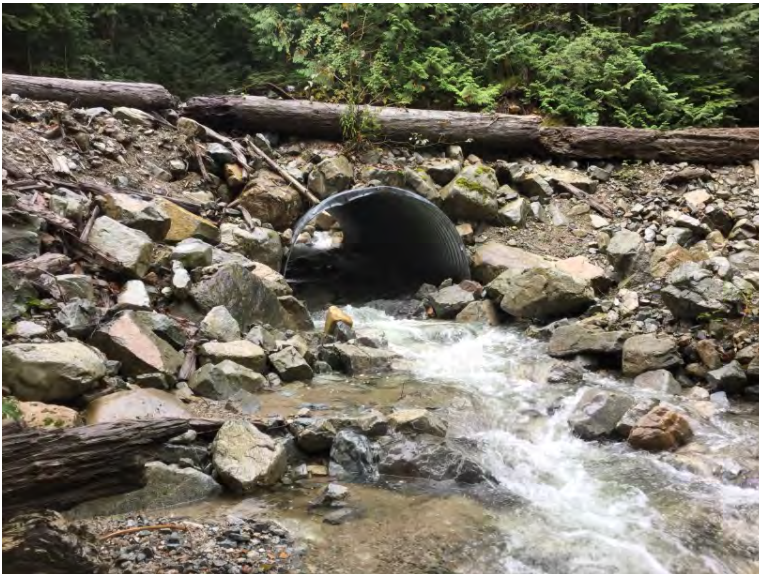
Outlet

Scouring

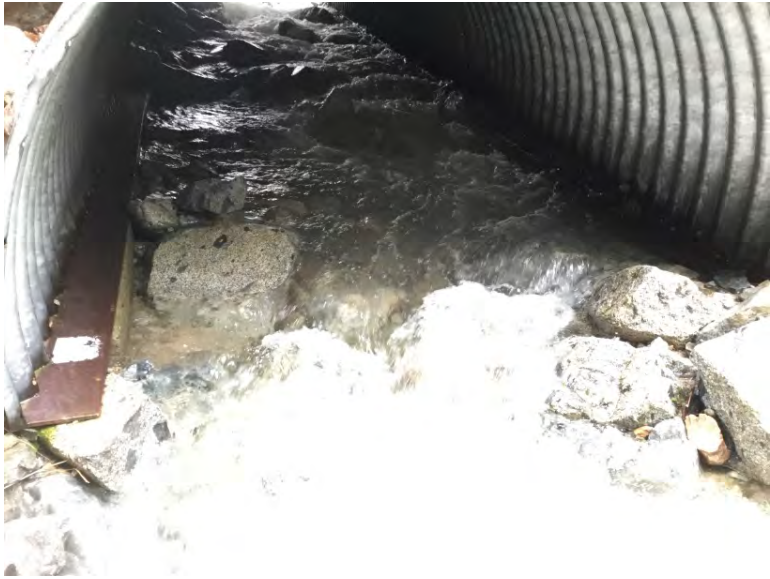
Appears to have consistent bearing

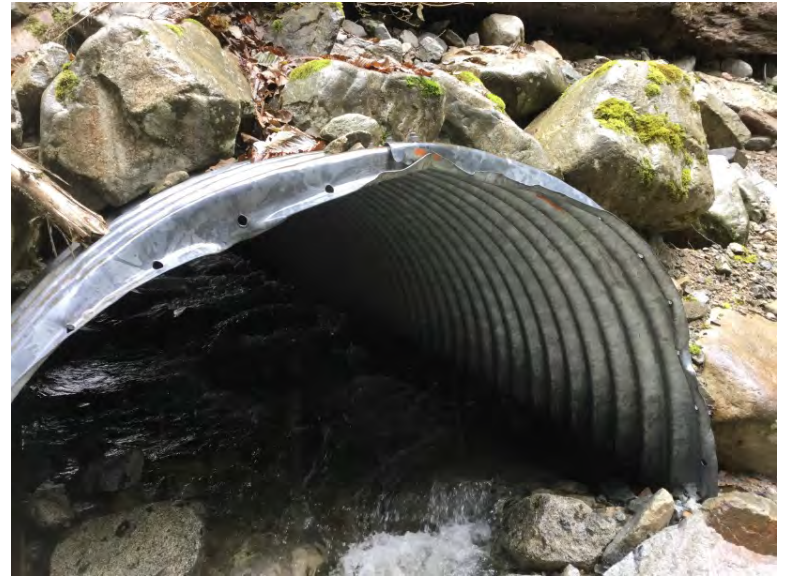
Only damage noted at outlet

Some damage to outlet of culvert

Comments Consider replacing the entire structure
