CK-2466

GARNET 7.6km

2019 Inspection

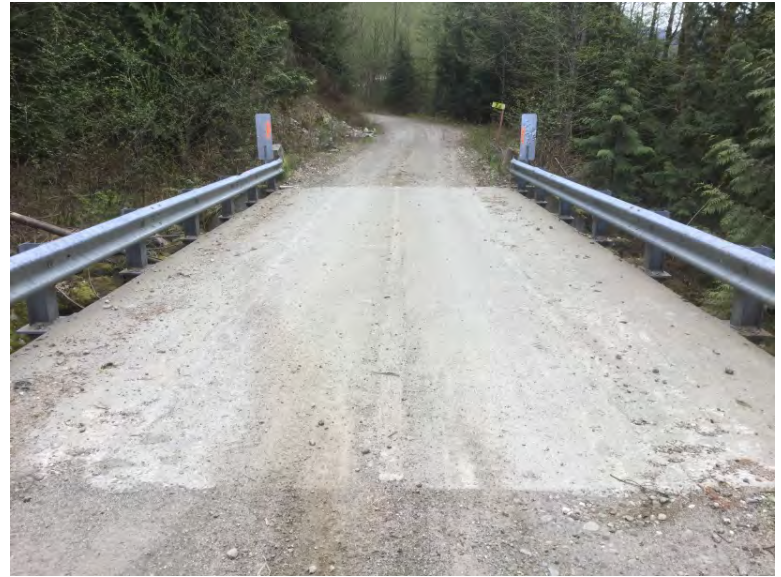
Deck, minor track damage

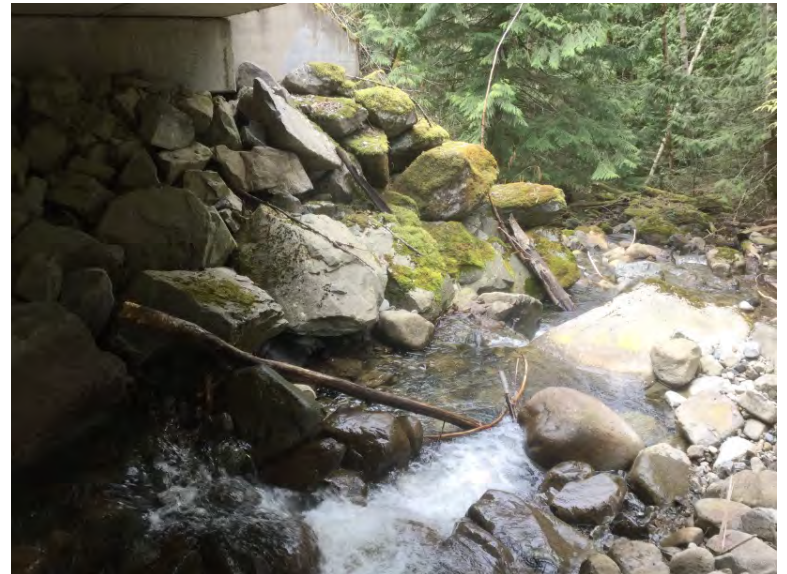
Riprap Good Downstream left bank is steep but appears stable

Downstream left bank, steep riprap but appears stable

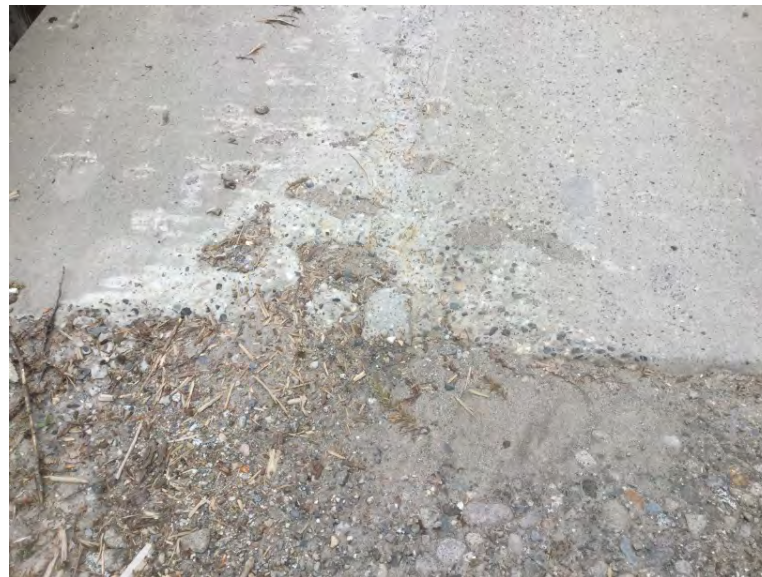
Damage to top of slabs due to tacked machinery
