CK-2487

STS'AILES (WEST) 7.9km

2019 Inspection

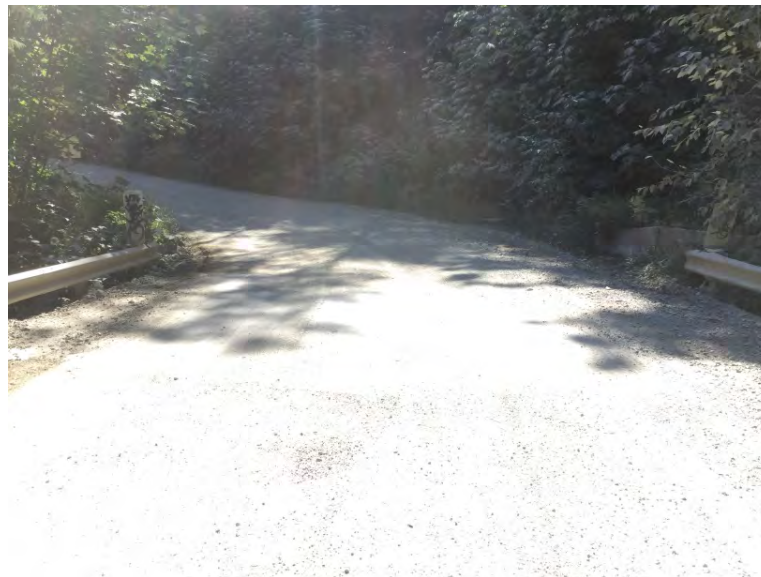
Deck

Running Surface      Fair      Sediment on deck

| Item | Priority | Repair Description |
|---|---|---|
| 3 | Low | Clean sediment from deck |

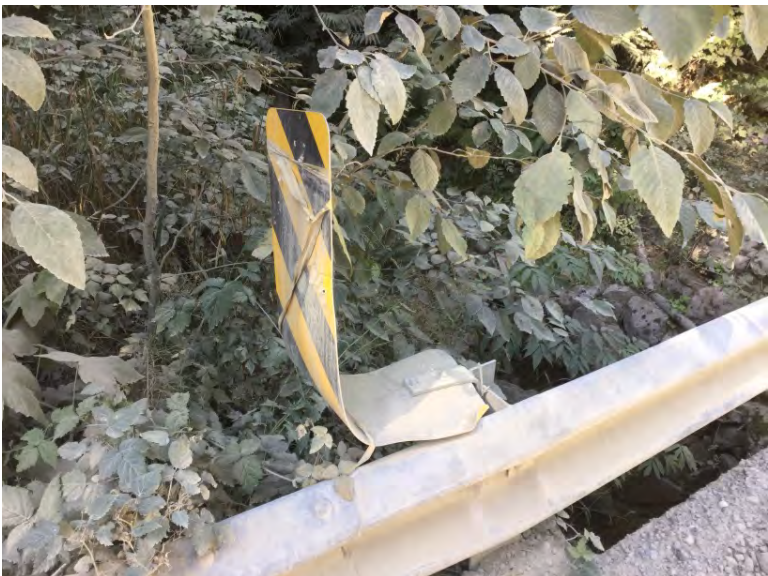
Curb Rail/Blocks/Posts      Fair      Minor damage

Delineator damage

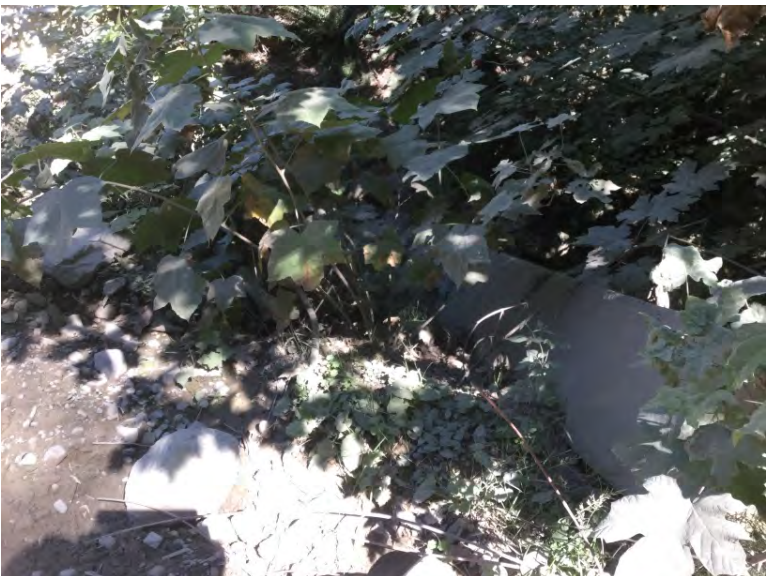
Realign at D/S right bank

No posts have been struck and are off road

Brush approaches. Realign the concrete no post barriers at the downstream right bank approach and clean the sediment from the deck. The current load rating of L150 or 136 tonnes to continue.

| Item | Priority | Repair Description |
|---|---|---|
| 1 | Medium | Replace no post barriers at downstream right bank |
