CK-2490

CHILLIWACK SOUTH 1.4km

2019 Inspection

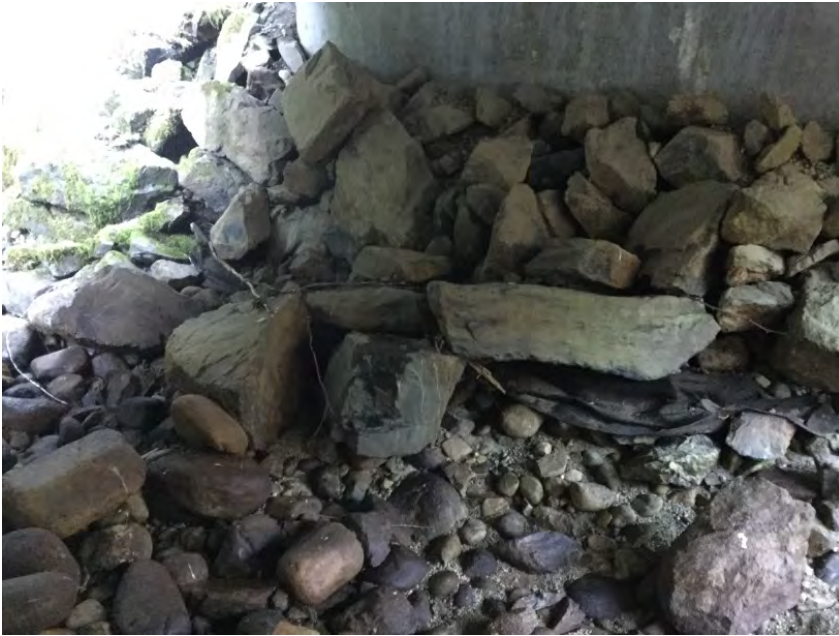
Riprap    Fair    Minor scour noted

Riprap scour

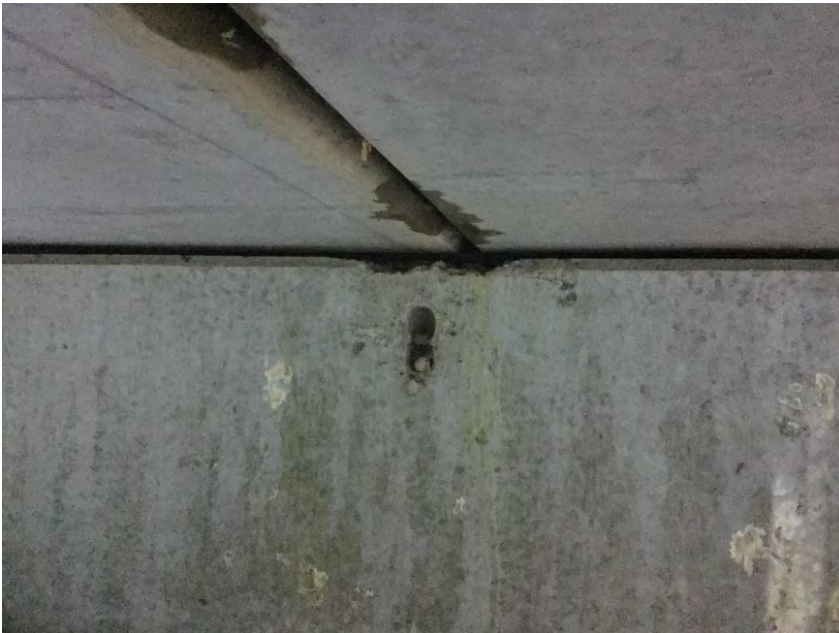
Minor cap spalls
