CK-2491

CHILLIWACK SOUTH 1.5km

2019 Inspection

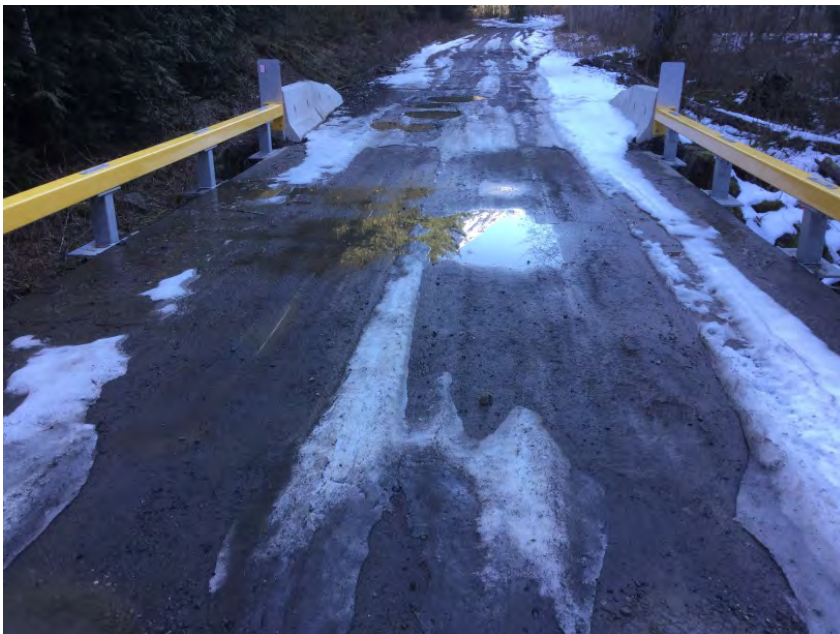
Concrete Deck      **Good**

Overall Deck Condition      **Good**

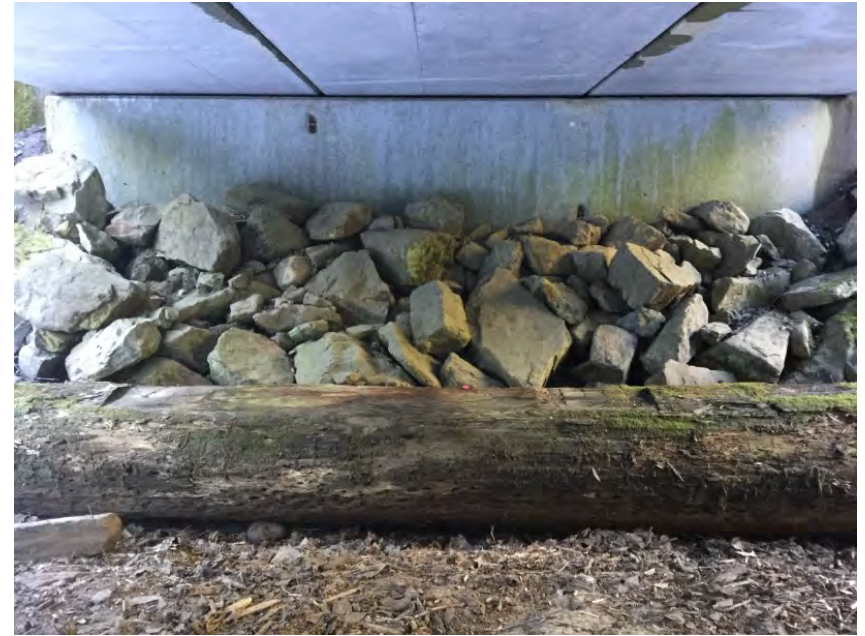
Left Bank Abutment when facing downstream

Wing Wall    Fair    Lock blocks with differential settlement

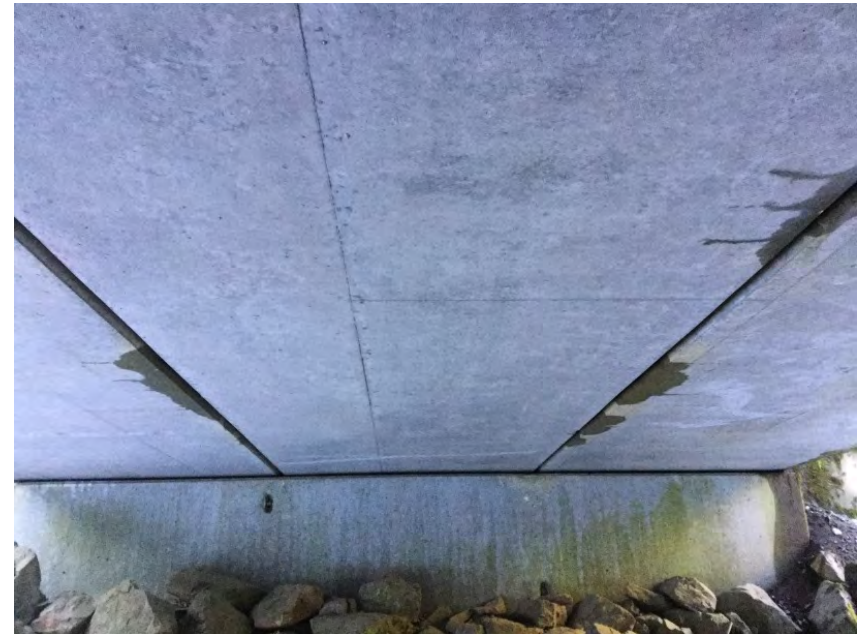
Superstructure

Girders Good 3 concrete slabs
