CK-2506

Alf 0.2km

2019 Inspection

## **As-Built Report for Bridge Installation DCK-2506**

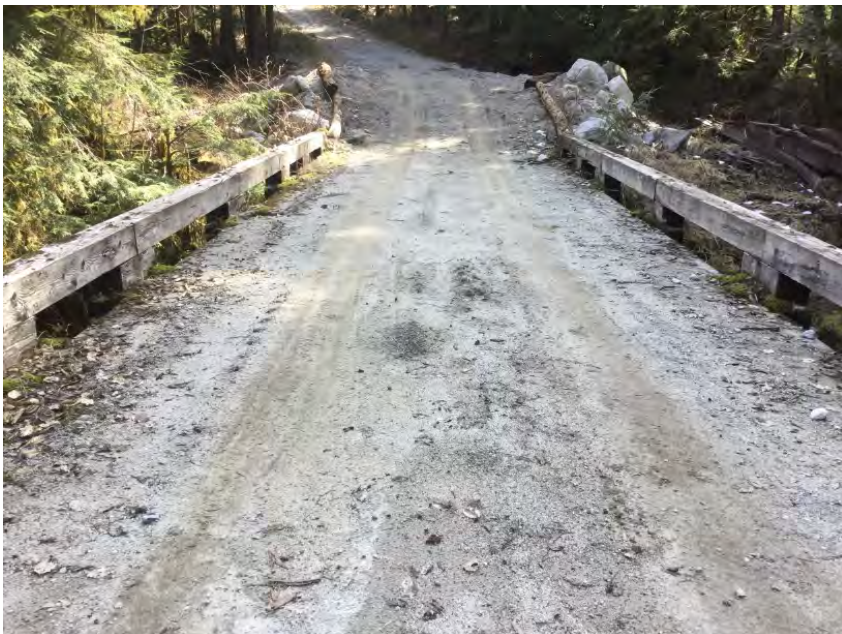
Running Surface      Fair      Sediment on deck

Concrete Deck      Unrated      Too much sediment to properly inspect

Deck

| Item | Priority | Repair Description |
|---|---|---|
| 2 | Medium | Clean sediment from deck |

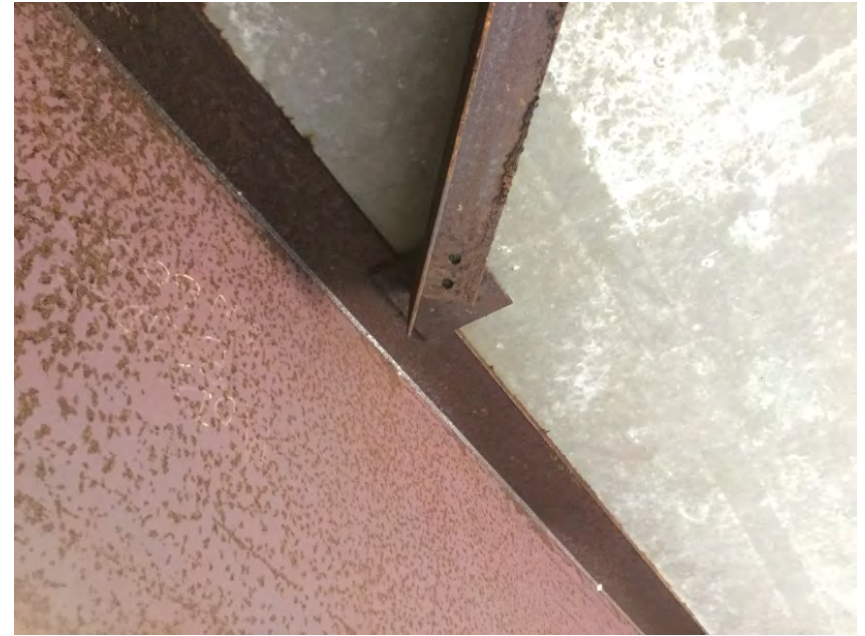
Hardware Fair Missing 2 bracing bolts

Bracing missing bolts

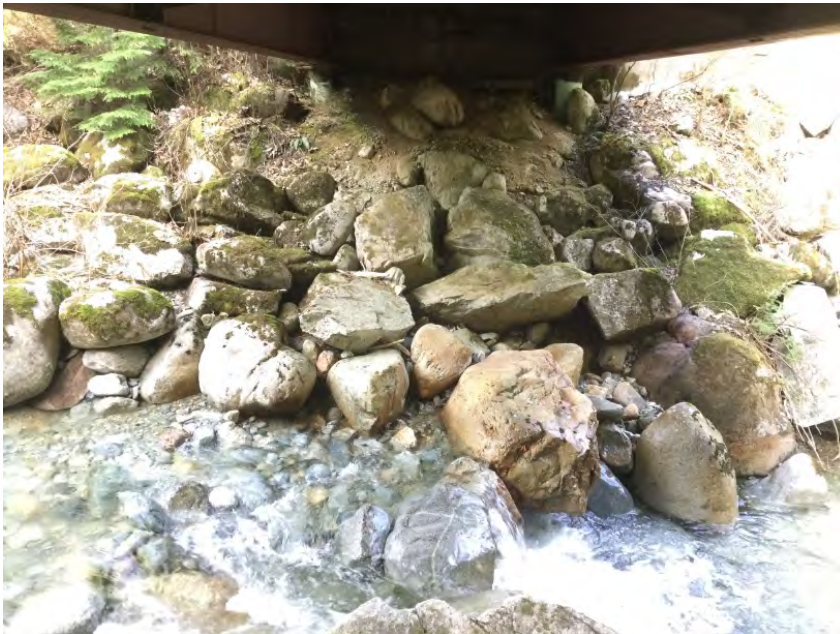
Left Bank Abutment when facing downstream

Ballast Wall Fair minor damage noted to top of left bank wall

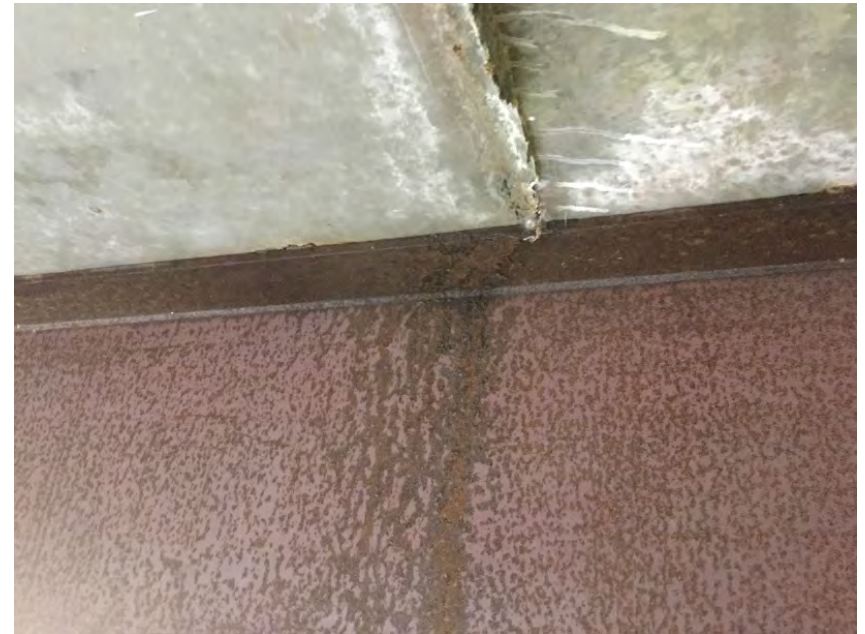
Deck Joints      Unrated      Too much sediment to properly inspect, however there are indications that water is getting through and onto the girders in some locations

Indications of deck joint condition

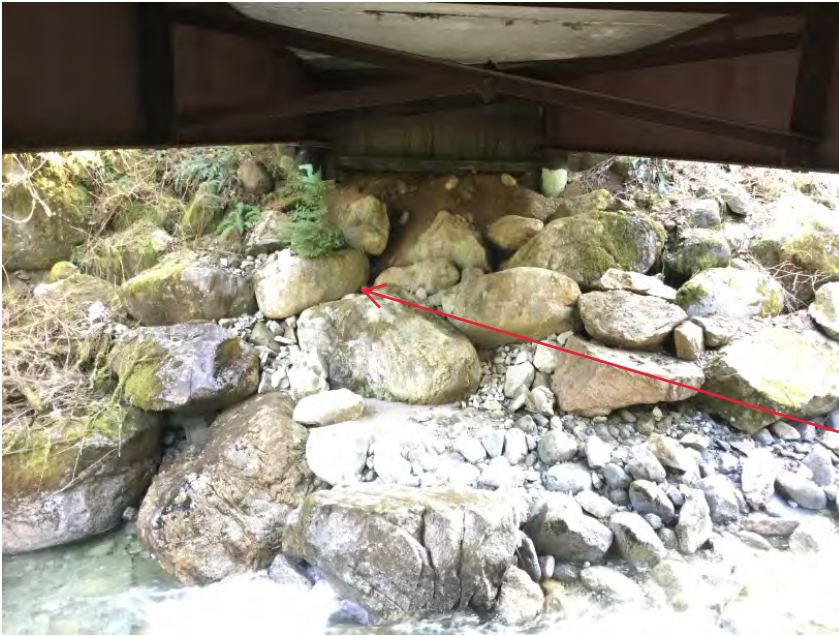
Right Bank Abutment when facing downstream

The downstream right bank footing was previously scoured which resulted in a reduced capacity and an All Steel Portable bridge was installed over top for temporary industrial access. The asbuilt report that was submitted by the licensee who completed the temporary install noted a temporary repair to the underside of the precast footing (see attached document). The All Steel Portable bridge has now been removed and because the previously scoured footing is obstructed from view a proper assessment of the footing cannot be made. Prior to bridge use the footing should be exposed and a qualified professional should assess the competency of that material under it. Until then then limit loading to L45 or 41 tonnes. Replace guardrail, risers and blocks; clean sediment from deck; replace missing delineators; and post bridge ahead signs.

Location of previous scour  
under footing

| Item | Priority | Repair Description |
|---|---|---|
| 4 | High | Expose right bank downstream footing to ensure it's well supported prior to any industrial activity |

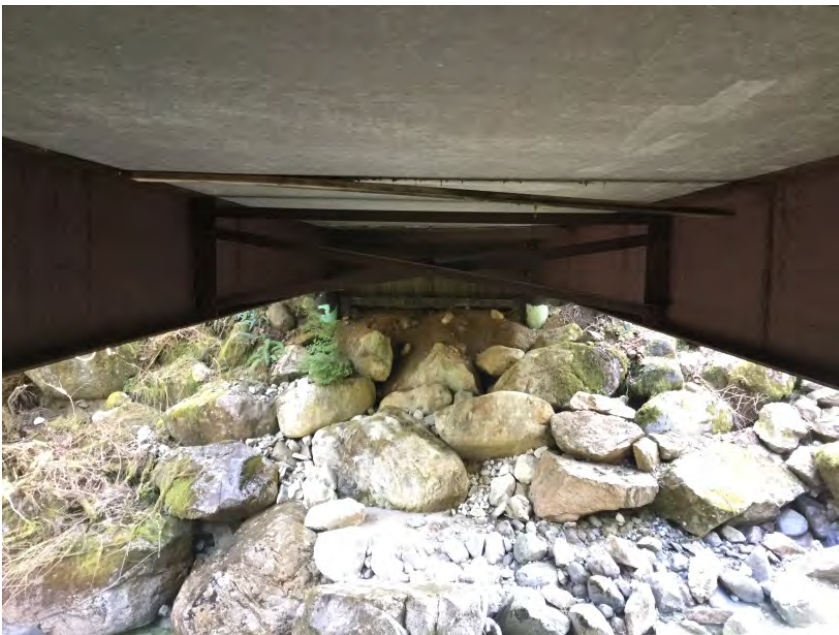
Superstructure

Girders Good Minor corrosion
