CK-2510

BOULDER 2.5km

2019 Inspection

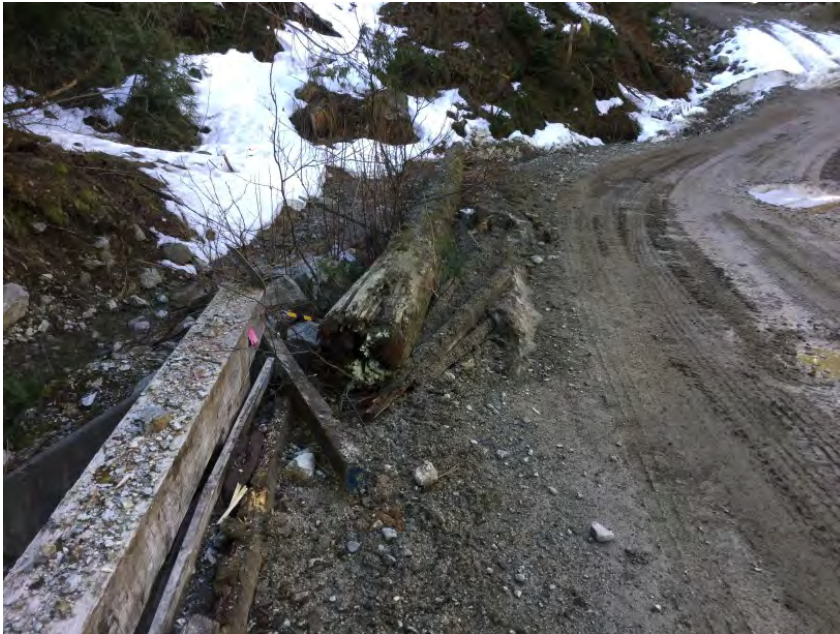
Missing upstream right approach but rock face directs traffic onto deck

Fender log inside running width

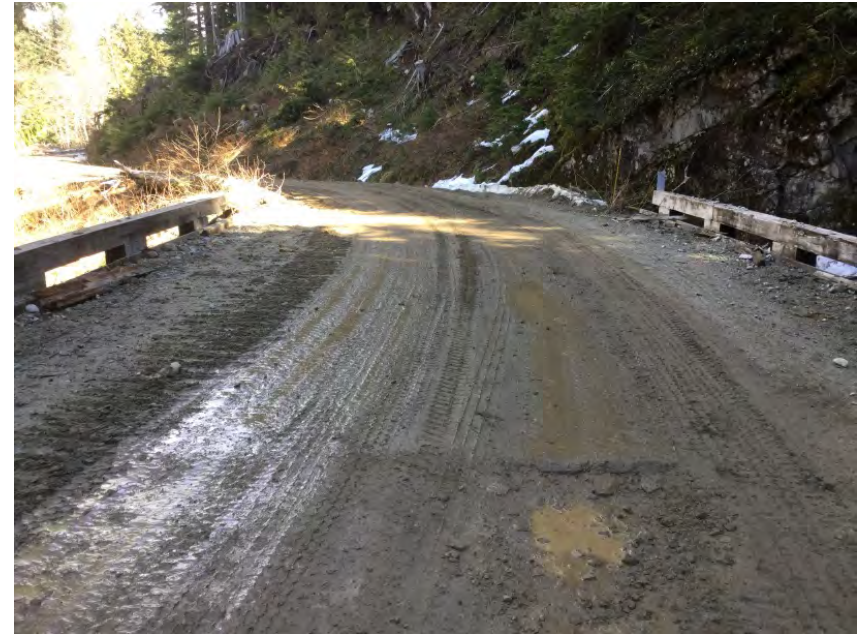
Concrete Deck Unrated Too much sediment to properly assess

Deck

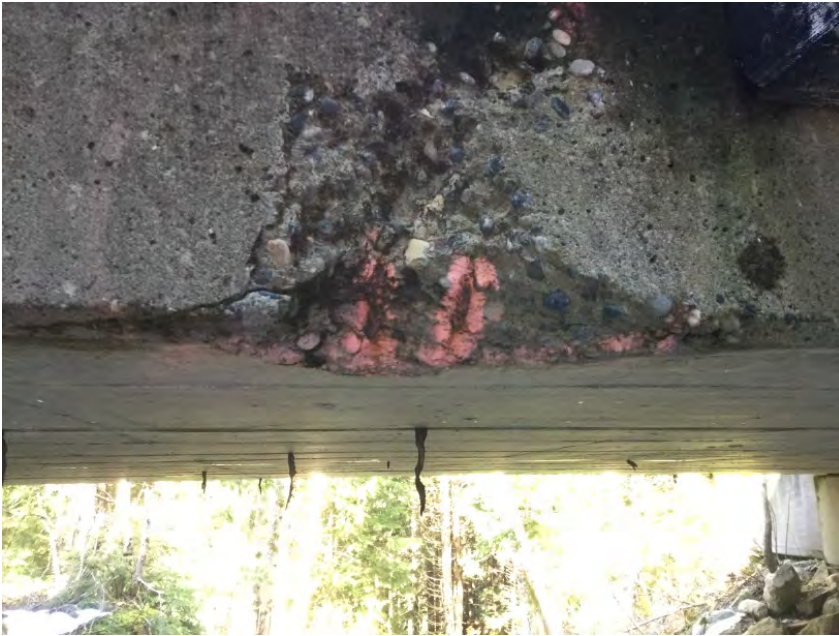
8 reinforced concrete slabs, minor damage noted at upstream girder

Damage to upstream concrete slab

Repair damaged upstream slab girder consistent with the Concrete Repair Guide for Concrete Bridge Components; replace the guardrail, risers and blocks; and post bridge ahead signs. At this length, width and depth of the individual concrete slabs the capacity of this structure could be L100 or 91 tonnes; HOWEVER the CEG doesn't have any structural or record drawings for this structure to verify, please send them in for review. In the meantime limit loading to BCL-625 or 63 tonnes.

| Repair Item | Priority | Repair Description |
|---|---|---|
| 3 | Medium | Repair damage noted to upstream girder |

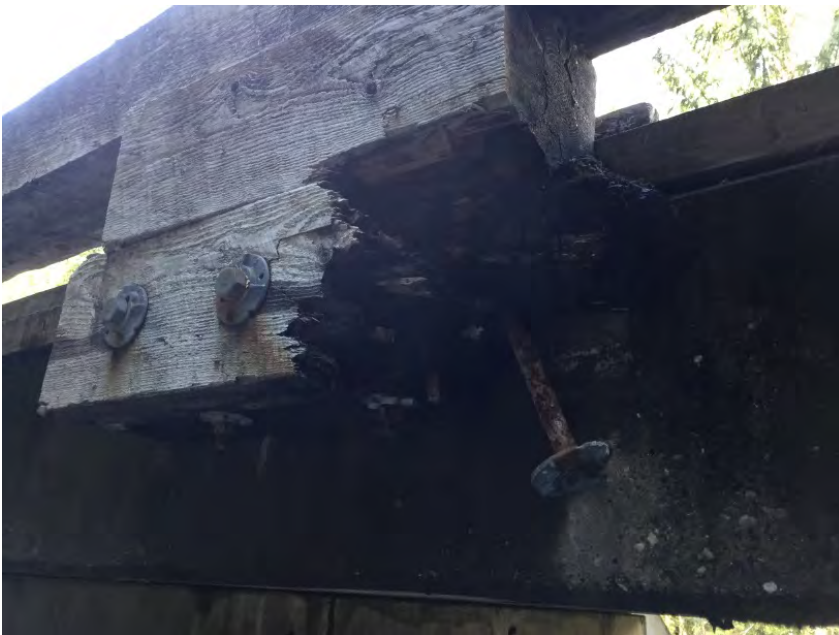
Curb Rail/Blocks/Posts Poor Rotten risers and blocks

Sideblock condition

| Repair Item | Priority | Repair Description |
|---|---|---|
| 1 | Medium | Replace guardrail, risers and blocks |
