CK-2519

GARNET 9400 3.5km

2019 Inspection

| Crossing Name | East Fork Garnet Creek |

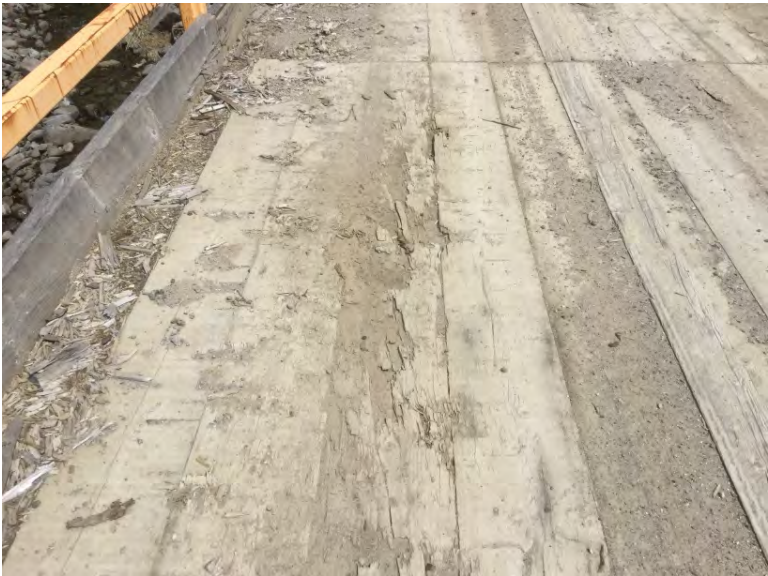
| Running Planks | Fair | Poor in some locations along wheel path |

Deck wear

| Repair | | Repair Description |
|---|---|---|
| 3 | Medium | Replace wear planks |

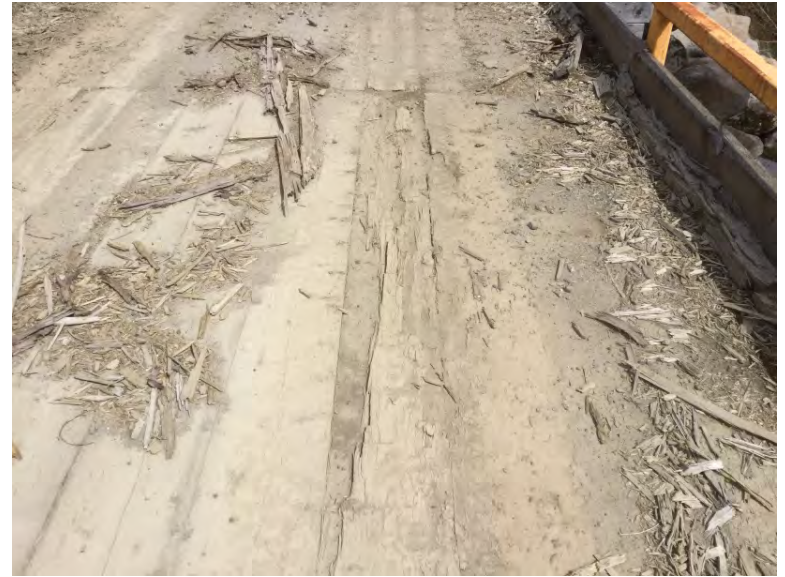
Deck wear

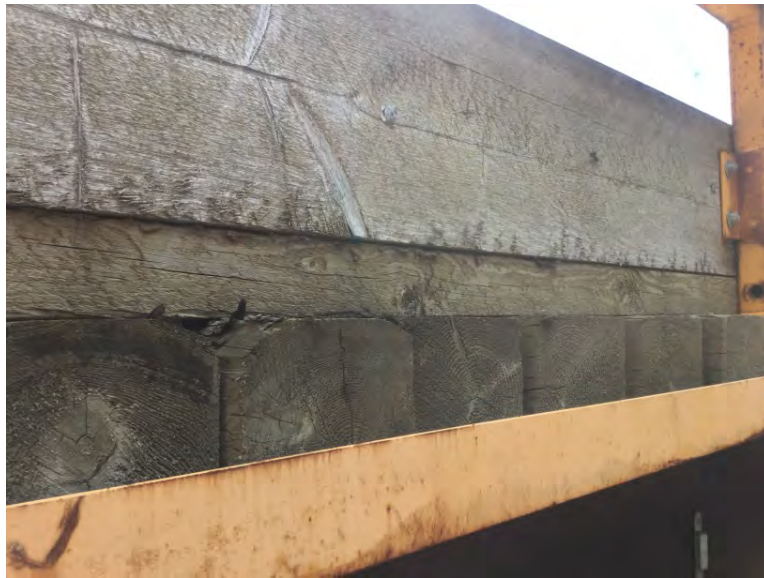
Treated ties and subdeck

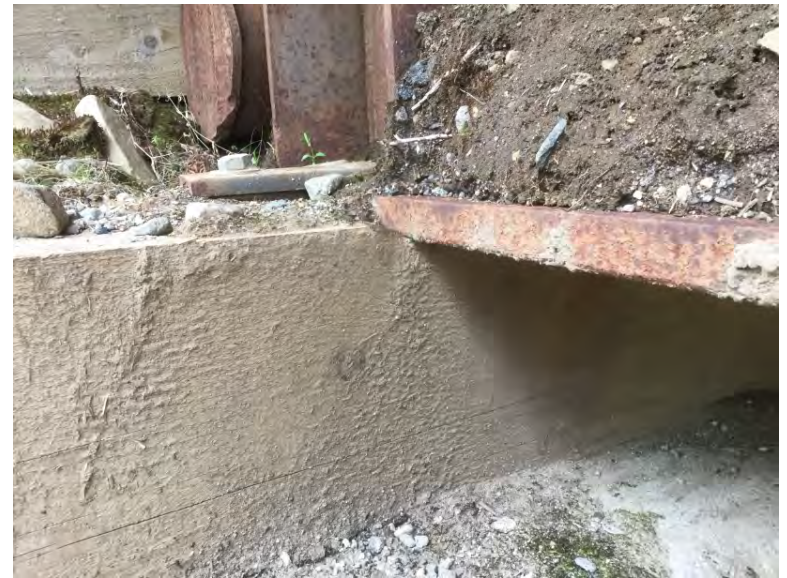
Timbers with minimal crushing noted - monitor

Monitor crushing of timber sill at left abutment

Left abutment timber sill 10mm crush

| Item | Monitor Description | Frequency |
|---|---|---|
| 1 | Crushing of timber sill at left bank | Routine Inspection |

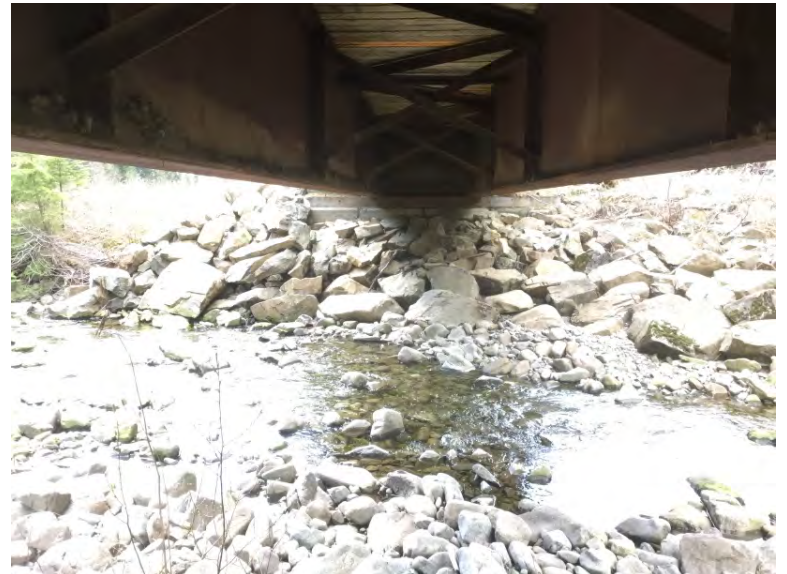
Right Bank Abutment when facing downstream

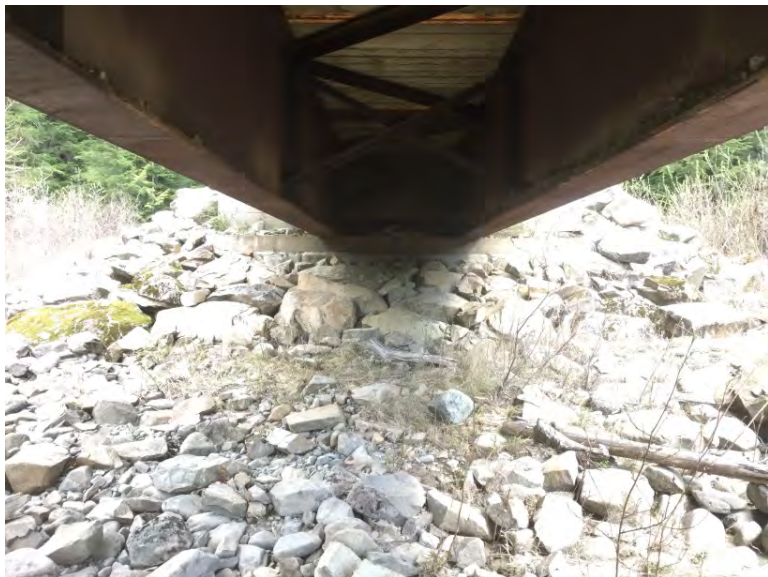
Left Bank Abutment when facing downstream

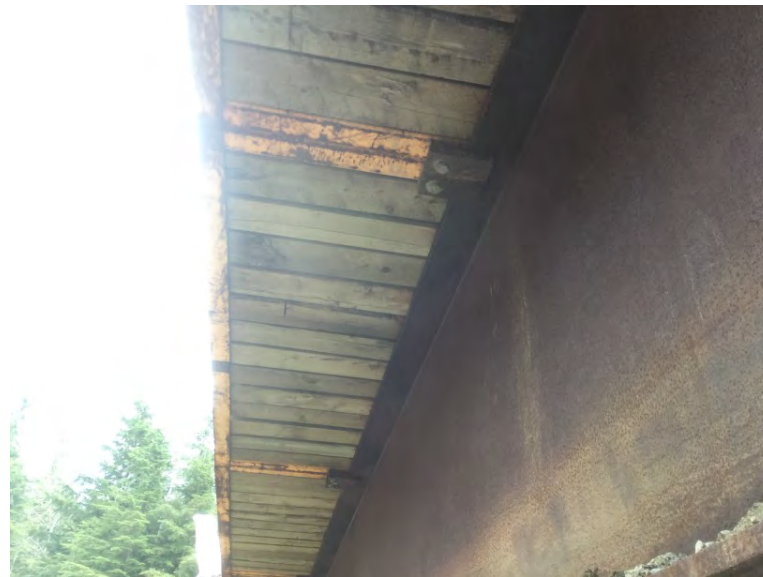
Deck clips in place and functional

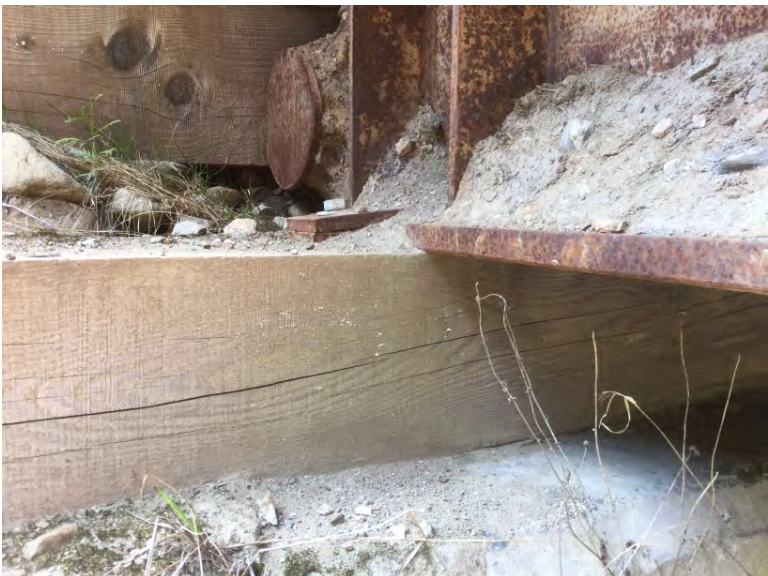
No timber sill crushing evident at right abutment

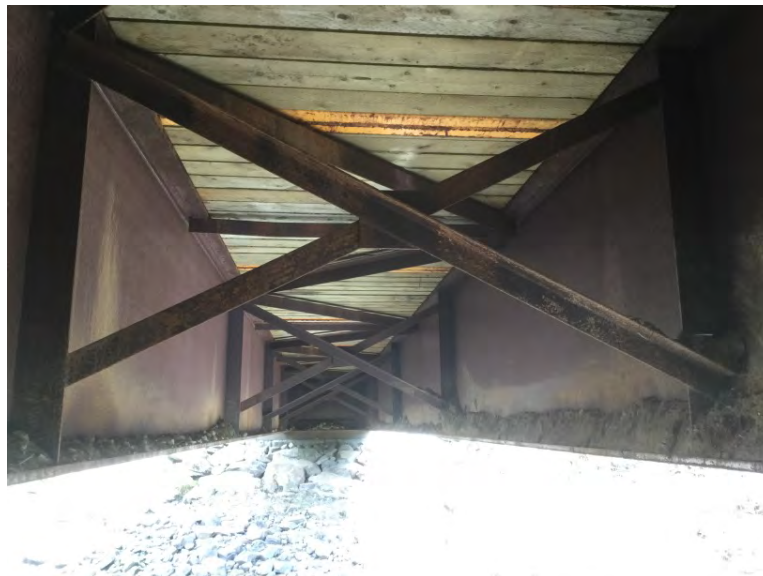
Superstructure
